Property Inspection

The Sample Group Corporation

**445 Lake Benbow Drive, Garberville,
California**

**North Coast Property Inspections LLC
PO Box 422
Field's Landing, CA 95537
(707) 444-2326**

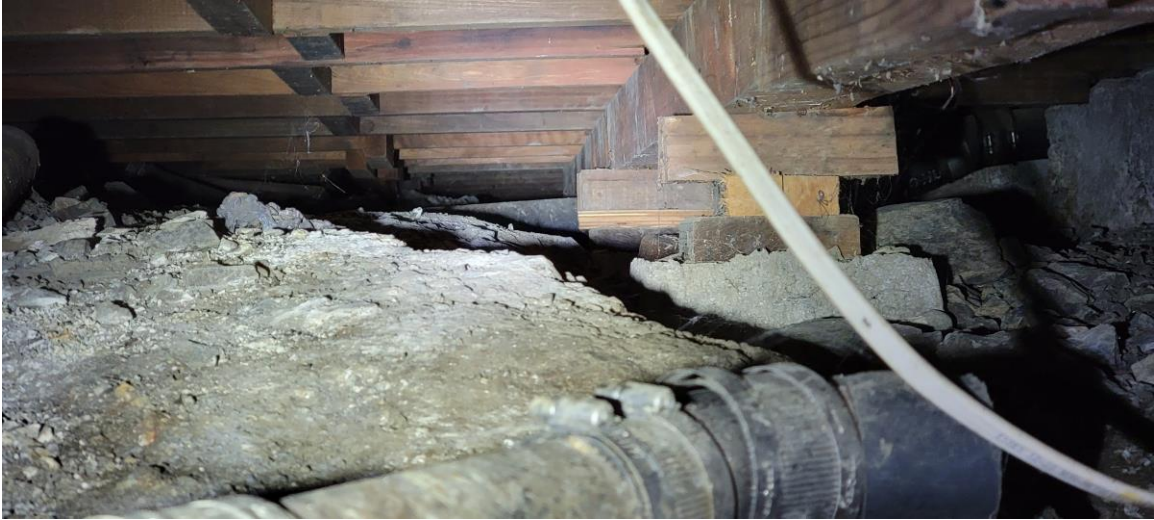
Bolting the building to the foundation was a standard building practice for a structure of this quality at the time it was constructed. The bolts are mostly not visible due to the method of construction and wall coverings. Limited evidence that the building is attached to the foundation is present in the open walls of the mechanical areas and crawlspaces. No cracks of any significance were found in the perimeter foundation. Access to the entire crawlspace was not possible due to the low head clearances (see below).

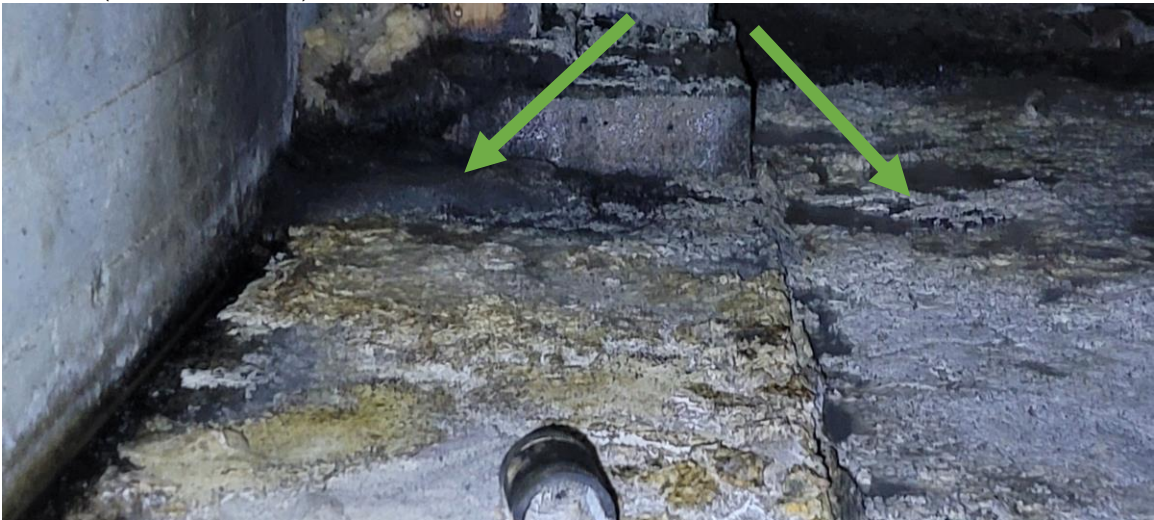
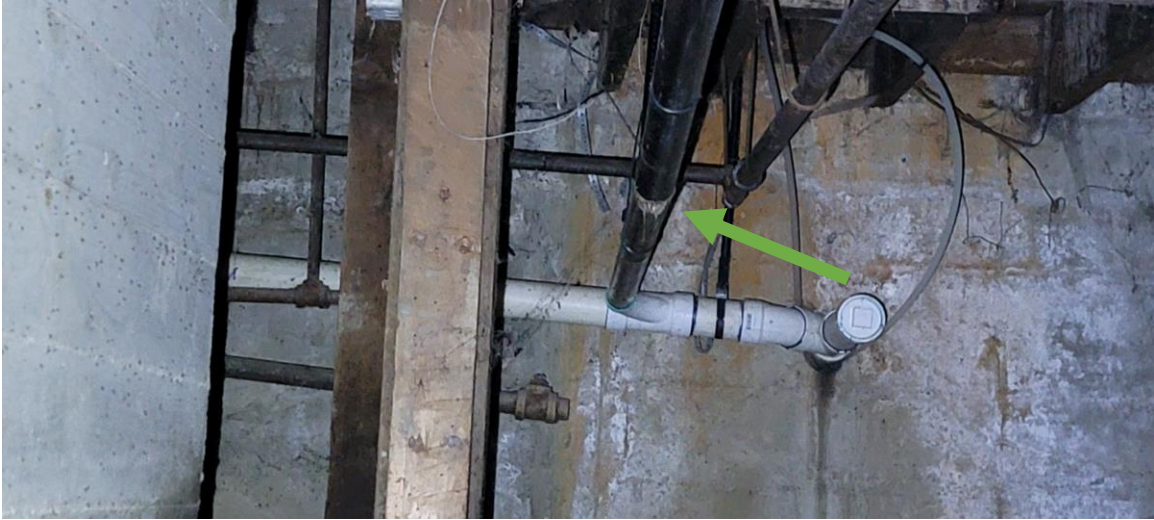
The accessible floor supports are strong and dry. There is earth to wood contact in many areas. The floor is not insulated. The soil under the original building is dry with the exception of the area under the employee break room at the southwest corner where there is a plumbing wastewater leak (see below).

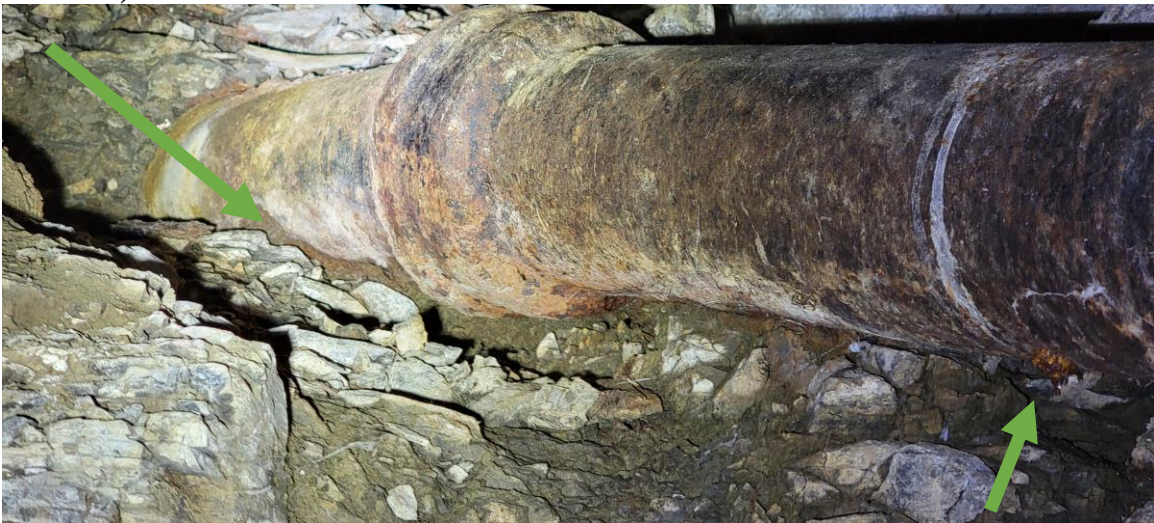
The original 96-year-old cast iron and galvanized steel drain lines are showing age with evidence of leaking (see below).

A licensed plumbing contractor should evaluate the installation and condition of this plumbing system. I recommend that a sewer scope be performed to determine the condition of the original 96- year-old cast iron drain lines, from under the building to the septic connection.

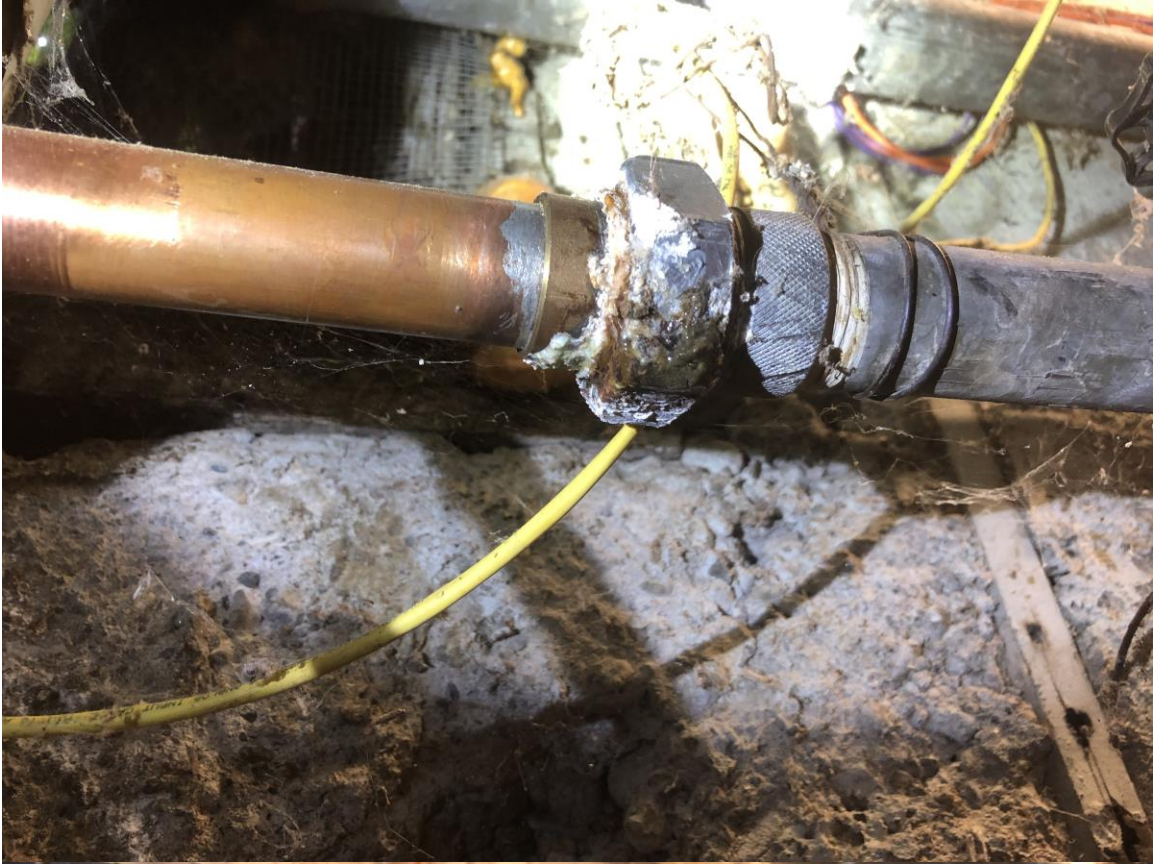
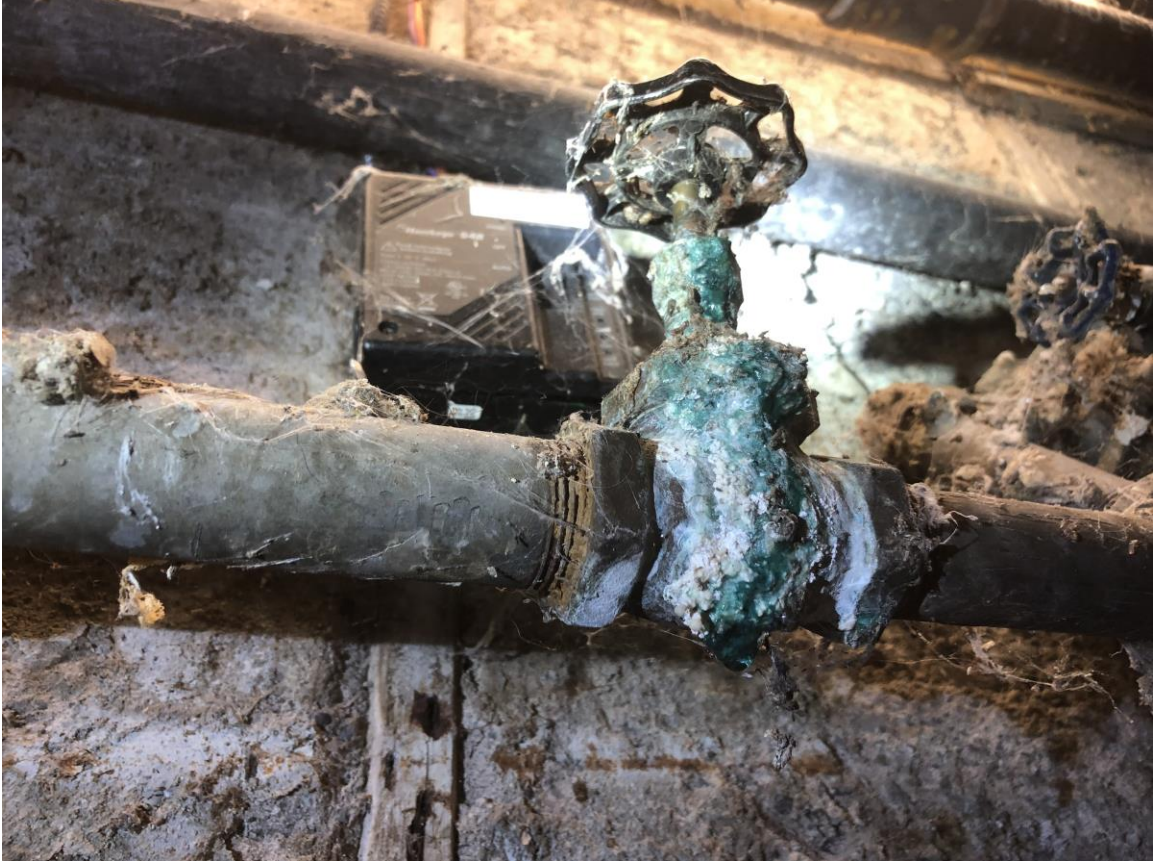
There are freshwater leaks at valves and fittings under the general dining areas (see below).

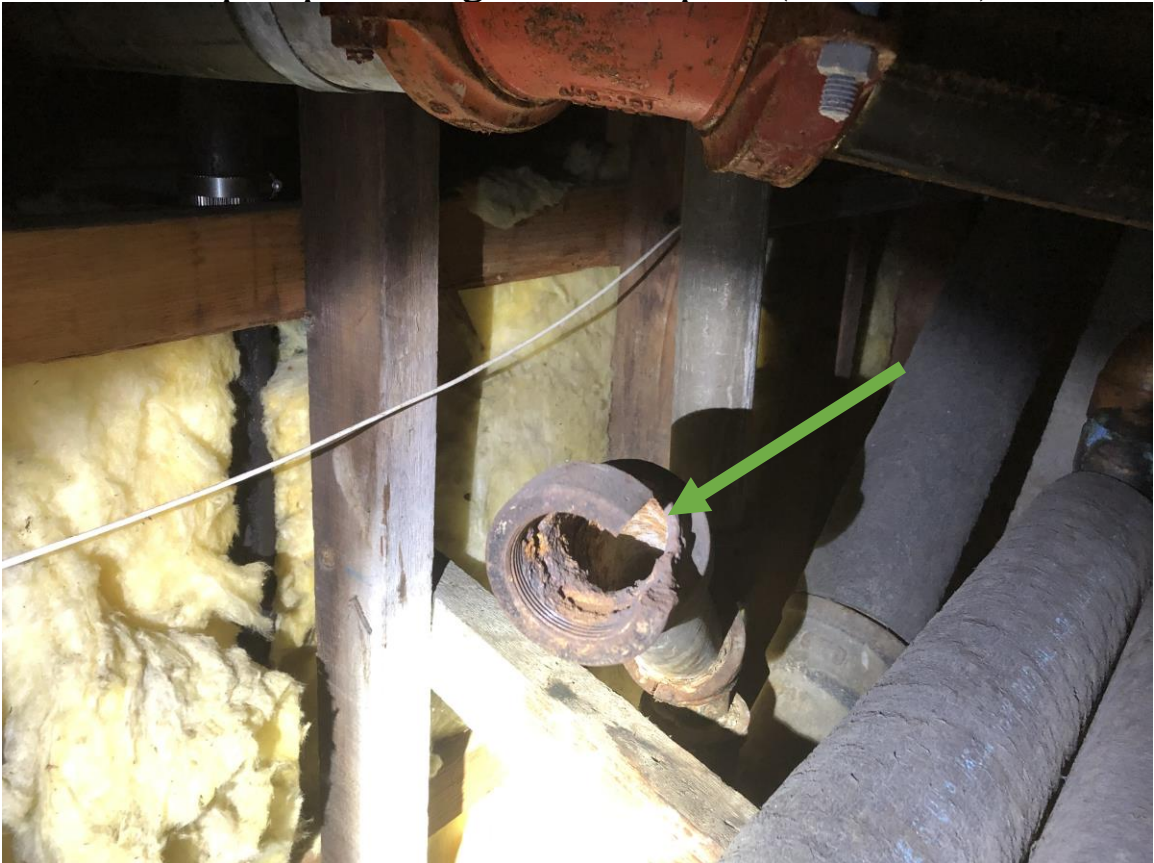
There are open plumbing vents in spots (see below).

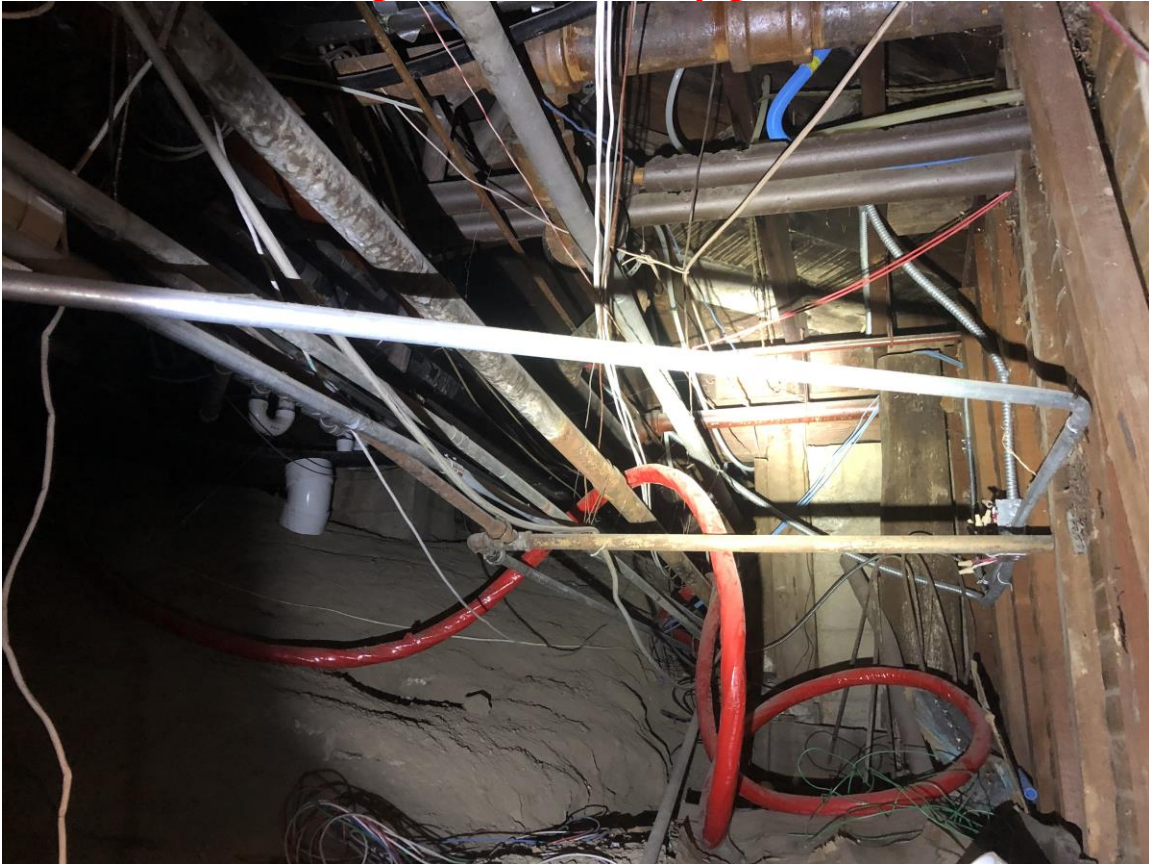
There are unsupported electrical wires not protected within conduit and live electrical wires not terminated within a covered electrical splice box in many places (see below).

1. **FOUNDATION:** Repair any live electrical wires not terminated within a covered electrical splice box. Complete the electrical upgrades by installing commercial grade wiring. Repair the freshwater leaks. Remediate any asbestos type of pipe wrapping still in the accessible crawlspace areas as recommended in the asbestos survey of Brunelle & Clark Consulting May 12, 2016. Repair the wastewater plumbing leaks and sanitize the contaminated area. Repair the earth to wood contact. Remove the construction debris from the crawlspace. Increase the ventilation in the accessible areas of the crawlspace. **I recommend that you consult with the engineer of record concerning the Terrace wing and 2017 addition in regard to the erosion and repairs to the river embankment.**

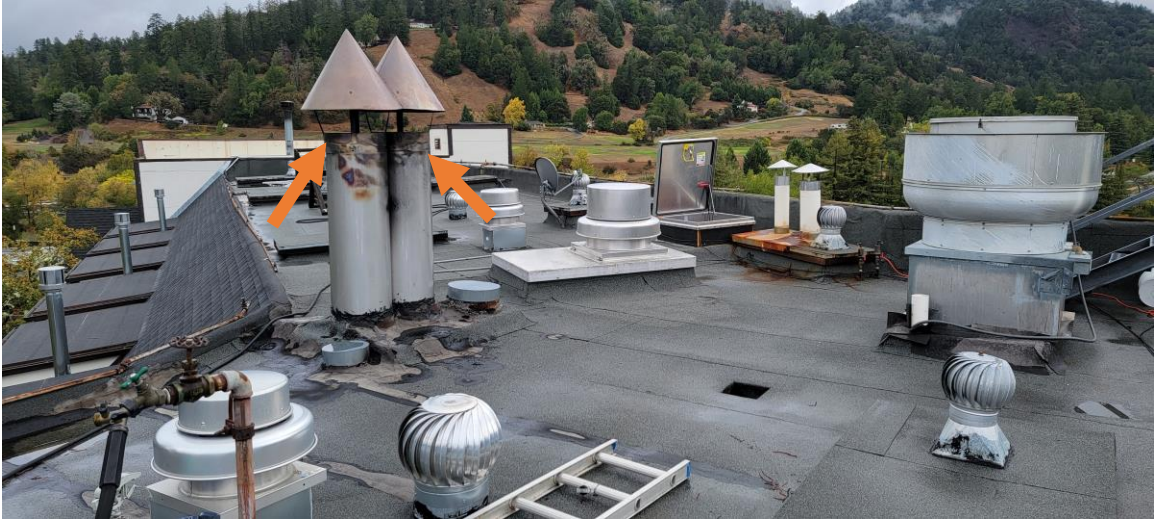
Proper metal flashing is applied. There does appear to be a flashing weak spot for water intrusion at the original wood frame structure/steel framed 2017 addition roofing connection (see flashing photos above). There are asphalt shingles that are likely damaged by birds. There are exposed fasteners in spots. There is considerable ceramic granule loss and fiberglass matting exposed on the front face entry of the building. There are rusted flashings and cracks or missing sealant at many of the plumbing and heating penetrations. The wood chimney flues over the original building have no spark arrestor screen (see below).

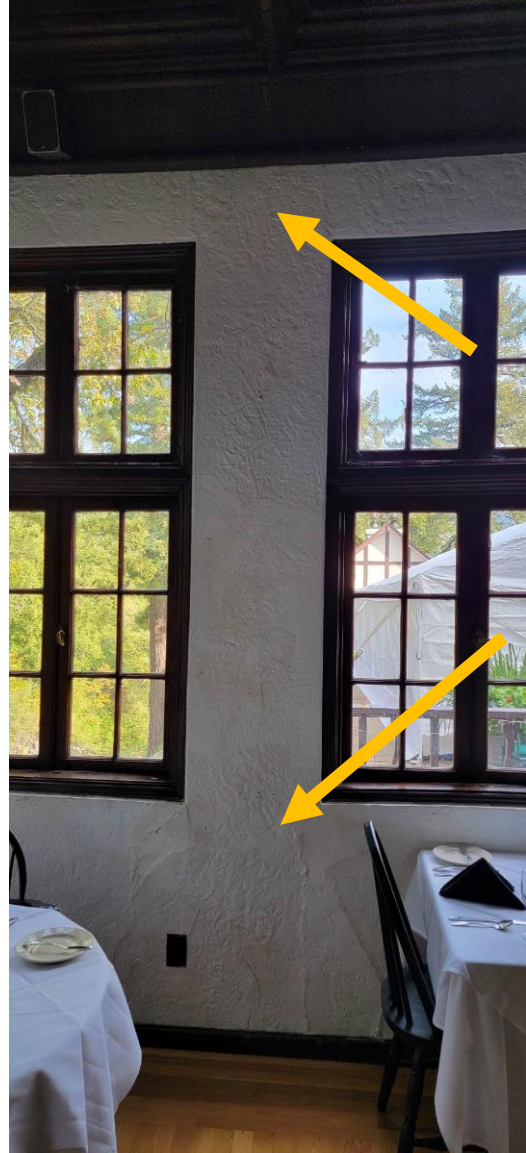
Dining outside wall

The gutters and downspouts are in good/fair and poor condition. There are gutters that have rusted out at the downspout connection over at the cottage east side. Some of the downspouts are not diverted away from the foundation of the building. Some of the downspouts are disconnected or appear to be allowing water intrusion in the wall cavity in the dining room (see photos below).

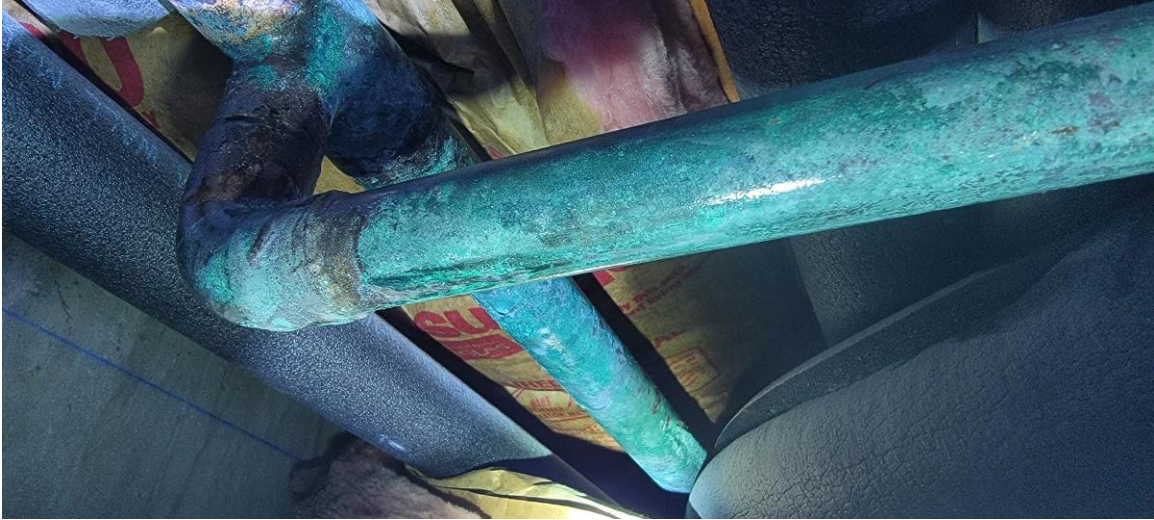
The roof over the terrace wing is the concrete patio. The actual material to waterproof this area is not visible. There is active water penetration to the hall below near the terrace rooms stairs. This may suggest that the cold water lines for the HVAC system are condensing in the floor cavity, and this is the source of the ceiling water damage (see below).

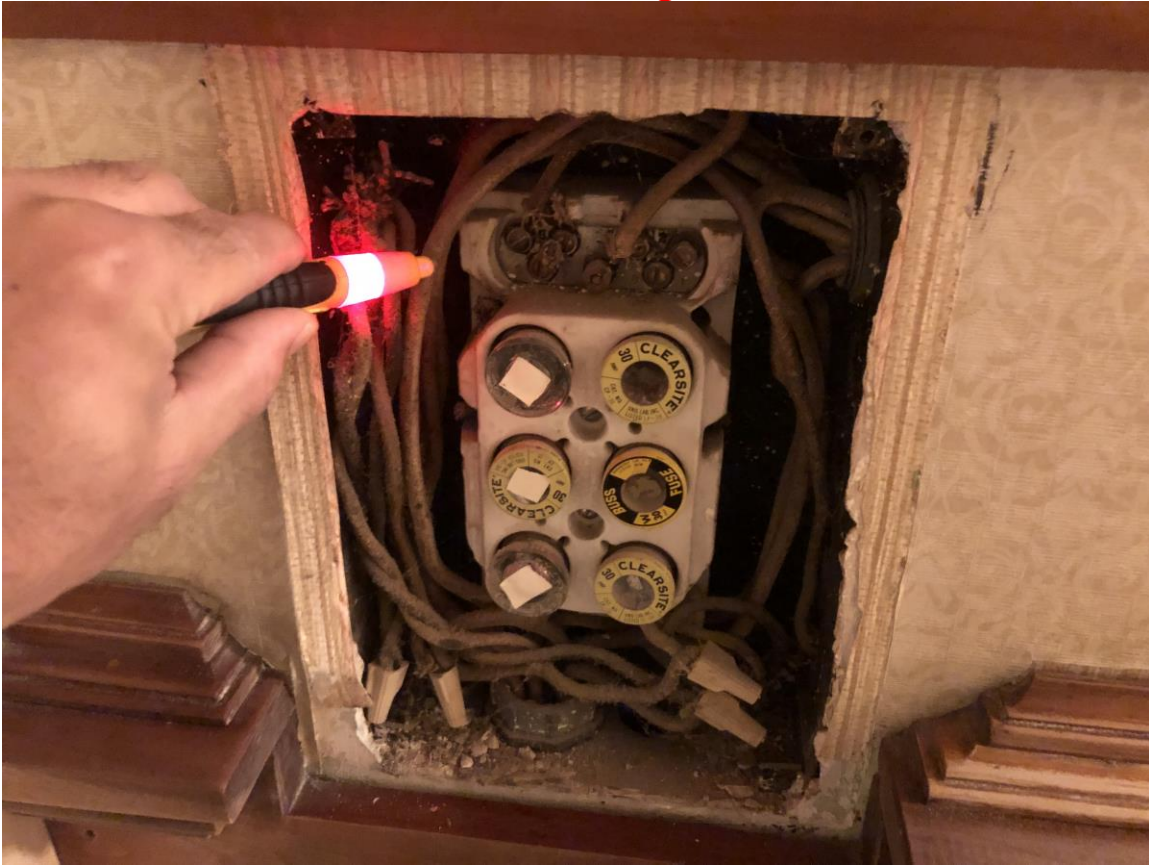
These old fuse boxes appear to be used as splice boxes with the old fabric knob and tube wiring still in use (see below).

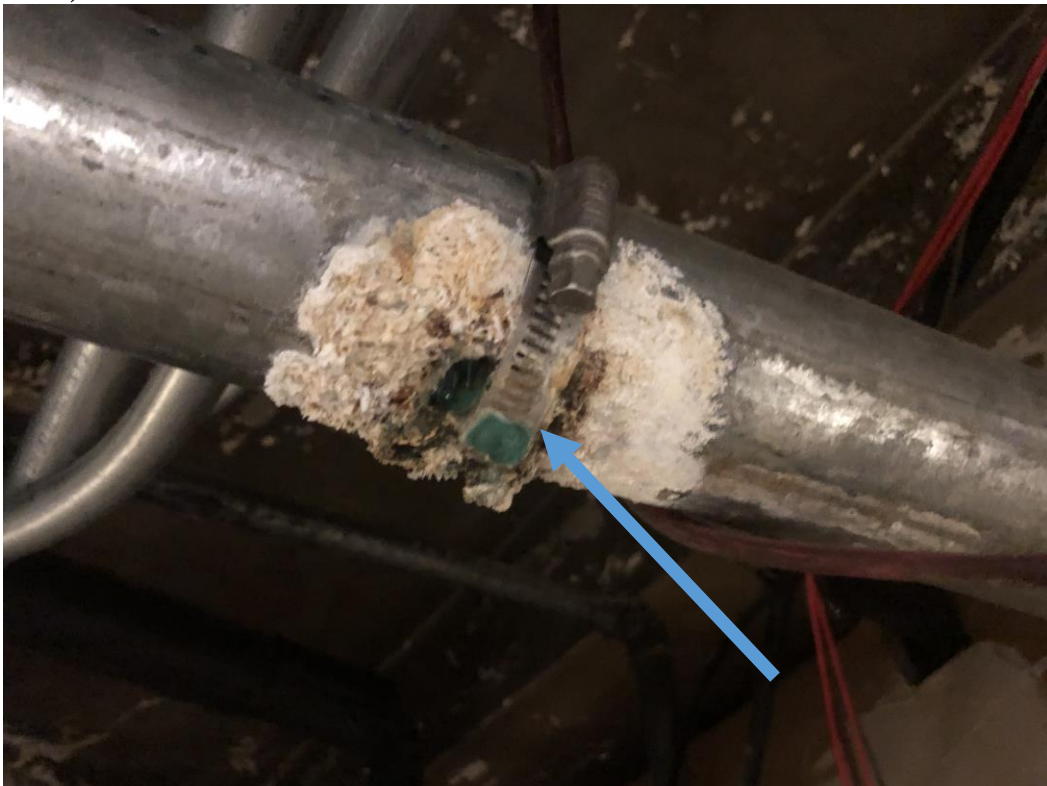
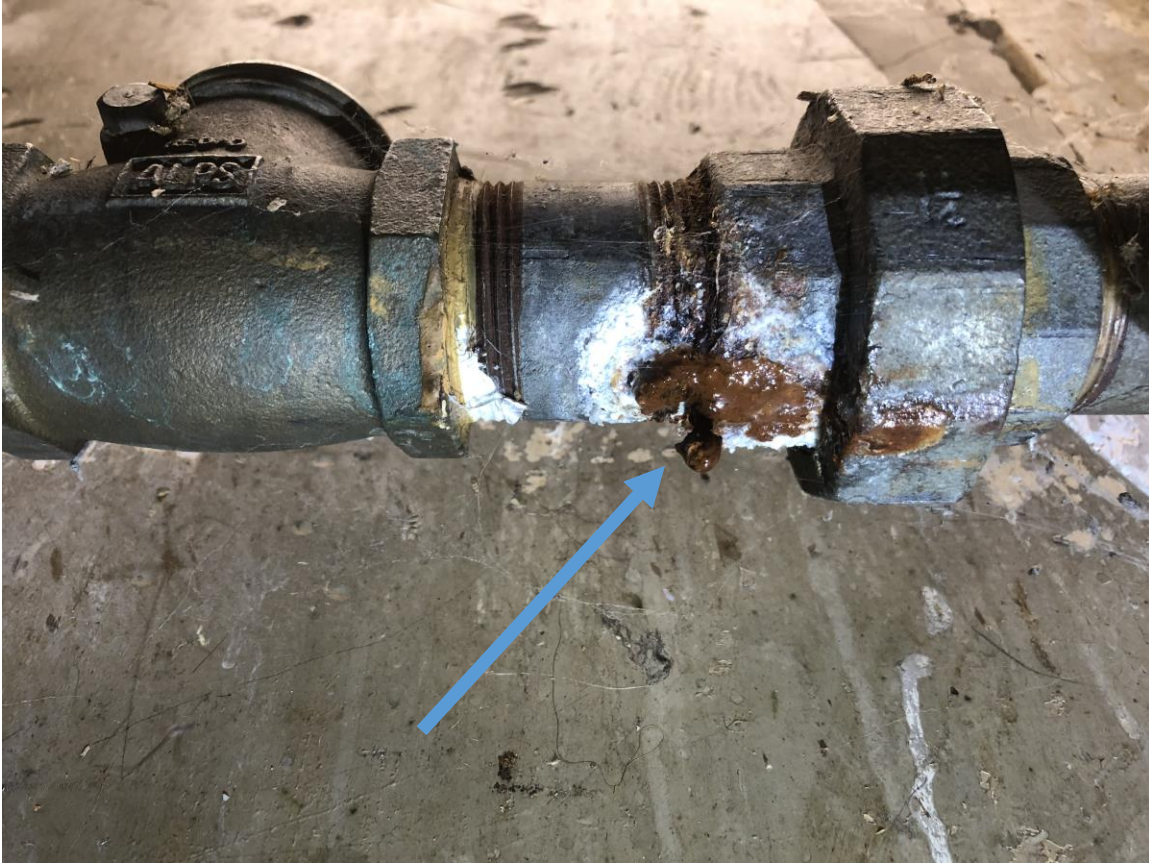
There are a number of minor freshwater leaks in the mechanical room and crawlspace and kitchen areas (see below).

4. **PLUMBING SYSTEM**: Repair the freshwater and wastewater leaks. Remove the old cast iron pipes and replace with plastic. Repair the toilet leaks. Secure the fixture valve handles and set the screws on the clawfoot tubs securely. Remediate any asbestos type of pipe wrapping still in the accessible crawlspace

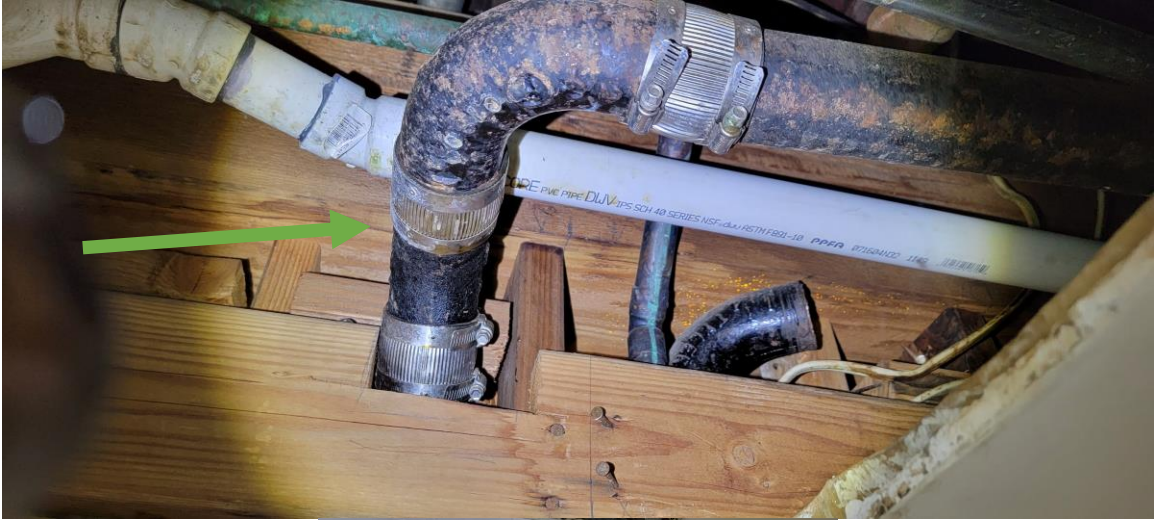
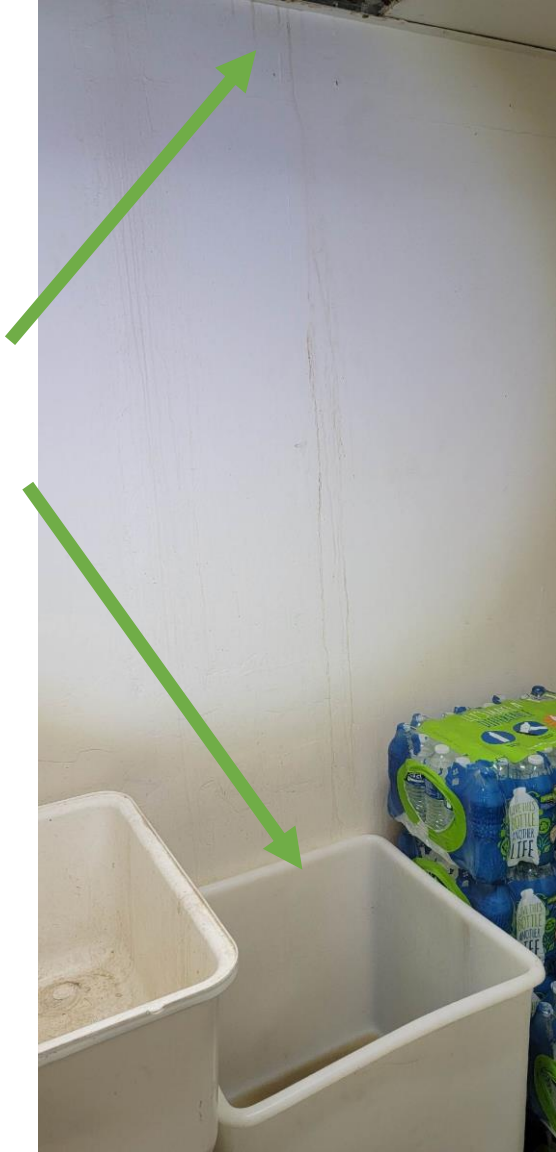
The waste system uses cast iron, galvanized steel and some plastic pipes. A kitchen sink drain is leaking in the basement hall area (see below).

The wastewater leak is being collected by a bucket. Waste leaks were found in the crawlspace and kitchen areas (see foundation section above and kitchen section below). No other waste leaks were found in any accessible areas, in or under the building. The plumbing system appeared to be functioning adequately at the time of inspection.

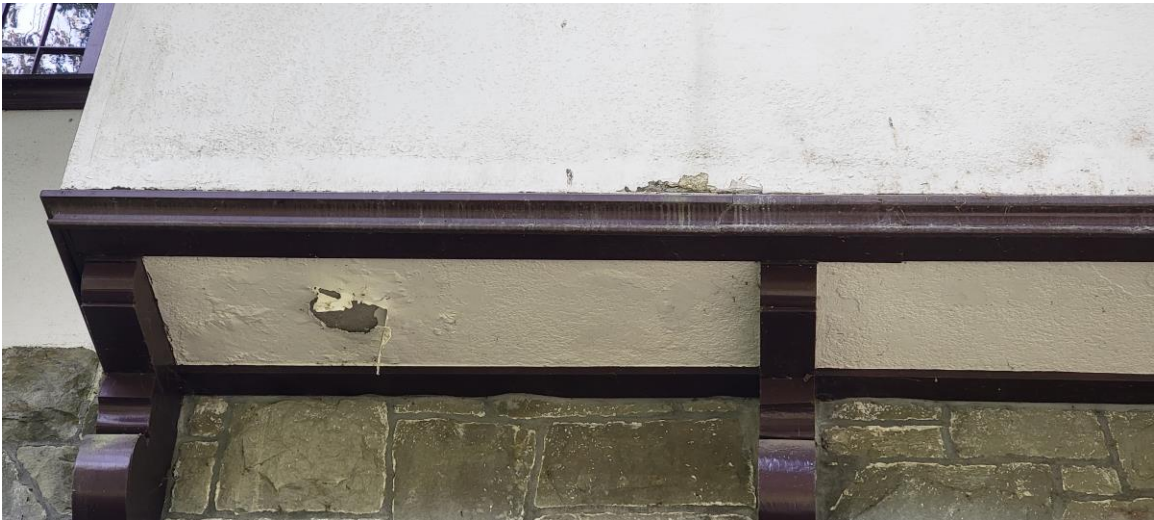
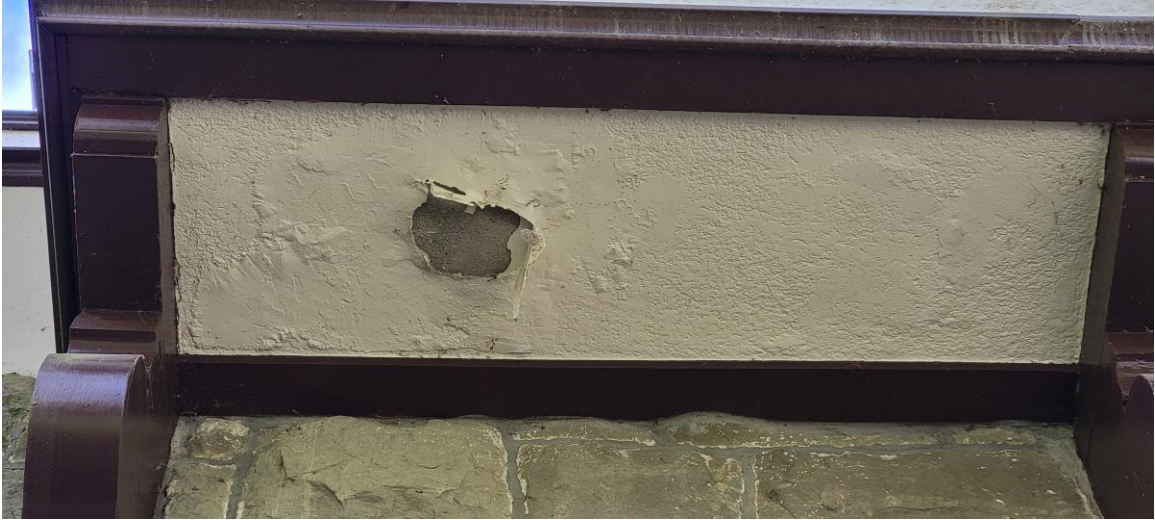
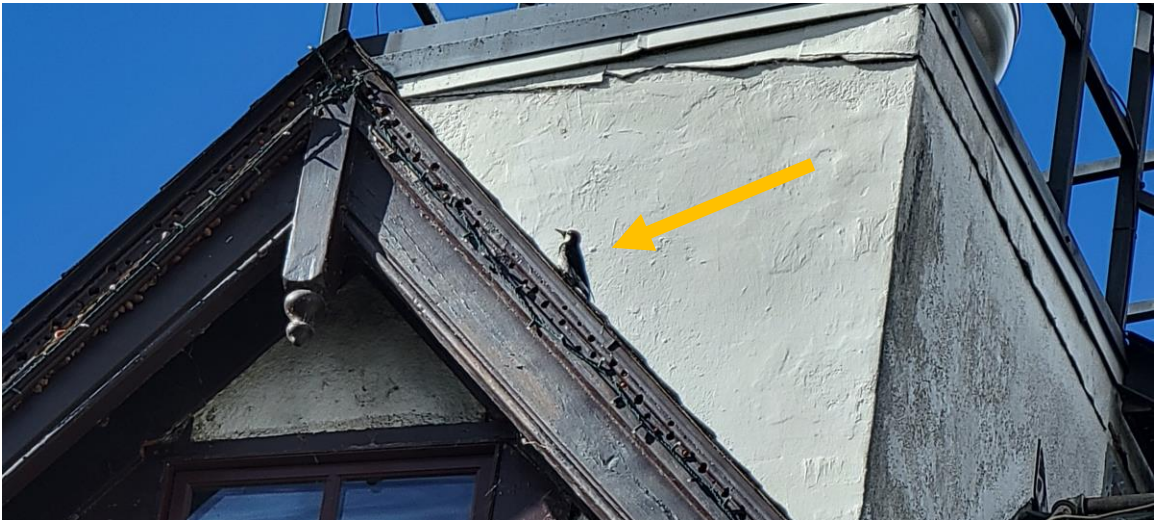
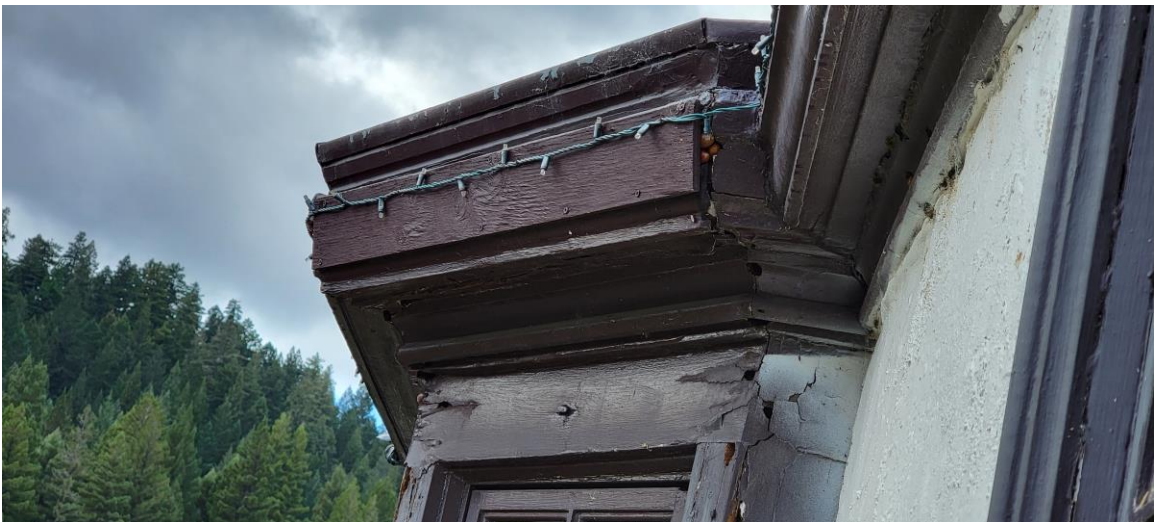
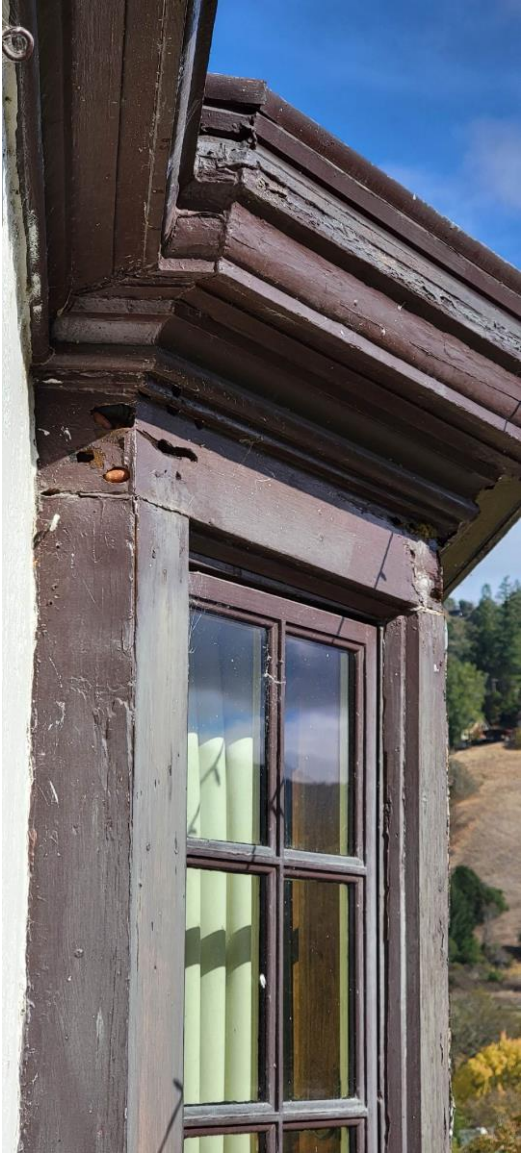
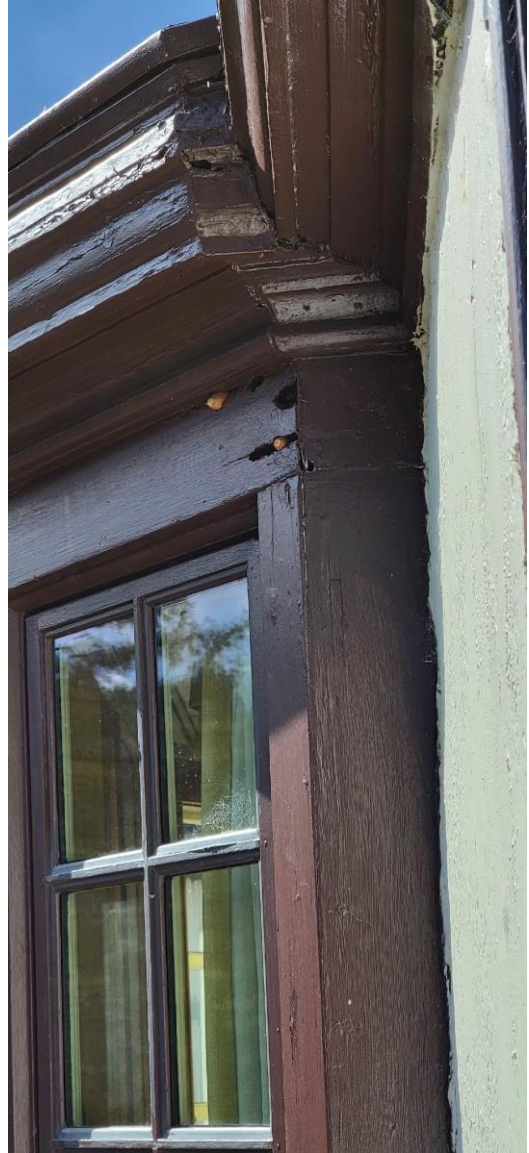
The exterior is in good/fair condition. There is evidence of water penetration in many areas of the stucco siding, wood window sashes, trim and corbel moldings on all sides of the original building. Neighborhood woodpeckers have extensively damaged the old growth redwood trim on all sides of the building depositing acorns into the void cavities. There is broken single pane window glass. There are many dual pane windows with failed seals. Many of the original windows do not close/fit properly. The hardware of many original windows are non-functional or damaged so as to not operate properly. Some balconies may be allowing water intrusion (see below). Many exterior doors and door jams are water damaged and allow water intrusion into some rooms (see photos below).

8. **EXTERIOR:** Repair the water and bird damaged original old growth trim and custom woodwork on the exterior. Repair the damaged stucco as needed. Paint the siding and trim as needed. Repair or rebuild the damaged original wood casement windows and doors. Replace or repair the damaged window and door hardware as needed. Replace the dual-pane windows with failed seals. Rebuild the upper lobby exterior stairs water damaged landing and safety railings for safe guest use. Repair the upper lobby porch water damaged wood columns and custom trims as needed. Repair the trip hazard at the upper lobby entry porch new building connection for guest safety. Repair the irregular lower stair landing pavers trip hazard for improved guest safety. Improve the weather seal at all windows and doors as needed for better energy efficiency. Repair the damaged and settled stone walkway to the river. Repair the Terrace wing tree damaged concrete patios as needed. Repair the water damaged Terrace wing decorative fencing. **Repair the exposed live electrical wiring at the terrace patio and garden transition areas and install (GFCI) protection at all exterior outlets.** Repair the broken window glass on the single pane windows and doors. Repair the water damaged trim on the building additions. Consider

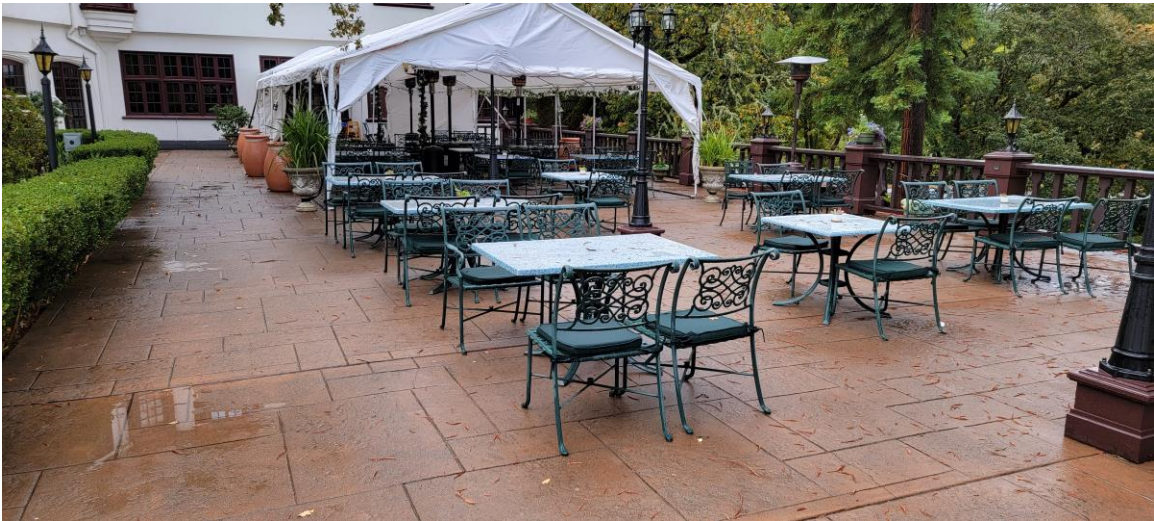
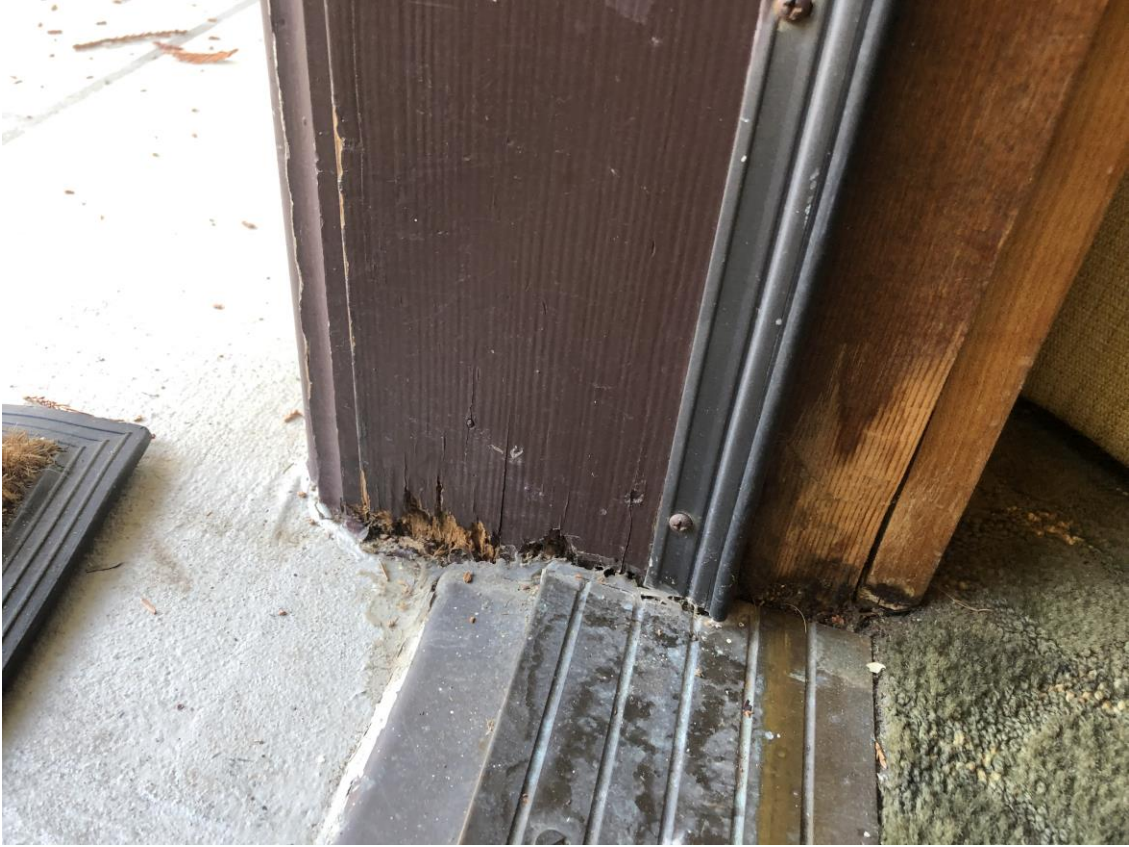
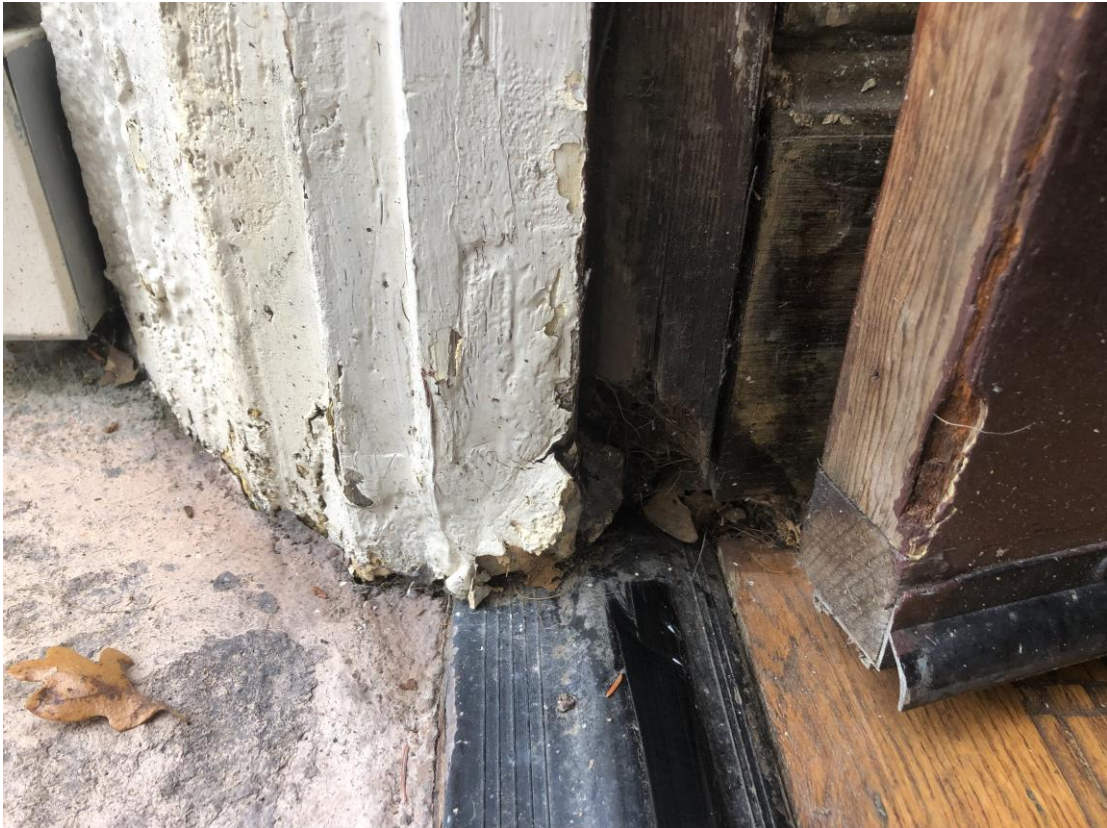
There are many terrace patio pavers in the courtyard that are cracked, allowing water intrusion into the space between the bottom of the pavers and the unseen waterproof membrane (see below).

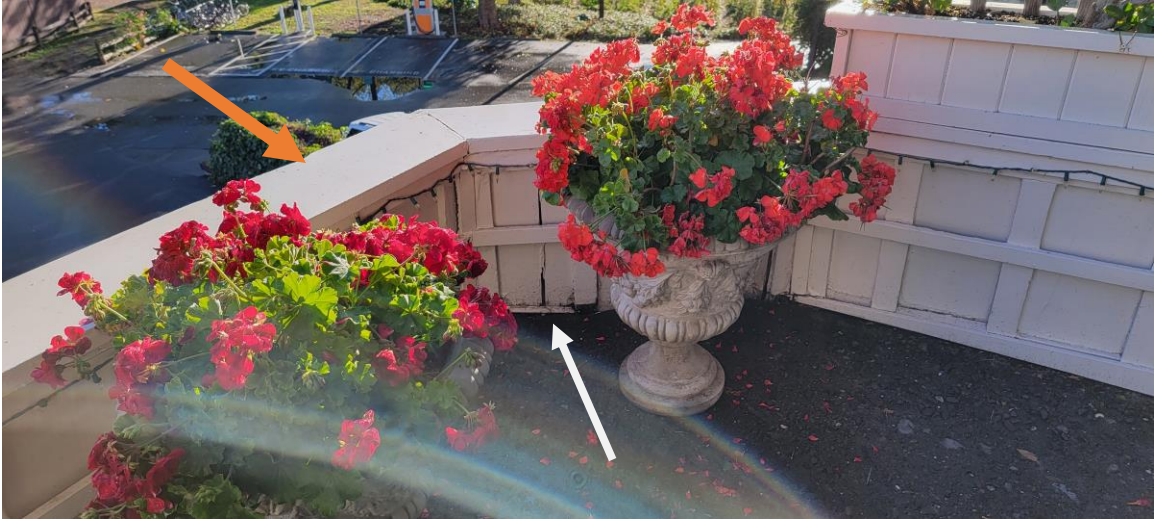
At the upper lobby porch there is water damaged posts and safety railing. The wood landing and framing members atop the entry stairs are water damaged. The safety railing is too low for guest safety and protected by planters (see below).

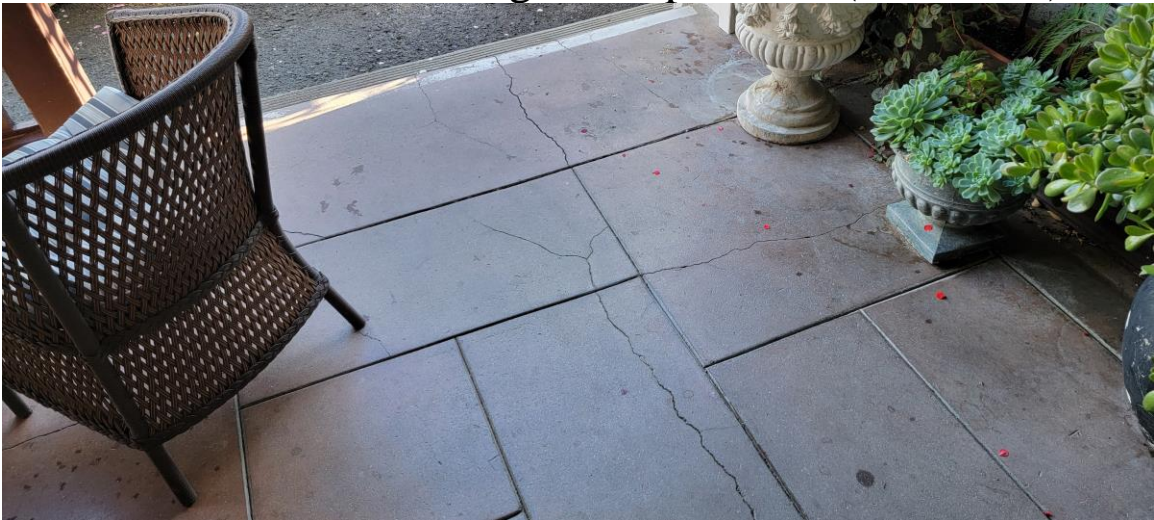
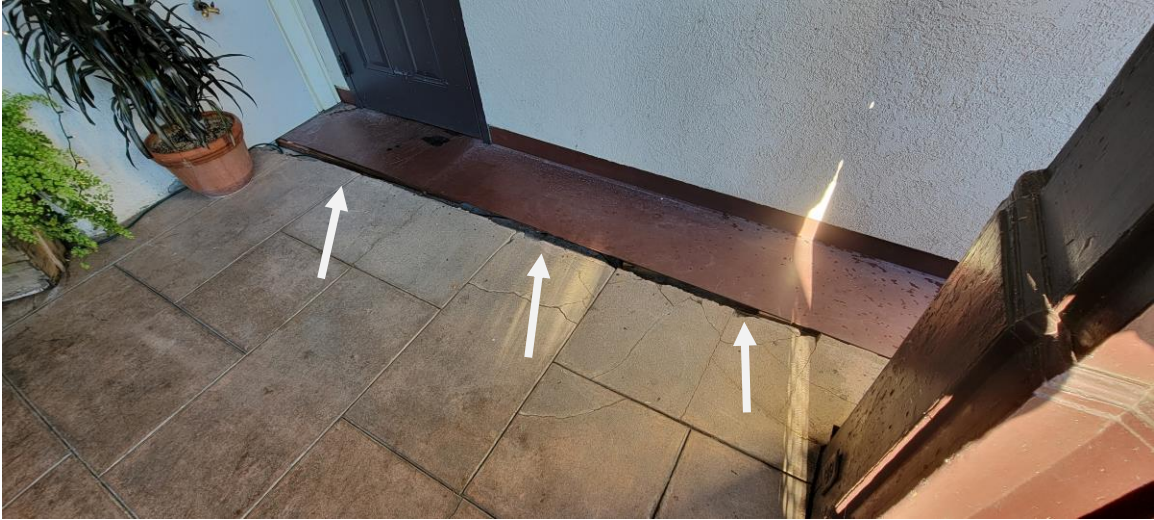
There are many cracked upper lobby porch tiles and the expansion plate on the porch between the original building and the 2017 addition is a guest trip hazard (see below).
