Property Inspection

The Sample Group Corporation

**445 Lake Benbow Drive, Garberville,
California**

**North Coast Property Inspections LLC
PO Box 422
Field's Landing, CA 95537
(707) 444-2326**

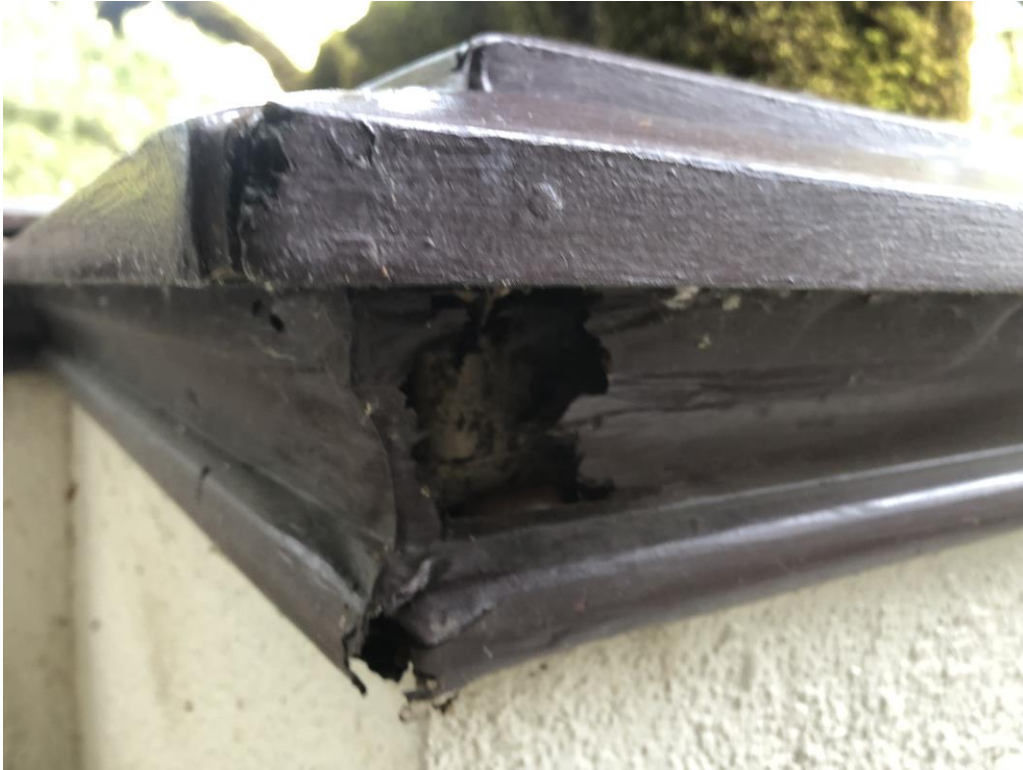
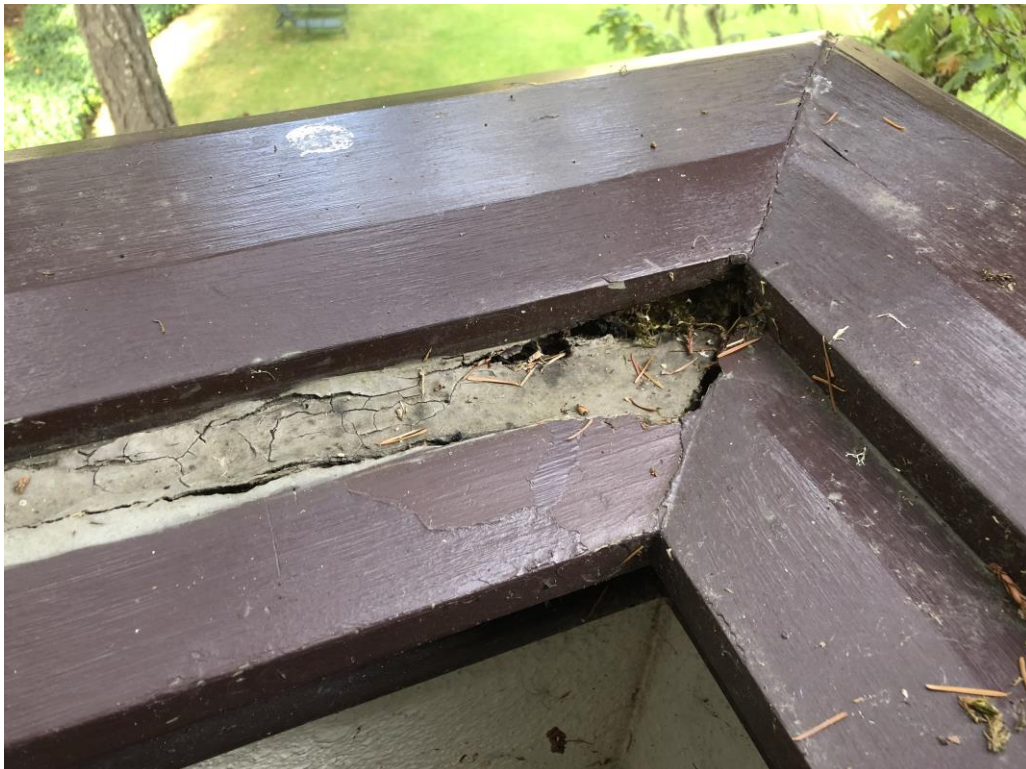
Exterior balcony handrail trim is water damaged (see below).

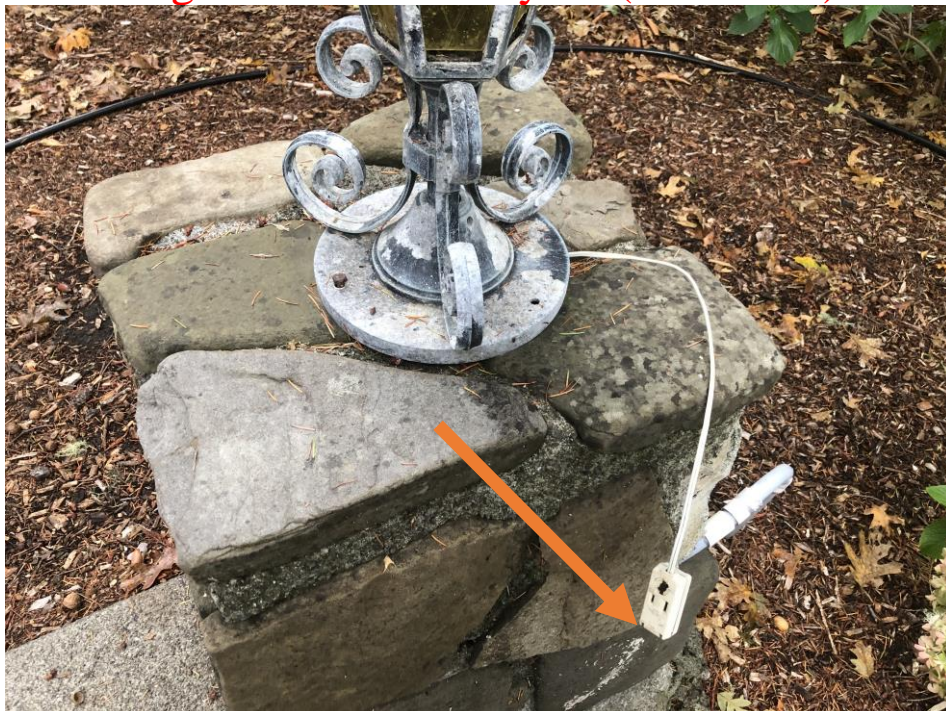
There are live electrical wires not terminated within a covered electrical splice box in several exterior common areas including the terrace courtyard (see below).

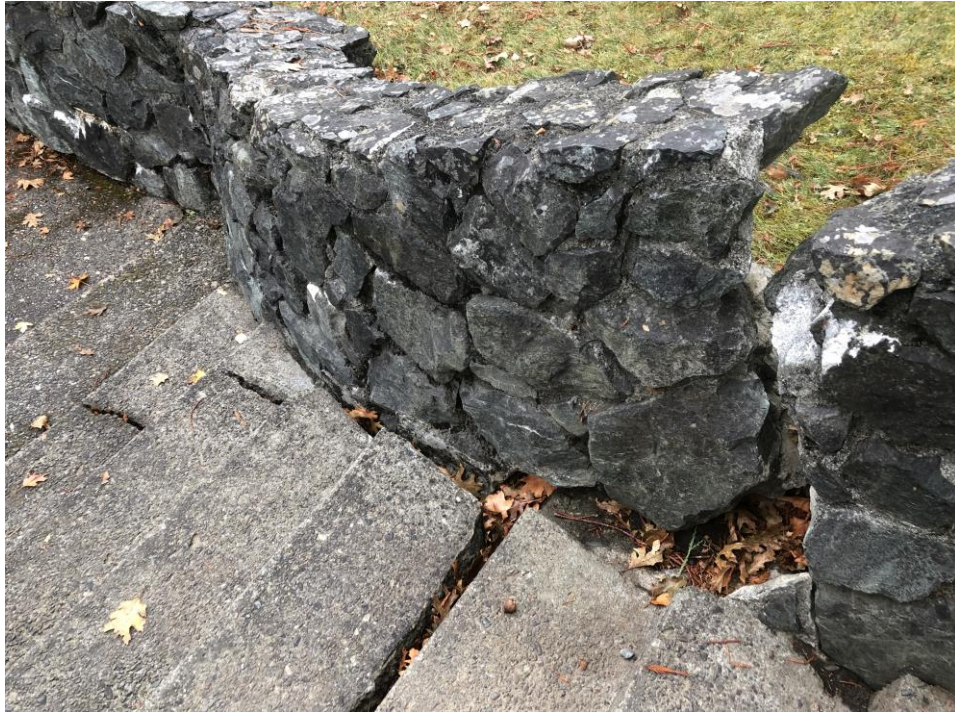
Many of the exterior outlets are not (GFCI) protected. There is a guest fall/trip hazard located at the rock wall path to the river (see below).

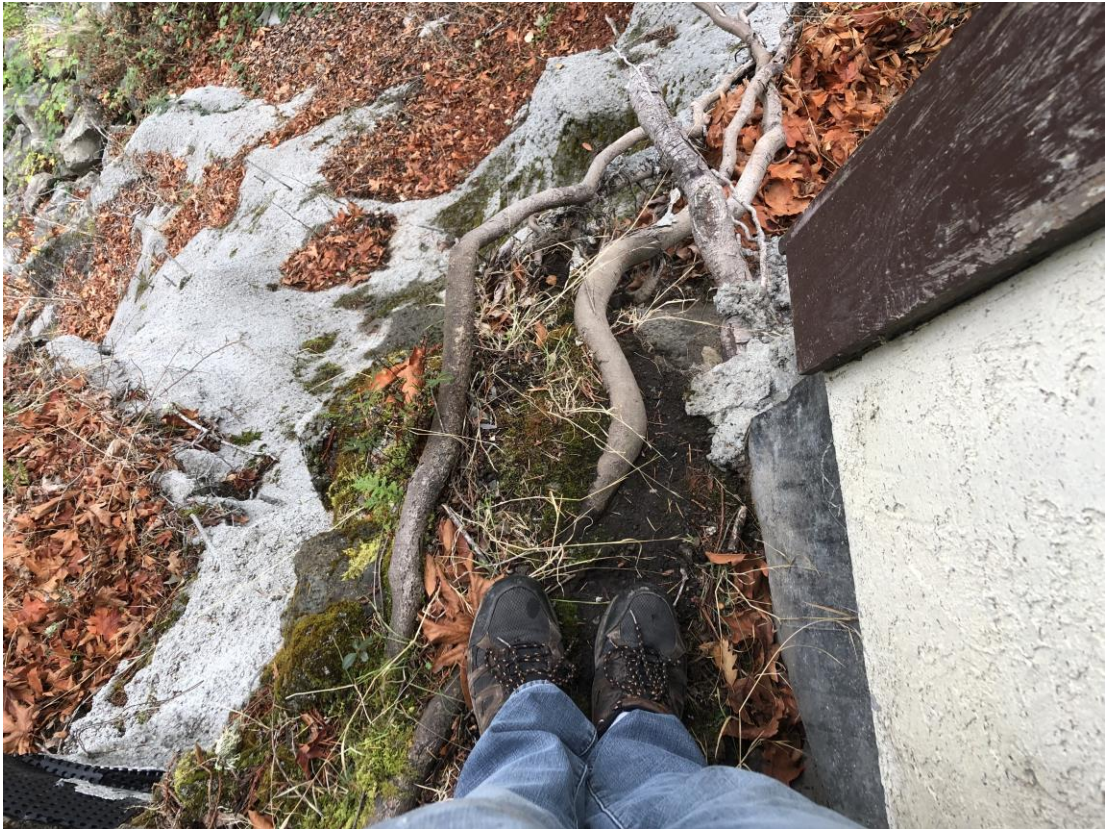
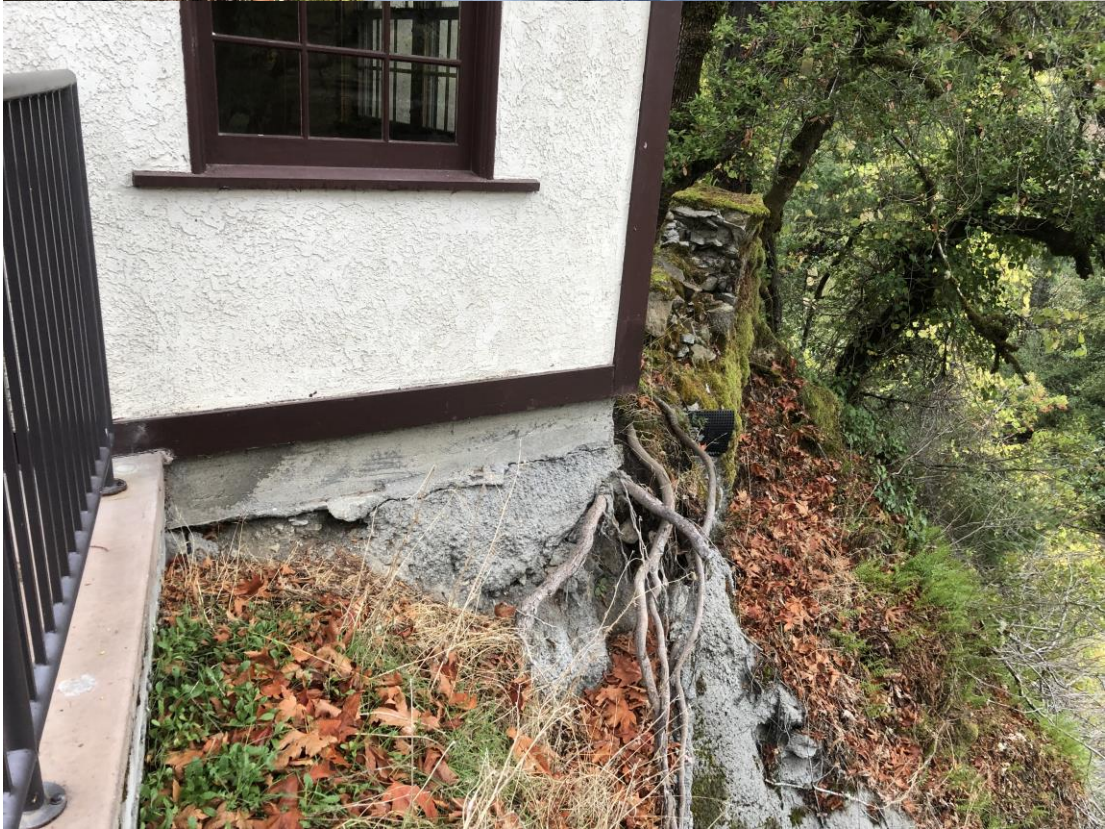
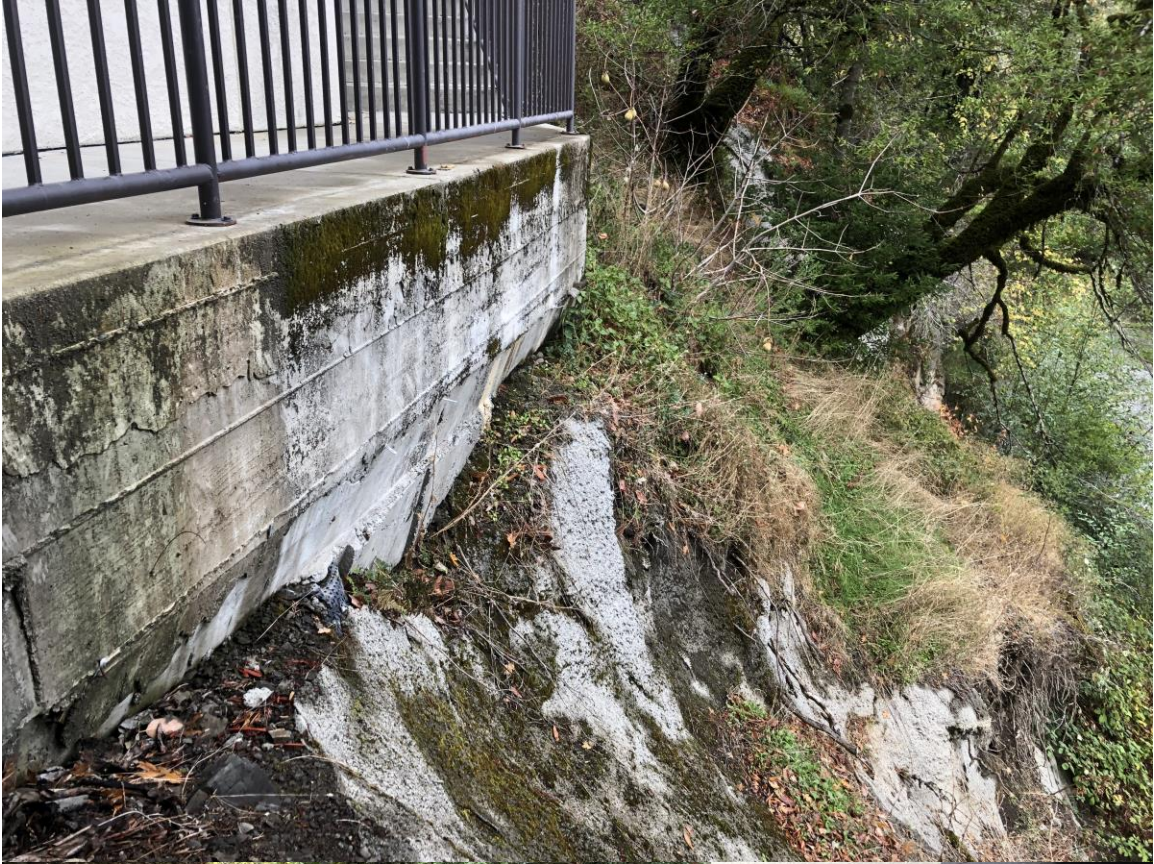
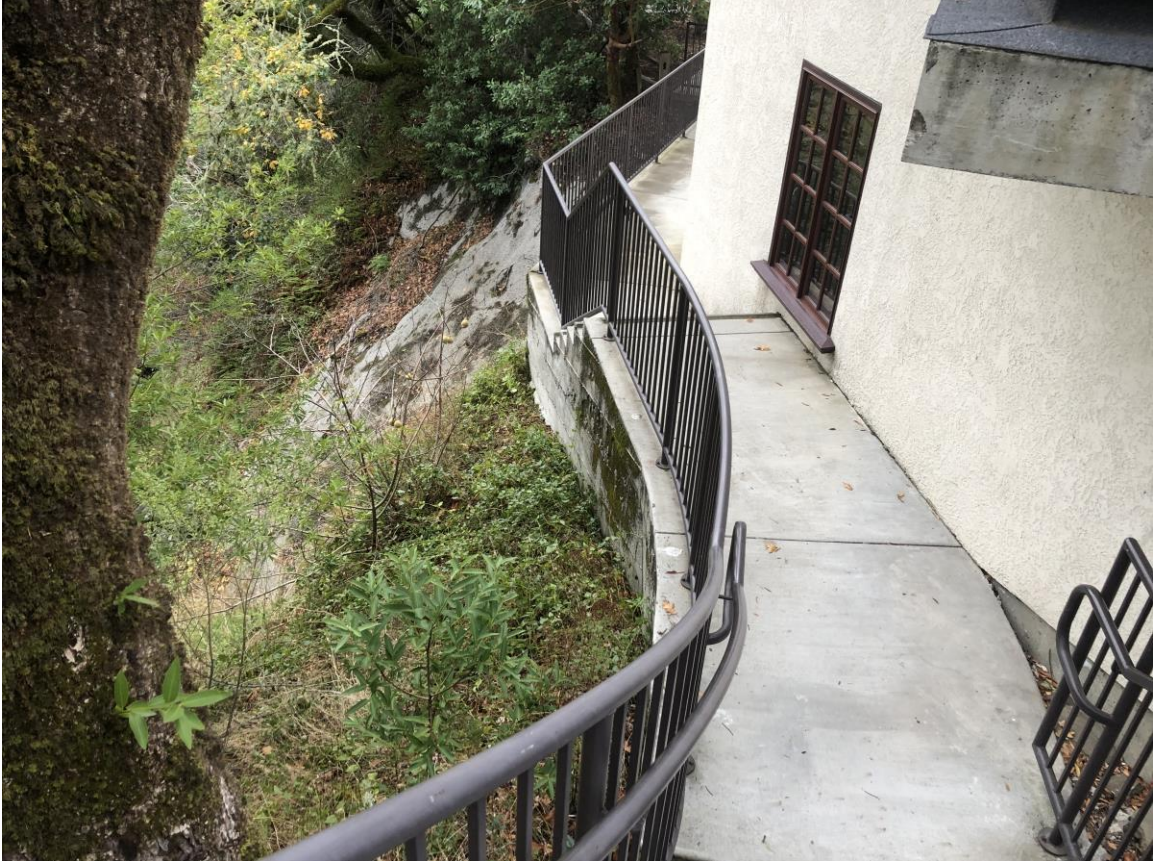
The cottage and terrace wing is too close to the grade drop off into the river (see below).

NOTE: The evident hillside erosion and any repair may have to be addressed with documentation by the engineer of record for the benefit of any new owner.

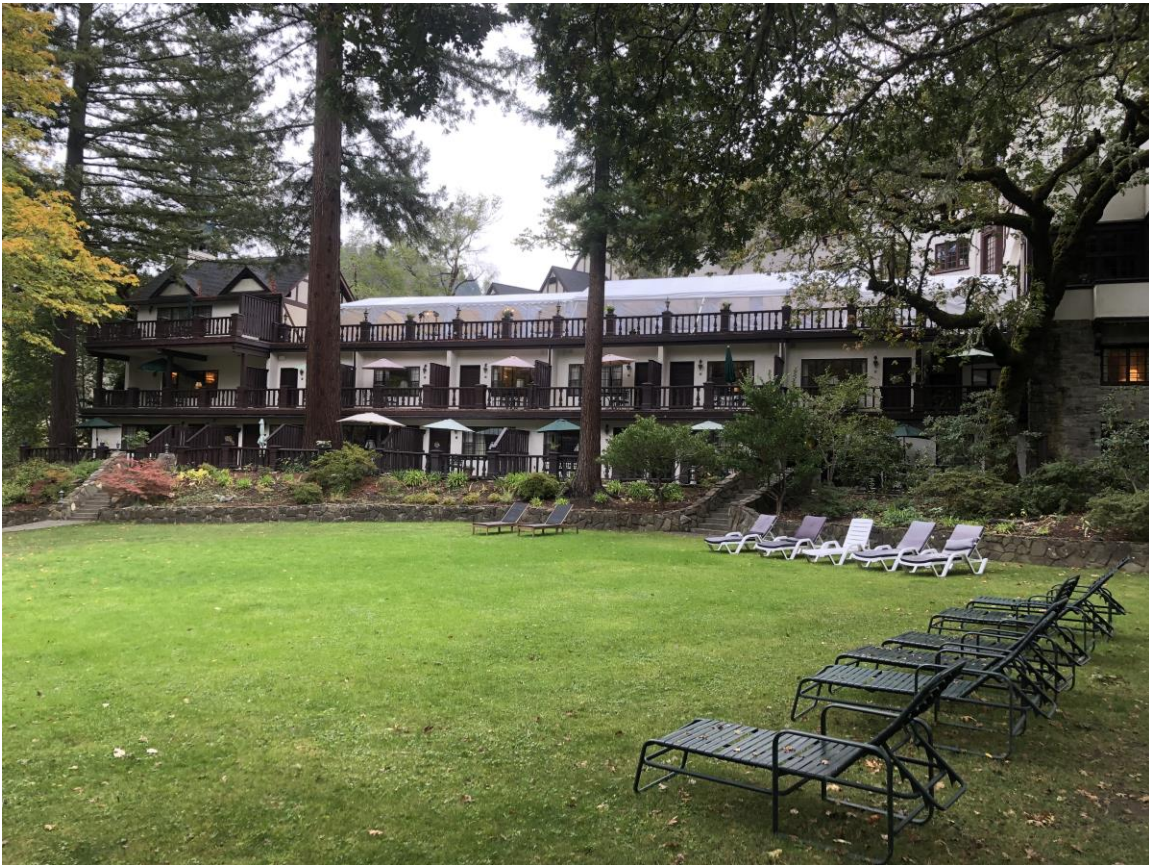
There are trees too close to the structure.

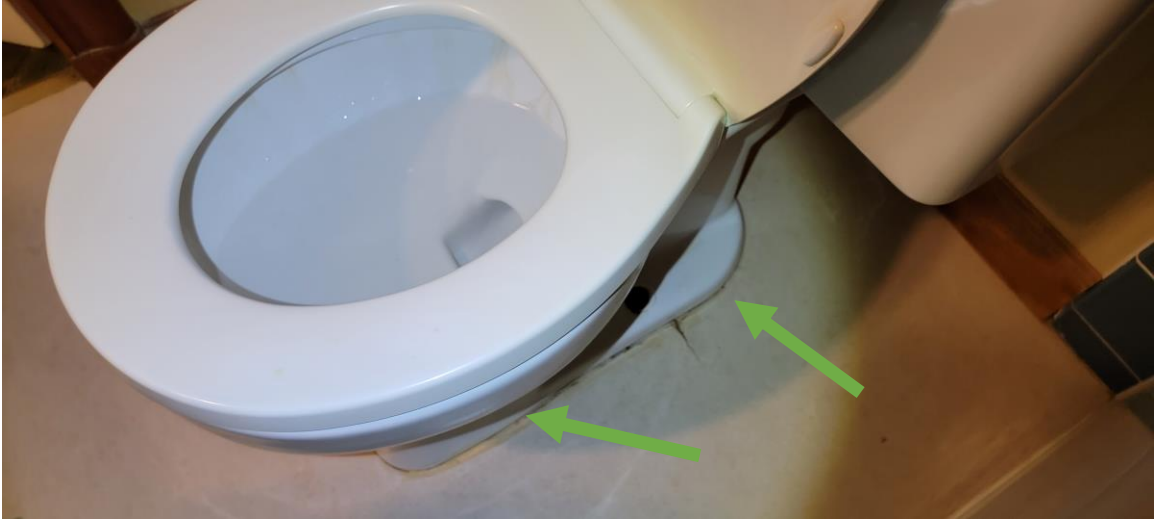
There are cracked tiles in some of the rooms at the showers and vanities. There are loose toilets in rooms 106, 216, 230, 205, 201, 213, 310, 307, 301, 303, 321, 313 and 409. There is a toilet base leak at room 310. There is water damage to the bathroom floors of rooms 310 and 307 (see below).

Room 310 toilet base has a leak (see arrows above).

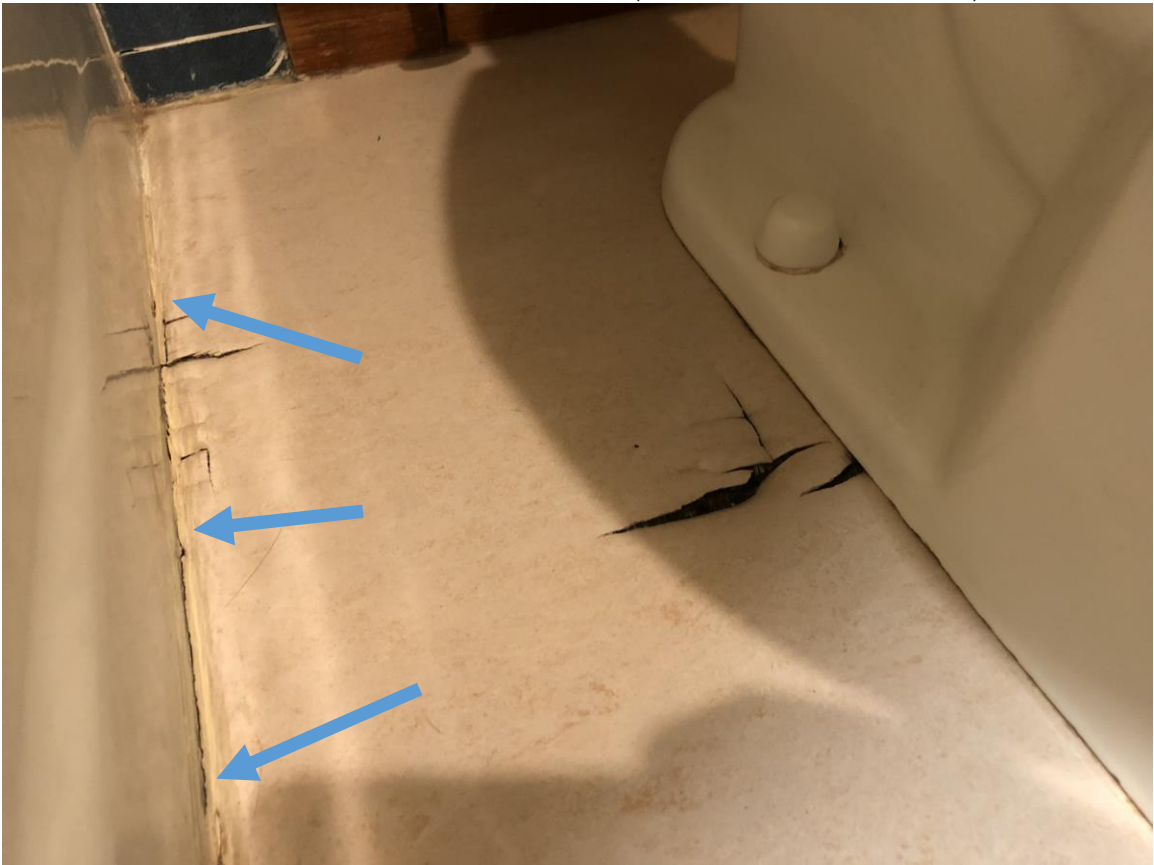
There is open sealant at many of the tub to floor connections (see arrows at the above photo). Many of the clawfoot tubs have loose fixture handles as well as the supporting legs (see below).

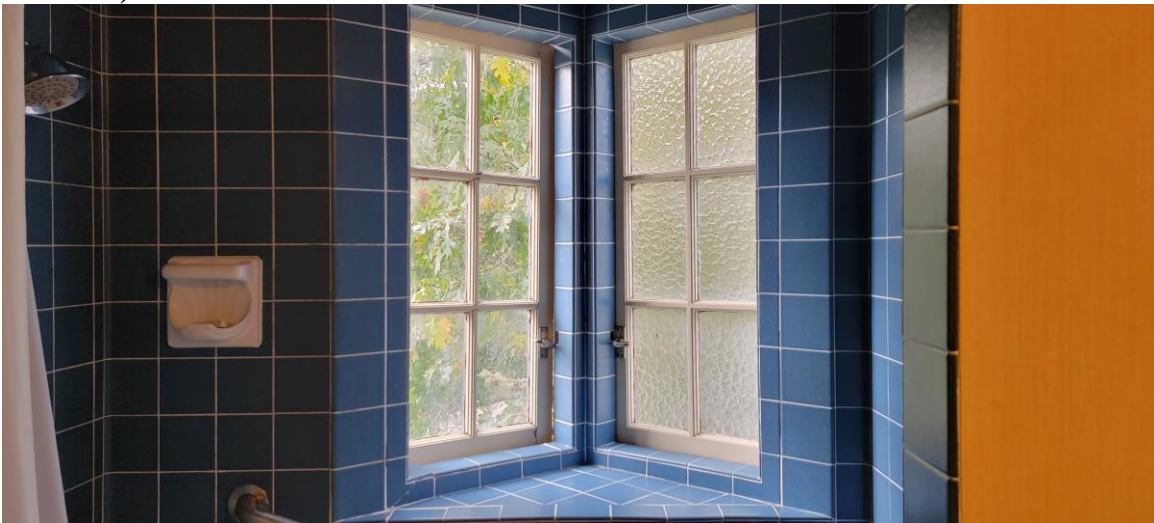
There are cracked tiles at tub/shower enclosures with windows that are damaged or will not properly close (see below).

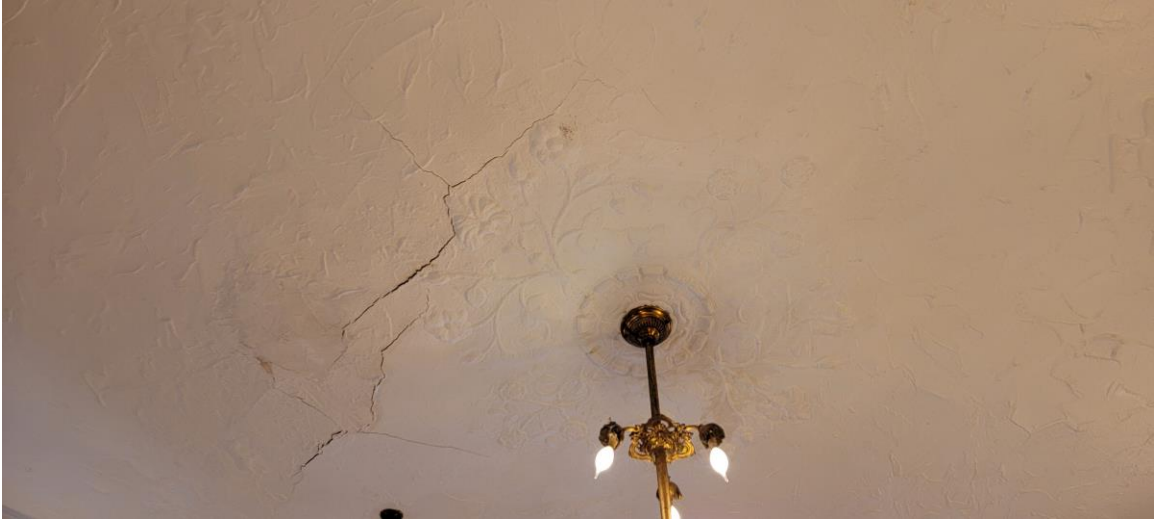
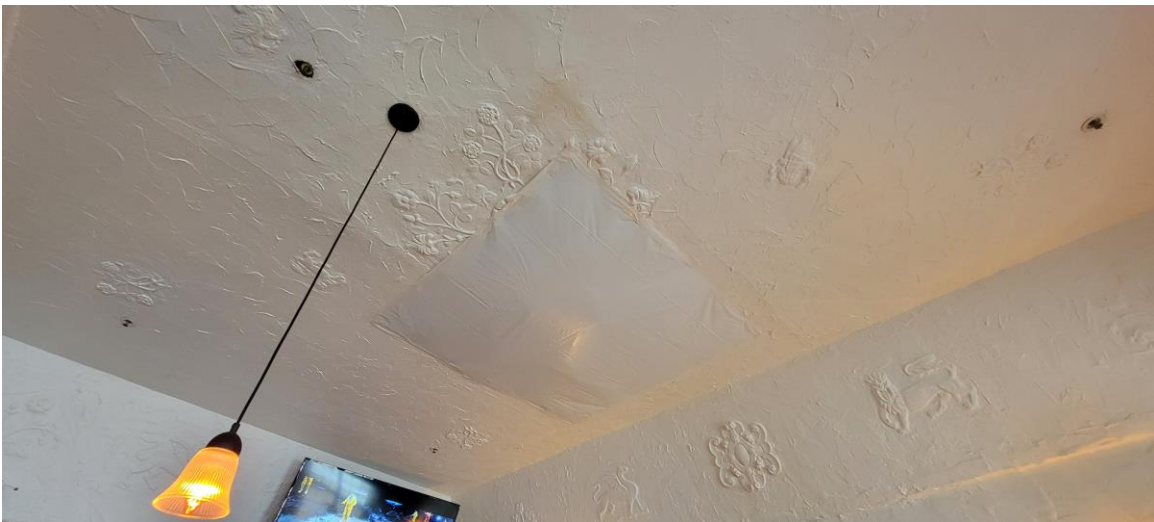
Wooden window sashes, sills, and trims are water damaged in many rooms. Much of the plumbing trims are worn and missing stoppers in the tubs and vanity sinks. There is evidence of water damage to ceilings in the common areas of the upper lobby, bar and formal dining room, likely caused by plumbing leaks in the above rooms (see below).

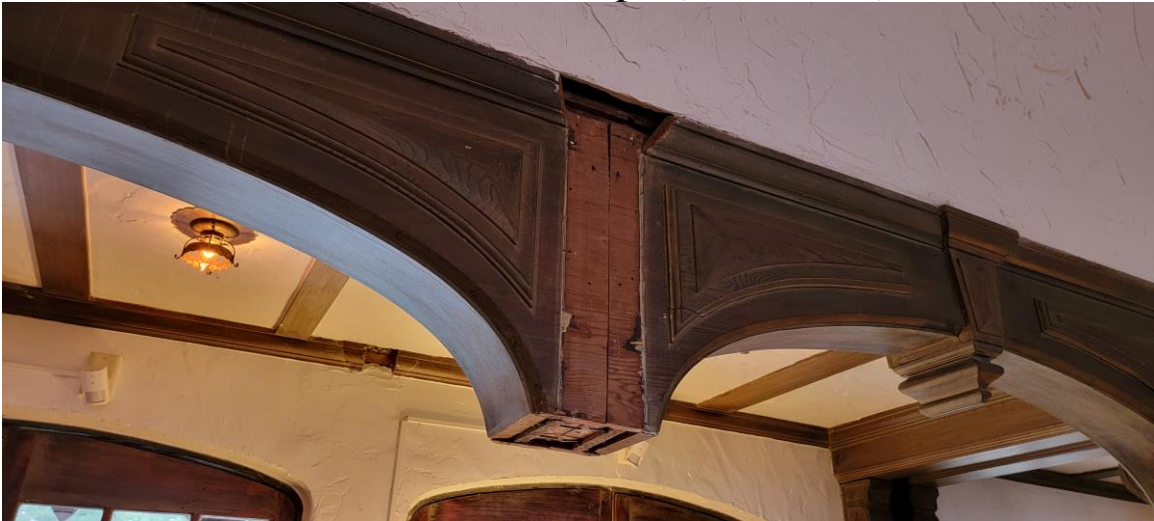
There are missing or damaged light fixtures, moldings and decorative corbels or column caps (see below).

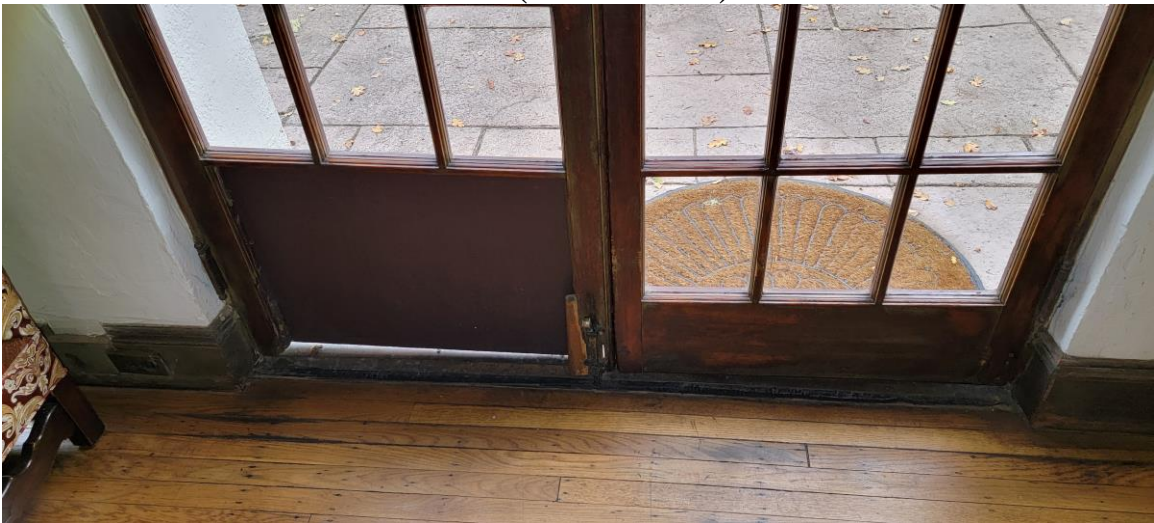
The hardwood floors in the upper lobby, bar and dining areas are water damaged in places, some from water intrusion at the thresholds (see below).

Some water damaged plaster walls (see above).

9. **INTERIOR**: Clean, paint, and update the interior as needed. Repair the worn finished plumbing trims as needed in the rooms. Repair the water damaged flooring as needed. Repair the water damaged bathroom floors as needed. Seal out the weather intrusion at the windows and doors as needed. Repair or rebuild the missing or damaged wood trims and moldings where needed. Install the missing lighting and repair the water damaged ceilings in the upper lobby, bar and dining rooms. Repair the open electrical boxes without cover plates. Repair the loose electrical boxes. **Update the fire extinguisher certifications as needed. Update the elevator certification and post. Post the fire evacuation maps where missing. Verify that the 20 minute fire rated door at room 404 is rated correctly for its location.** Correct the conditions as needed (see interior section page 55-64 above).

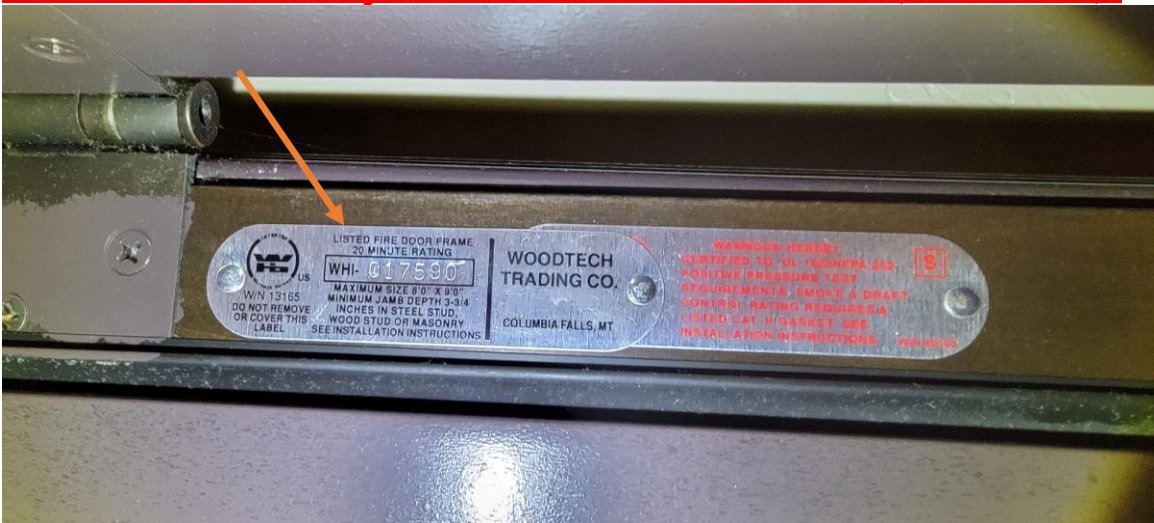
There are some missing fire exit maps missing in rooms and common areas (elevator/stair foyers). The entry fire door is rated at only 20 minutes for room 404 (see below).
