Property Inspection

Commercial Sample LLC

2013-2019 Central Ave. McKinleyville, Ca

6/23/2023

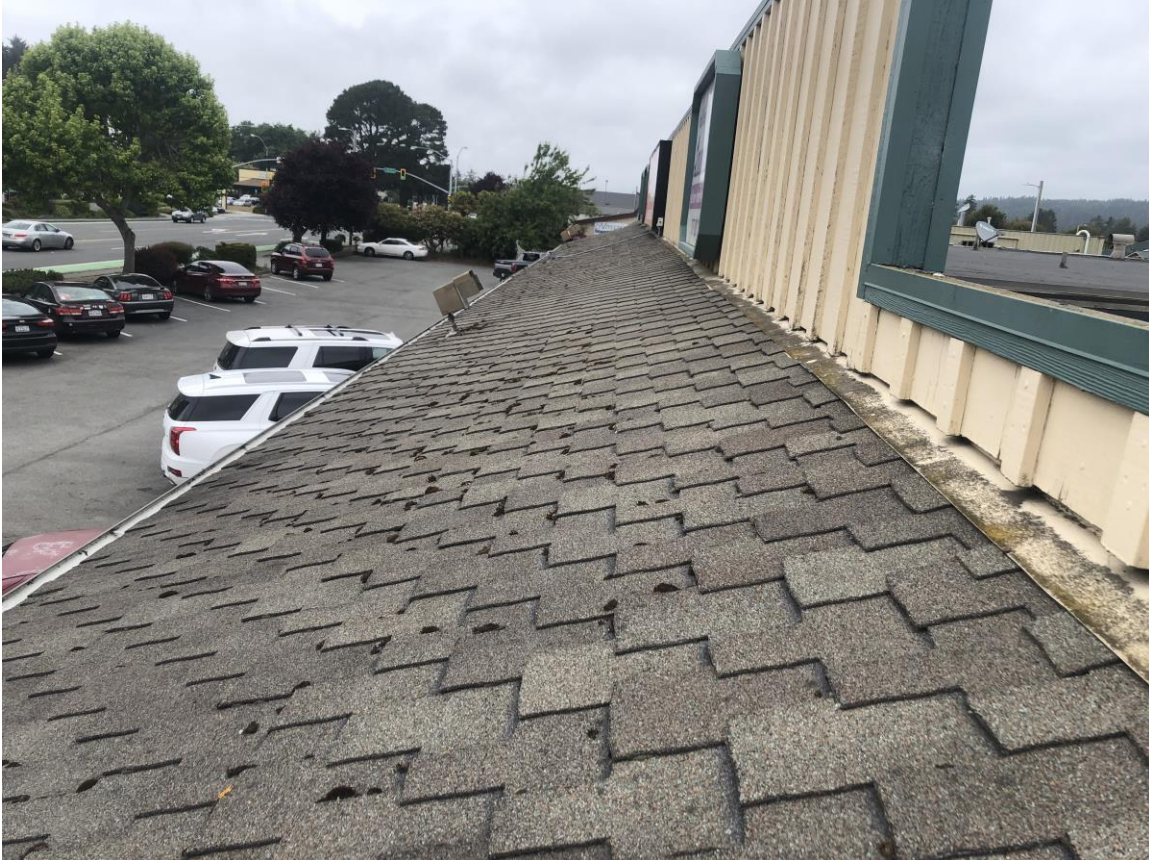
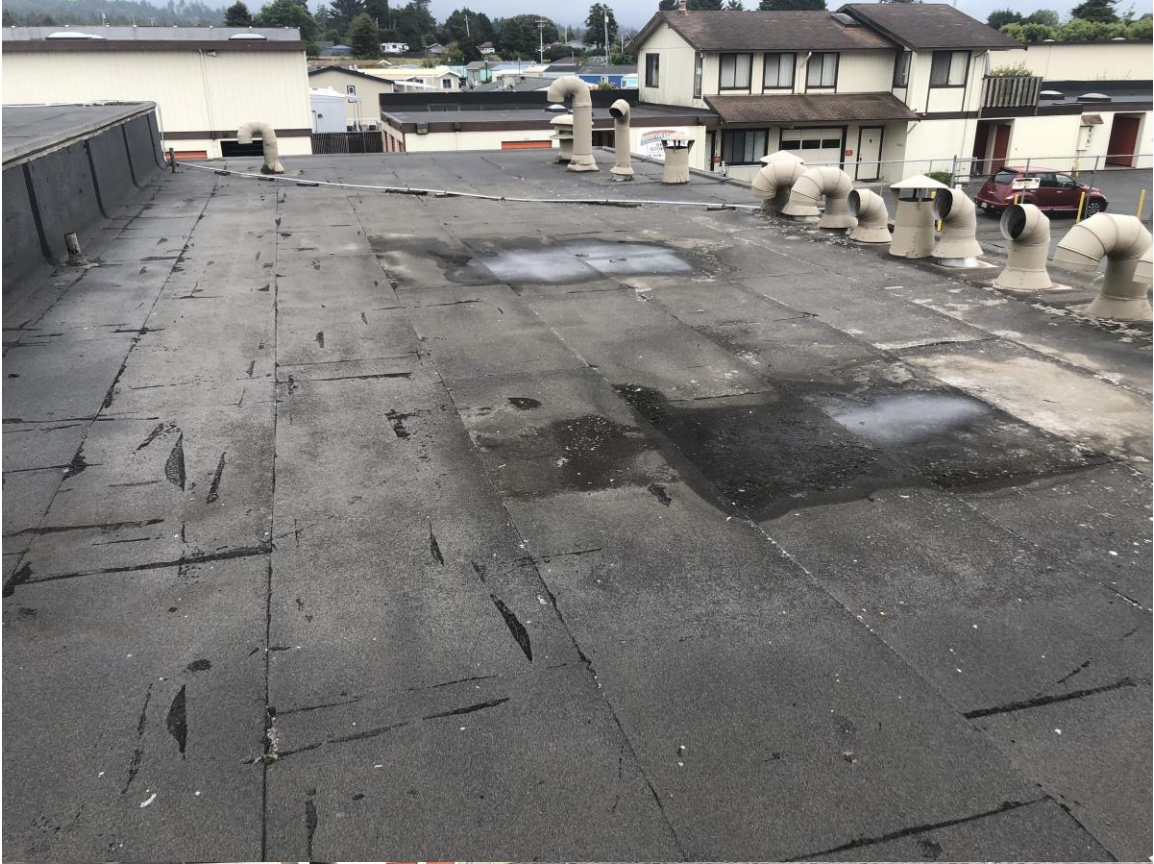
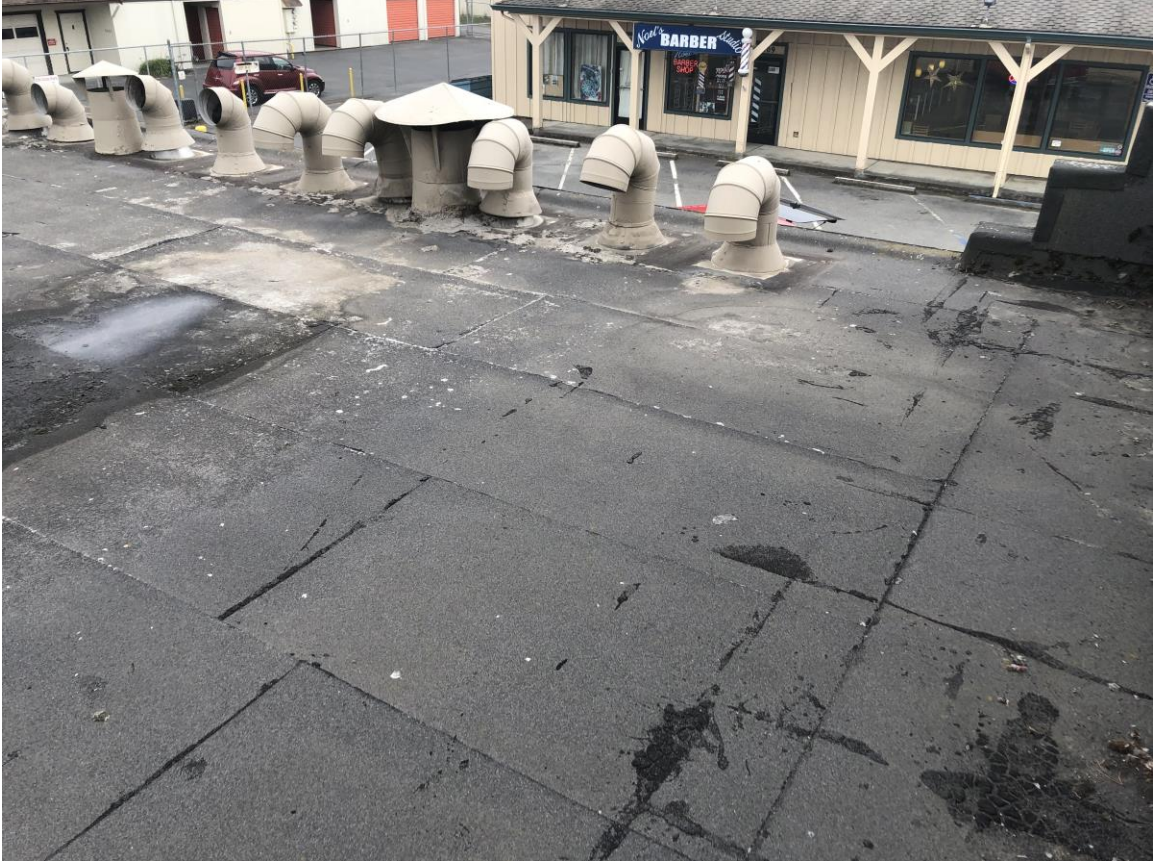
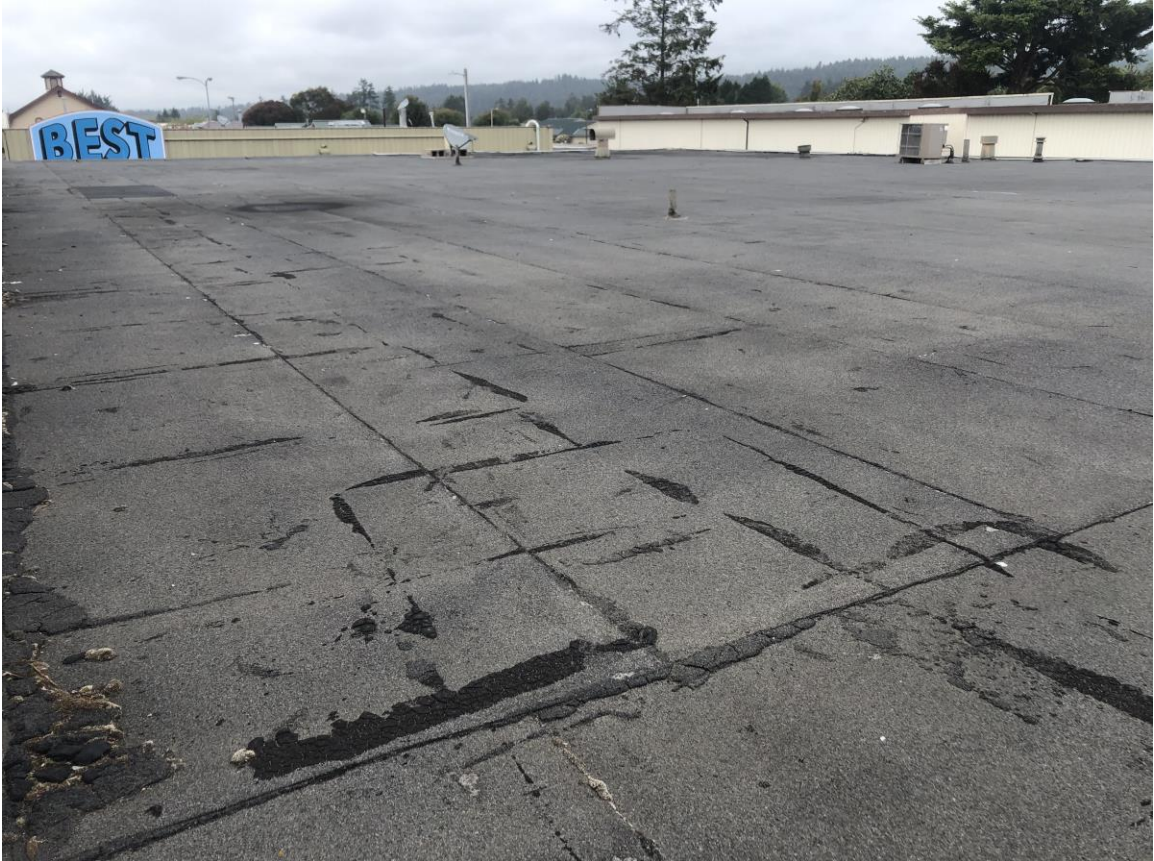
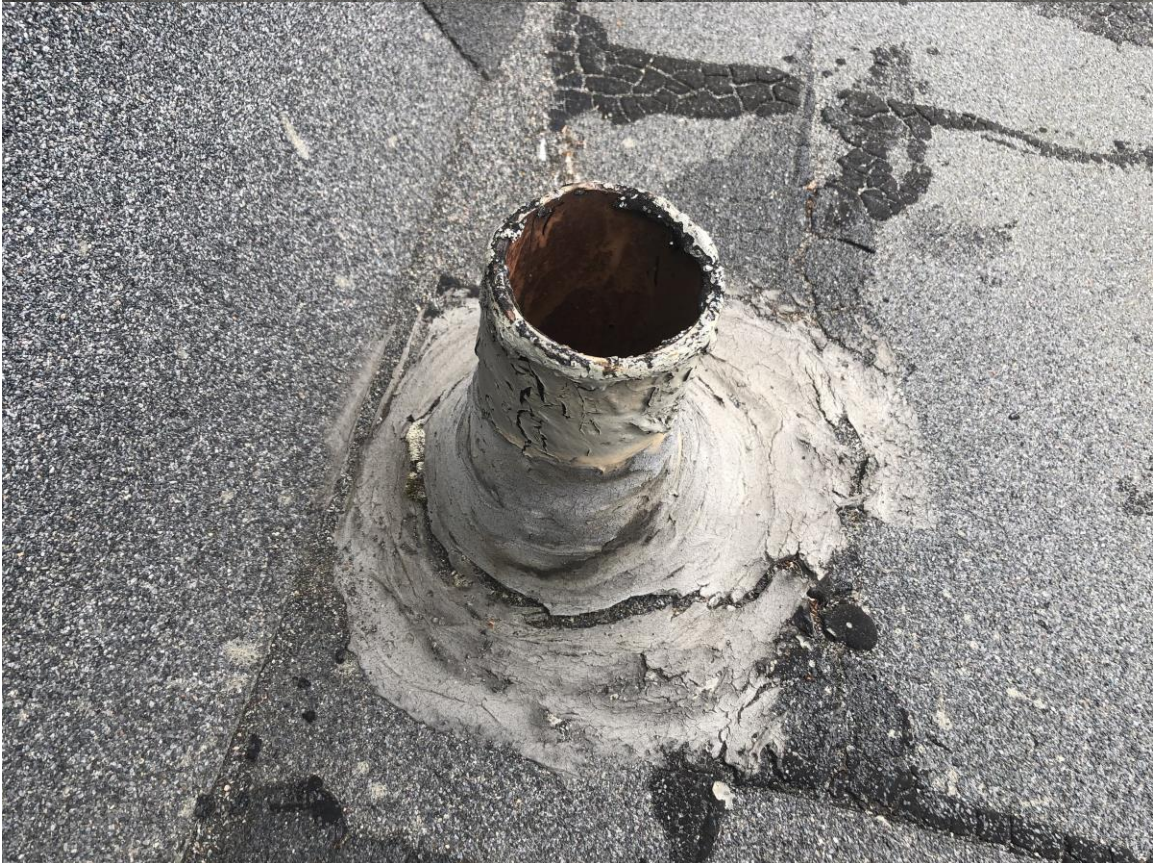
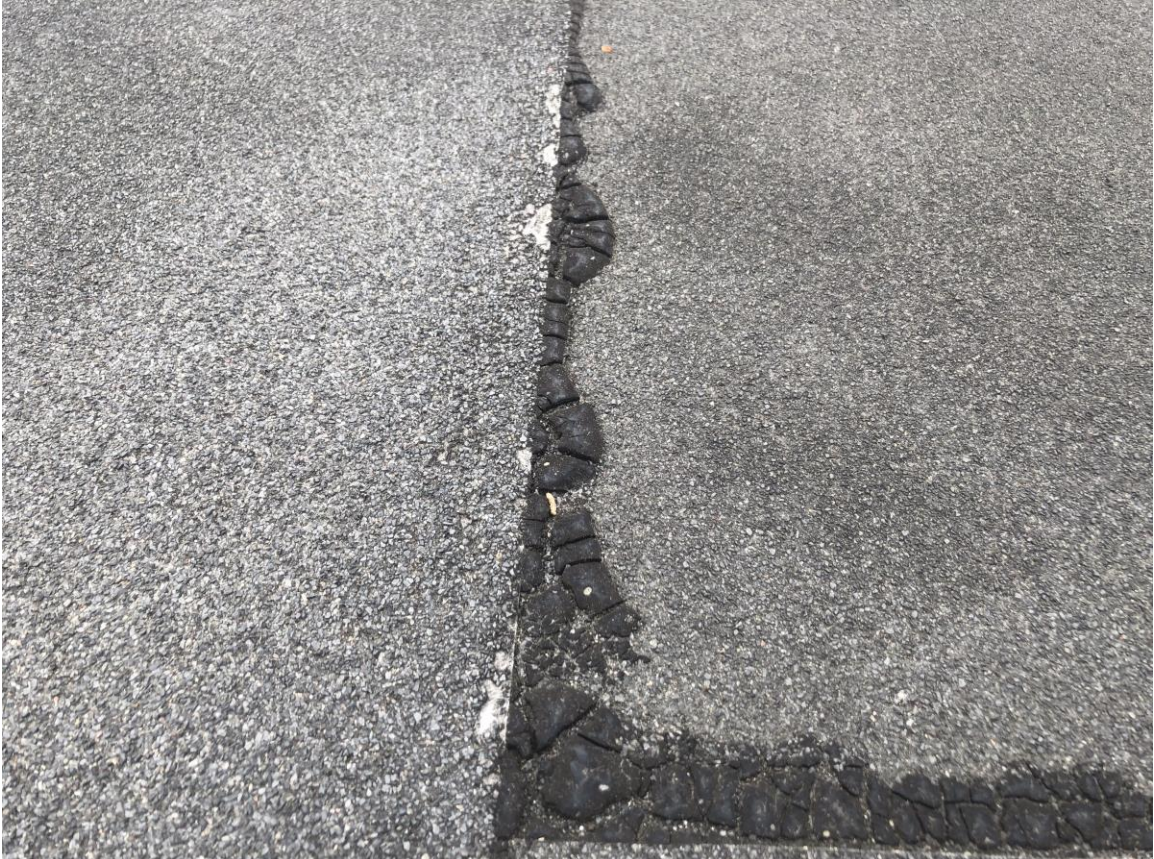
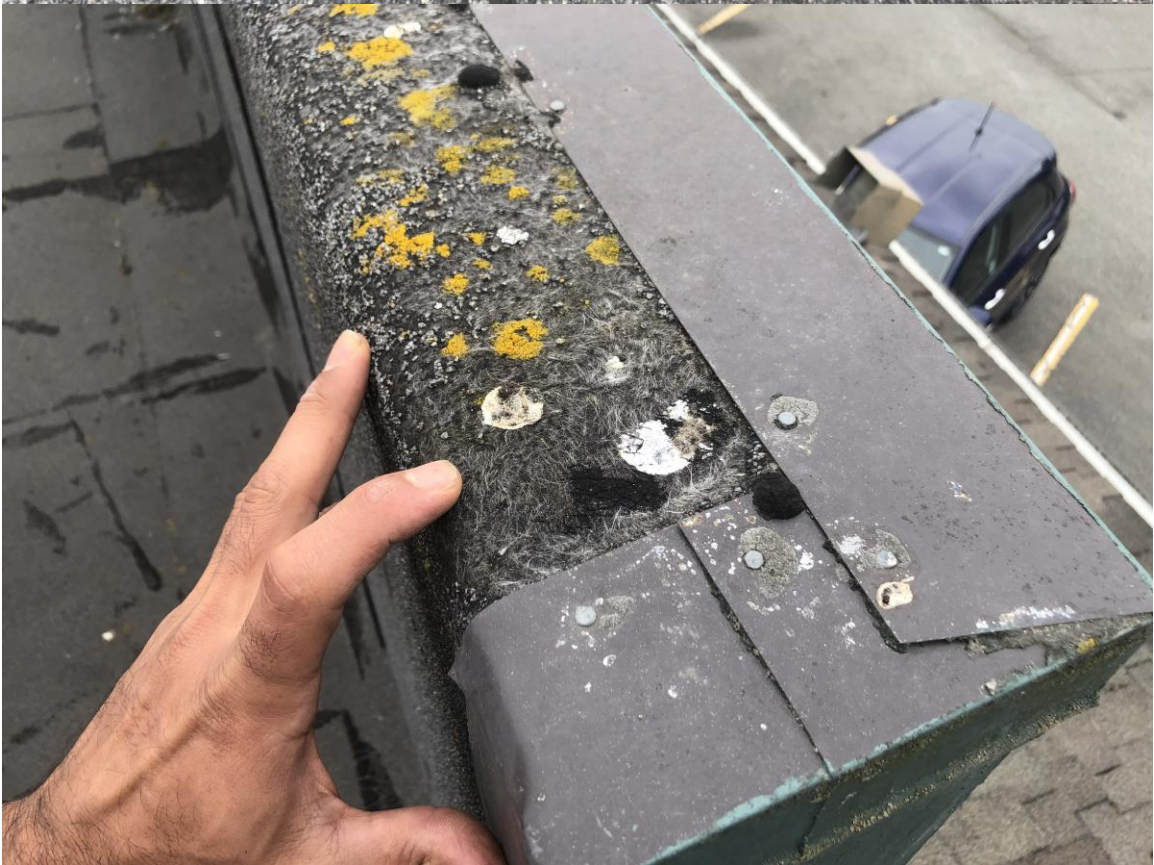
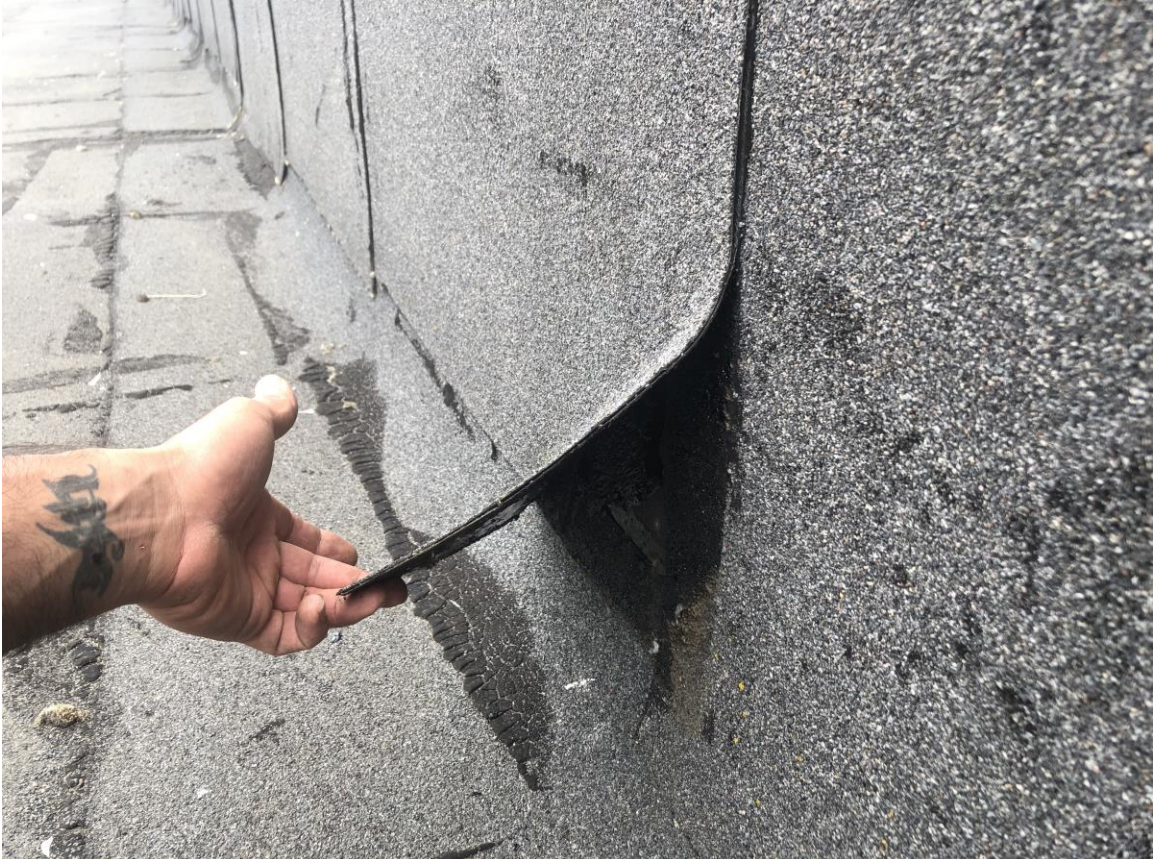
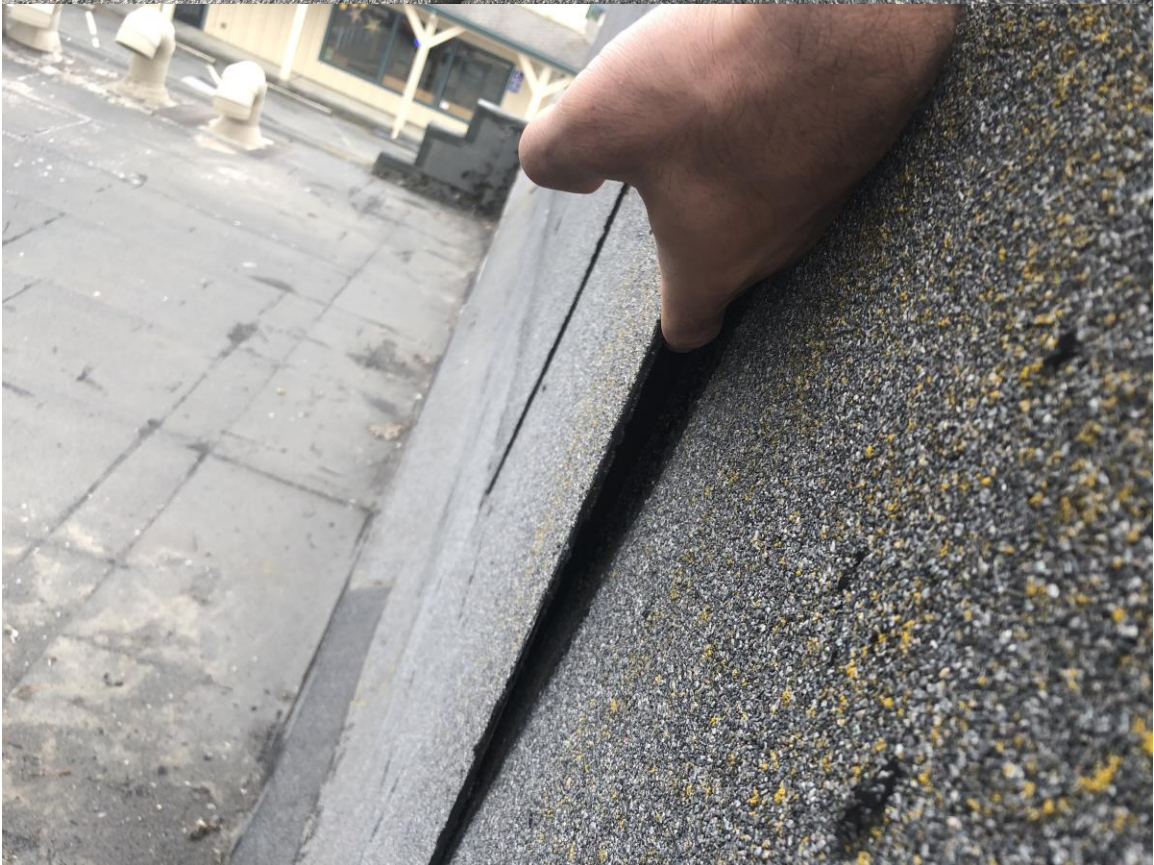
The roofing material for this building is a combination of rolled composition and asphalt composition shingle. The condition of the roofing material is good/poor (see below).

Proper metal flashing is applied. There is cracked or missing sealant at many the plumbing and heating penetrations. The scuppers and downspouts are in good condition. The scuppers are dirty with ceramic granule and organic blockage. The downspouts are diverted away from the foundation of the building.

1. **FOUNDATION:** None
2. **ROOF/ATTIC:** The installation of this roofing material should be evaluated by a licensed roofing contractor. Repair any damaged or missing vent screens. Repair the intake penetration vents on the south side to prevent water intrusion. Clean the dirty gutters. **Repair any live electrical wires not terminated within a covered electrical splice box.**

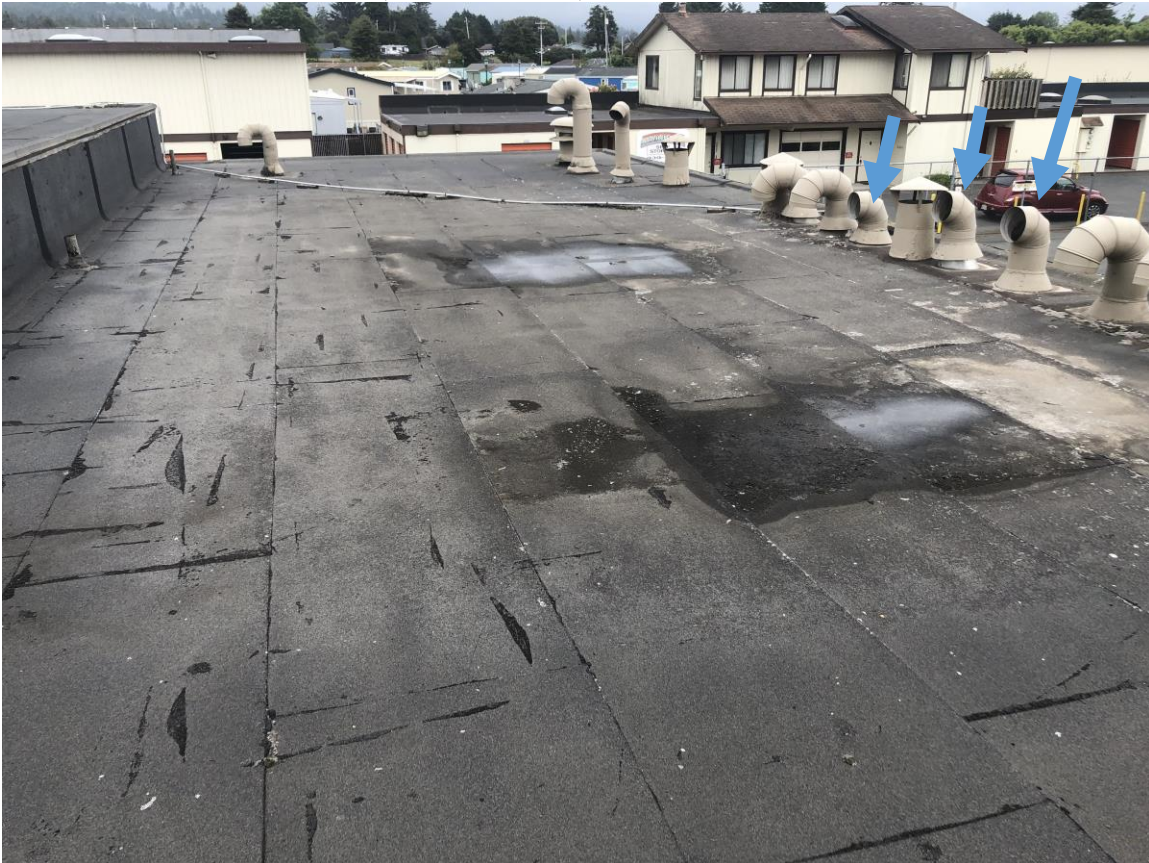
The attic appears strong & dry and is accessible from every suite with the exception of suite 2015 which has a drop ceiling. The attic is vented and insulated in suites 2017 & 2019 (4-6 inches). The attic over suite 2013 is not insulated. There are missing or damaged vent screens. There are vent stacks with missing intake elbows allowing for water intrusion (see below).

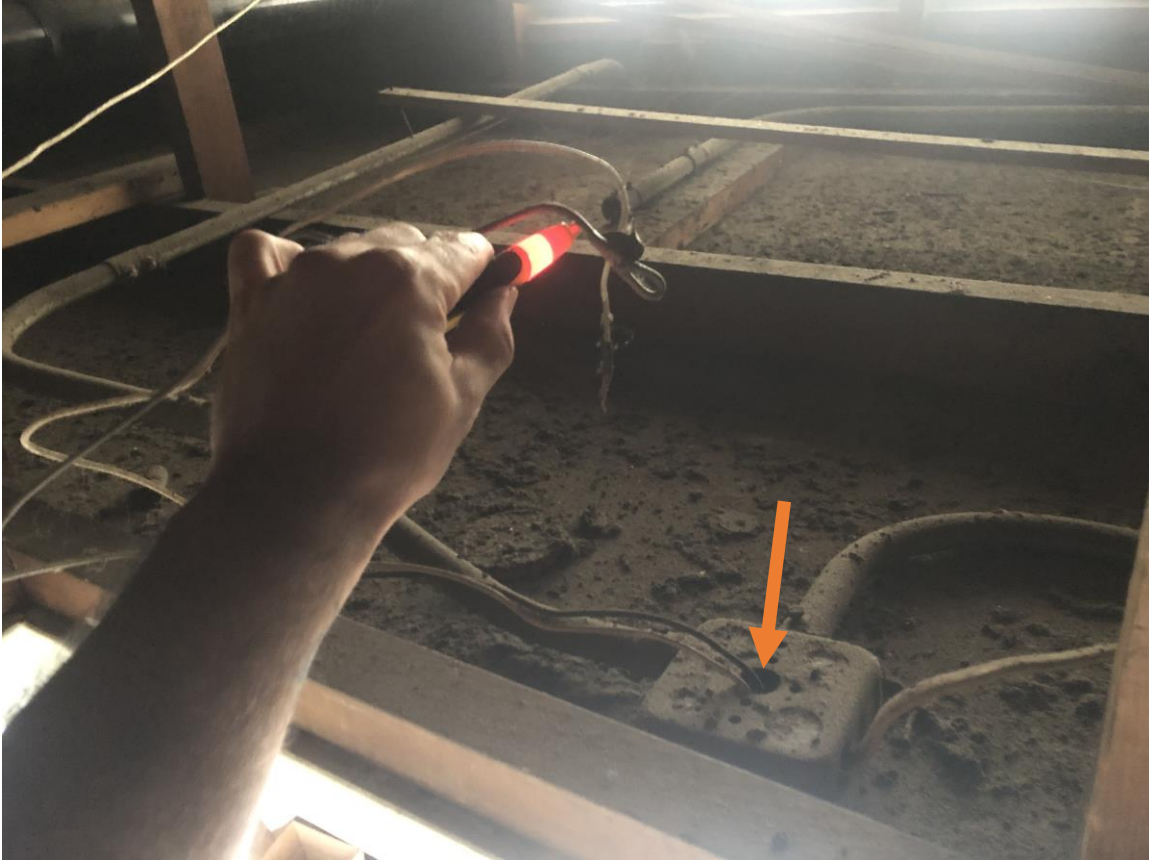
The bathroom ceiling fans appear to terminate to the exterior. There are electrical splice boxes that have no bushings or clamps at the knockouts (see below). There are live electrical wires not terminated within a covered electrical splice box (visible over 2013 (see below)).

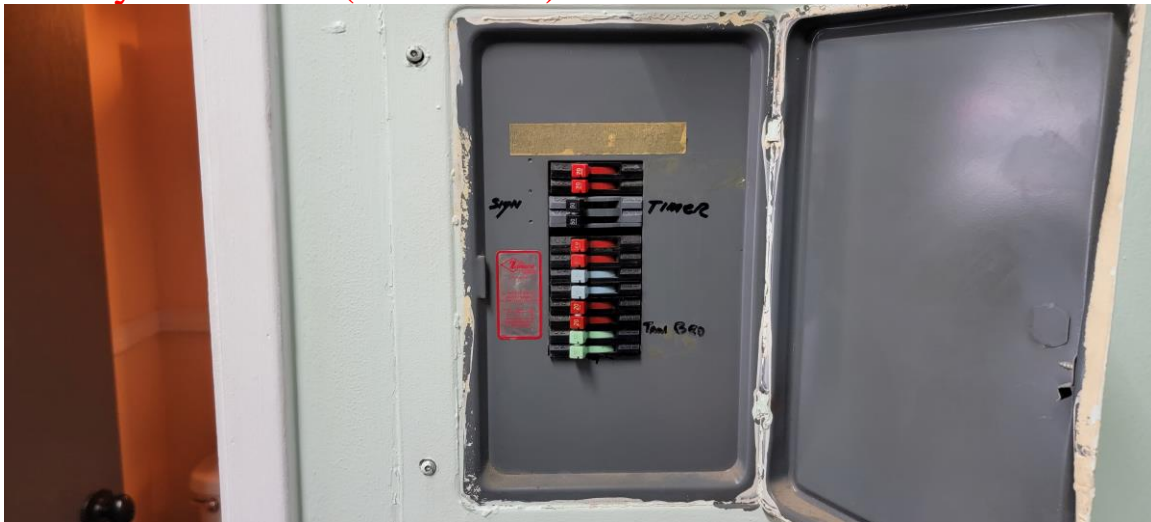
Suite 2017

The electrical service panel is located inside each suite. There are multiple service panels inside suite 2013 (laundromat). The main service disconnects are located at the exterior. The disconnect panels are secured with a padlock on the north side. The amount of incoming Amperage to the building and to each suite could not be determined. Ground Fault Circuit Interrupter (GFCI) protection is present in some areas (see attached pdf sheets). The electrical system was functioning properly at the time of inspection. All of the three-prong outlets tested were properly wired. **The service panels in suites 2017 and 2019 are the Zinsco brand and design. Zinsco panels have a history of failure (see below).**

3. **ELECTRICAL SYSTEM:** **Install GFCI protection in all bathrooms, kitchen sink areas and any exterior outlets (see attached sheets). Replace the Zinsco service panels to modern panels with a safety record.** A licensed electrical contractor should complete the upgrades to this electrical system.

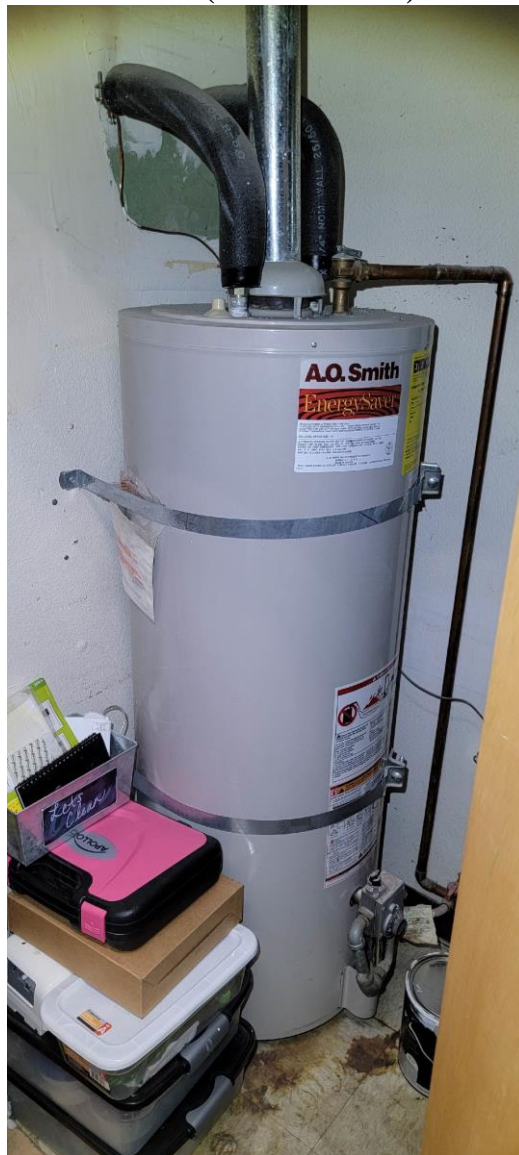
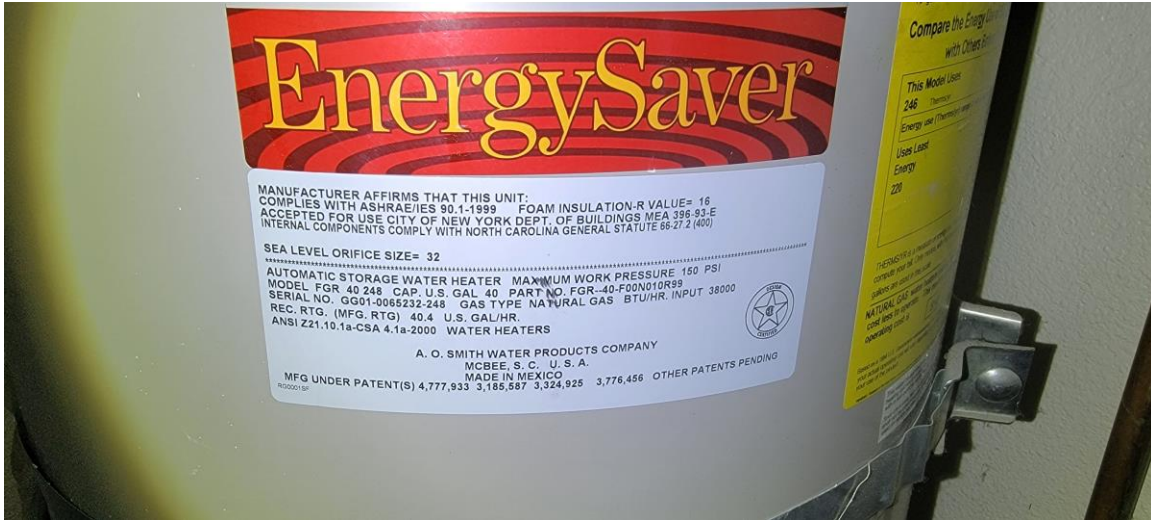
Fresh water for this building is provided by copper pipes. Hot water is provided by a gas-fired electric water heaters located in suites 2017 and 2015. Suites 2017 and 2019 appear to share the same water heater located in Suite 2017. The water heater in Suite 2017 is a 22-year-old, 40 gallon, water heater by AO smith (see below).

The water heater is properly strapped for seismic stability according to today's standards. The temperature/pressure relief valve at the water heater is adequately vented. No freshwater leaks were found in the building.

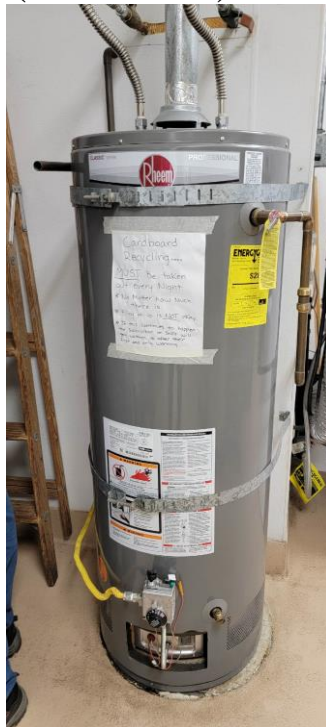
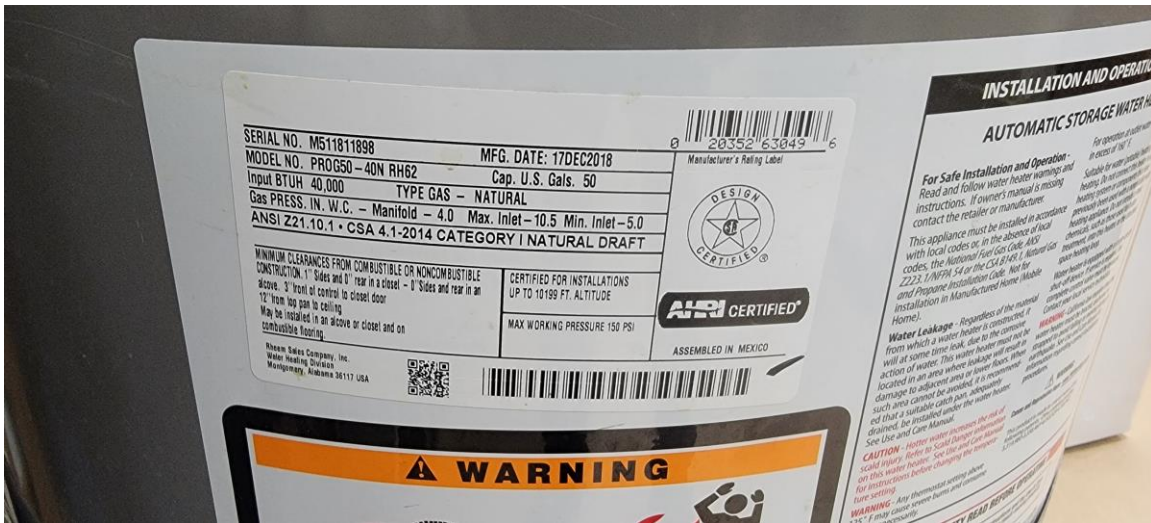
Hot water for Suite 2015 (Subway) is provided by a 5-year-old, 50-gallon, gas-fired water heater by Rheem located in the back storage area (see below).

The water heater is not properly strapped for seismic stability according to today's standards. The temperature/pressure relief valve at the water heater is not adequately vented. NOTE: the T/P is venting into the washer standpipe and overflows onto the floor under test. No freshwater leaks were found in the building.

4. **PLUMBING SYSTEM:** Properly strap the water Heater (suite 2015) or boiler and storage tank (suite 2013) for seismic stability according to today's standards (see attached pdf sheets). Properly vent the temperature/pressure relief valve at the water heater to not risk interior water damage or operations disruption in (suite 2015).

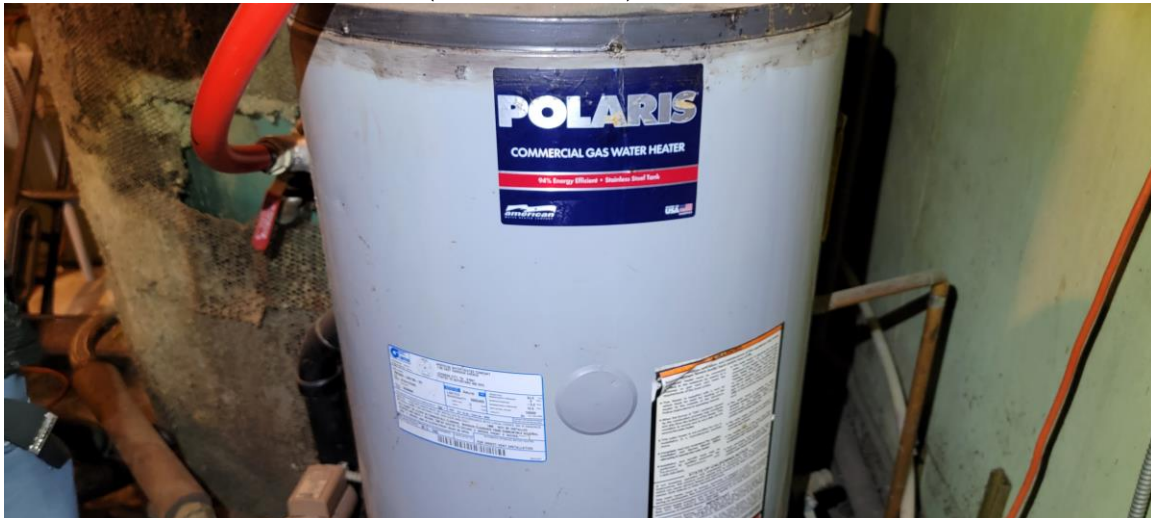
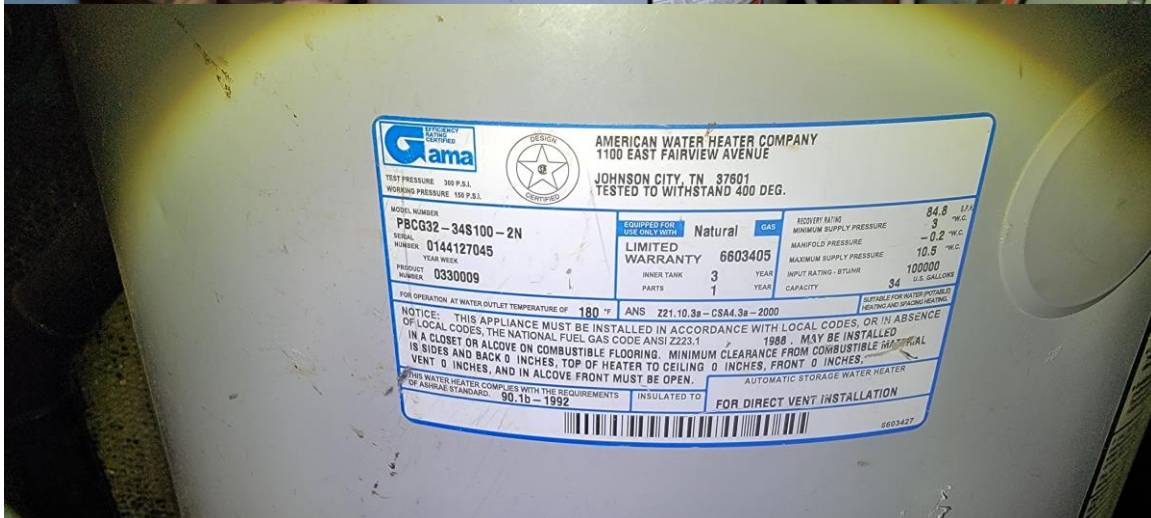
Hot water for Suite 2013 (Laundromat) is provided by a 22-year-old, 34-gallon, gas-fired boiler by Polaris located in the mechanical room (see below).

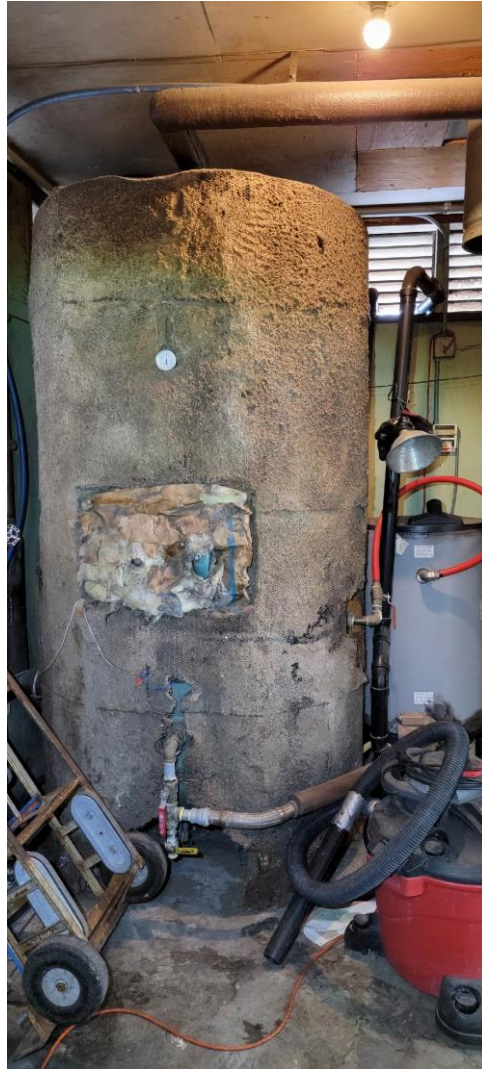
The hot water storage tank capacity is approximately 200 gallons (see below).

The boiler and storage tank are not properly strapped for seismic stability according to today's standards. The temperature/pressure relief valve at the water heater is adequately vented. No freshwater leaks were found in the building.

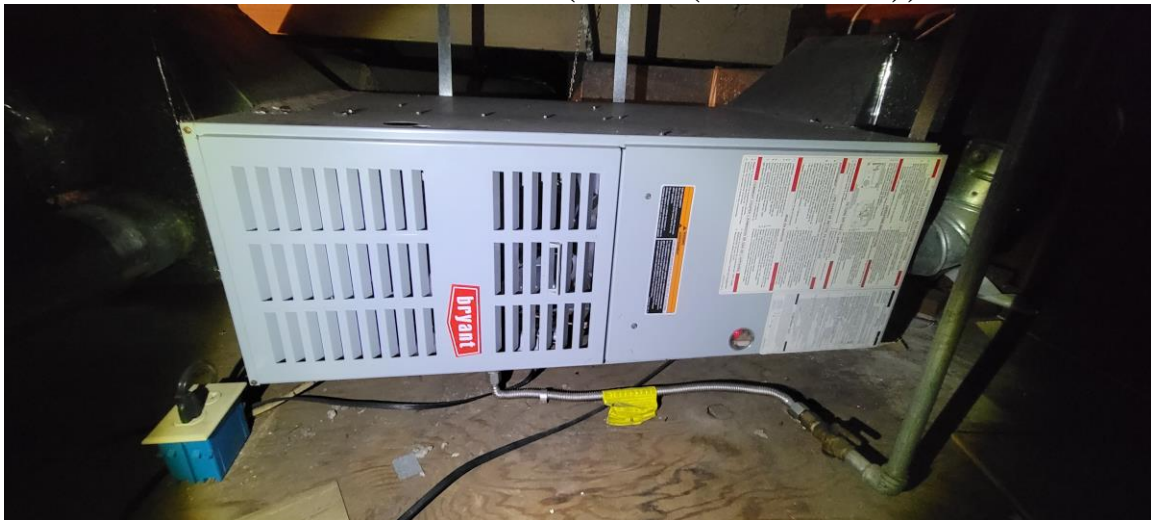
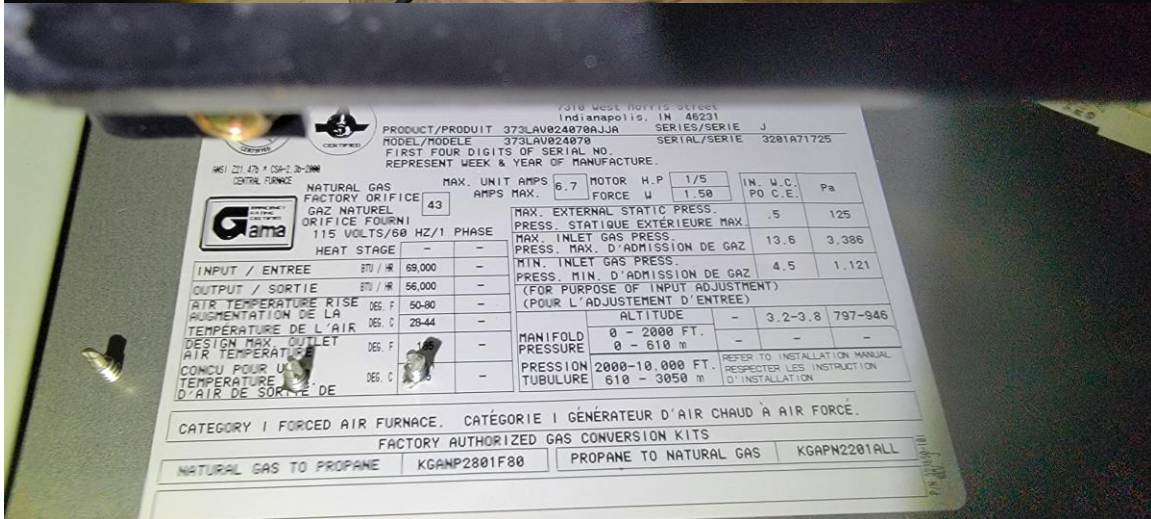
Heat for Suites 2017 and 2019 in this building are provided by a 22-year-old, 69,000 Btu, gas-fired, forced-air furnaces by Bryant and Armstrong Air located in the attic (2019) and in the mechanical closet (2017 (see below)).

According to the National Association of Home Builders, the life expectancy of a gas-fired furnace is 18 years. The furnace filters are dirty. The filter for Suite 2017 is located at the furnace. The filter for Suite 2019 is located at the ceiling air-return grill. The forced-air heating systems were functioning at the time of inspection.

5. **HEATING/HVAC SYSTEM:** Upgrade the old furnaces for energy efficiency in suites 2017 and 2019. Due to the age and condition of the HVAC at the Suite 2015 system I recommend that you call a local heating professional to clean, and service the unit. At the same time the heat exchanger can be more adequately inspected for possible cracks or damage. Replace/clean the furnace filter/s as often as needed. Seal the heating ducts in the attic over suite 2017 (see below).

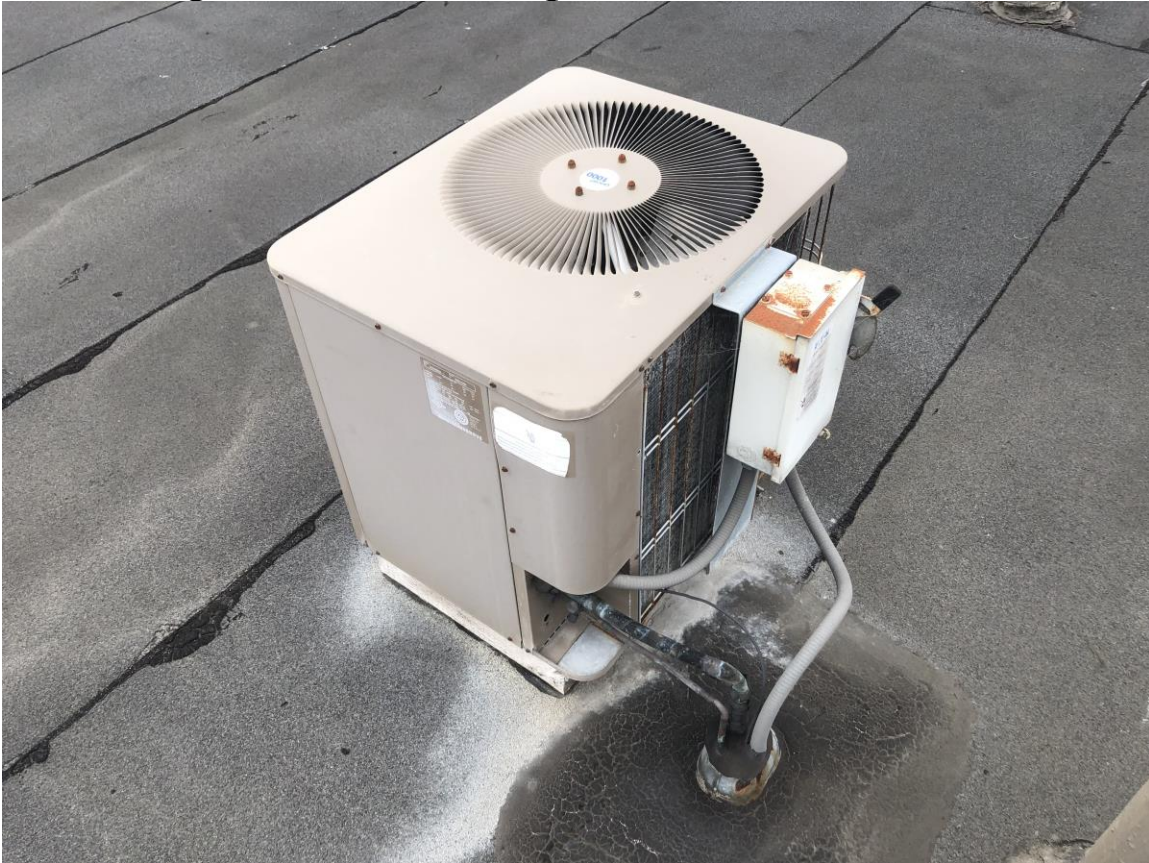
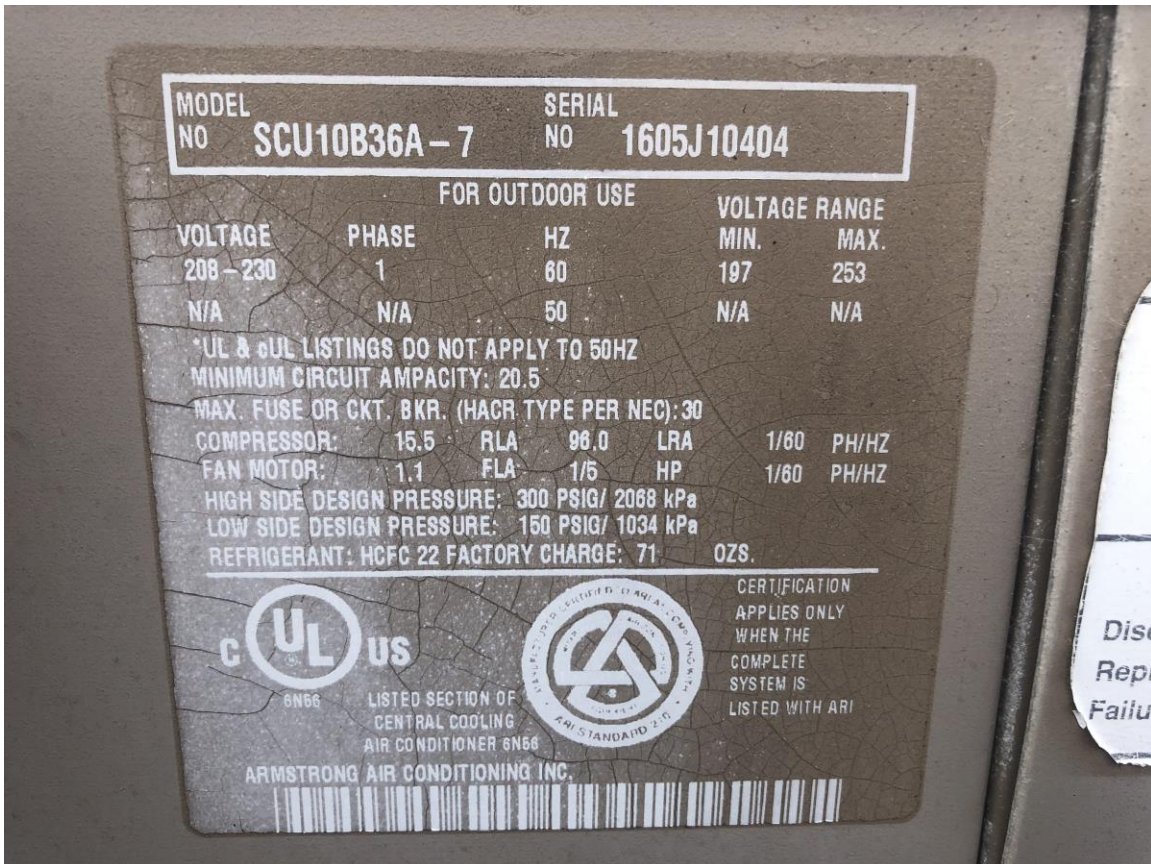
Heating and cooling (HVAC) for Suite 2015 (Subway) is provided by an 18-year-old, 3-Ton rated, electric unit by Armstrong Air located on top of the roof (see below).

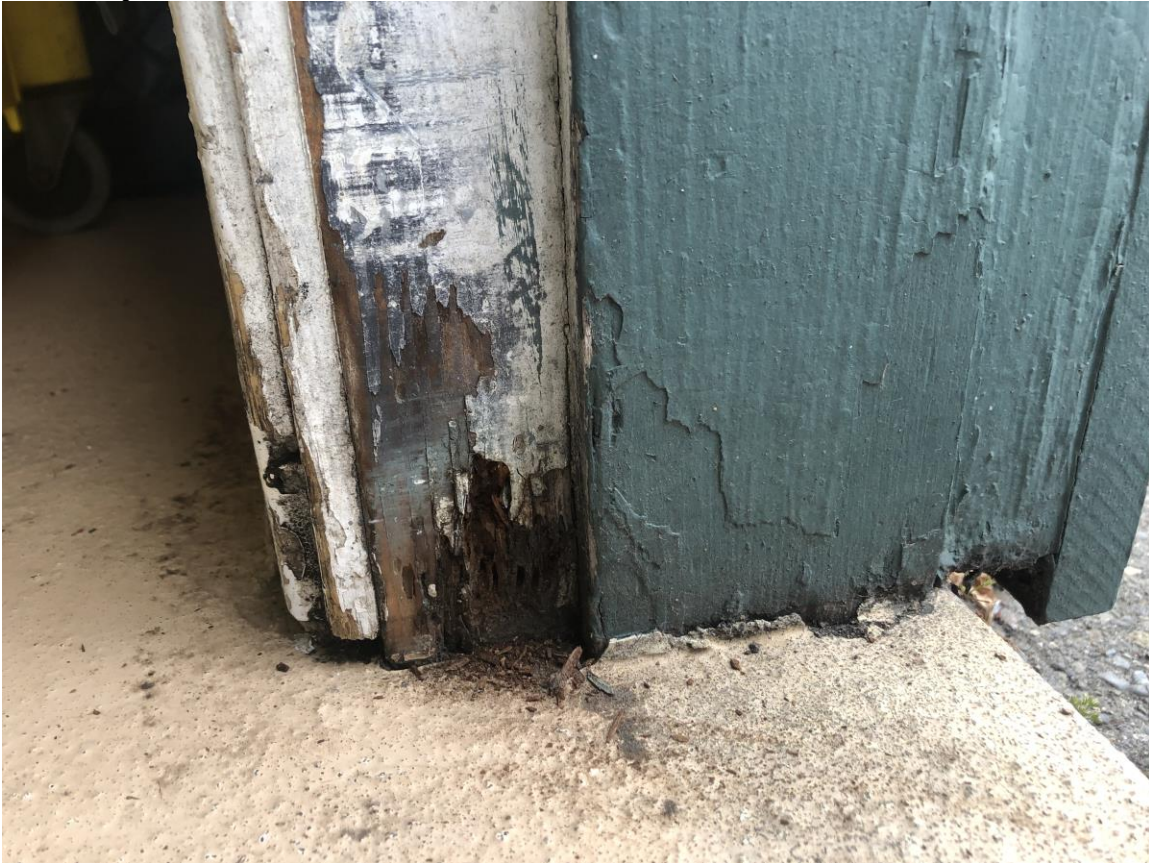
The exterior is in good/fair condition. There is a broken storefront window at Suite 2013. There are a number of damaged or missing window screens. There are parking spaces designated for ADA use. There is a damaged steel post at the garbage enclosure on the north side (see below). There are some water damaged entry doors and jambs at the ally entries (see below).

6. **UTILITIES SUPPLIED:** None
7. **EXTERIOR:** Correct the conditions as needed (see exterior section page 23 above).
8. **INTERIOR:** Clean, paint, and update the interior as needed. Correct the conditions as needed (see interior section page 24 above). **Install GFCI protection in all bathrooms, kitchen sink areas & any exterior outlets (see attached pdf sheets).**

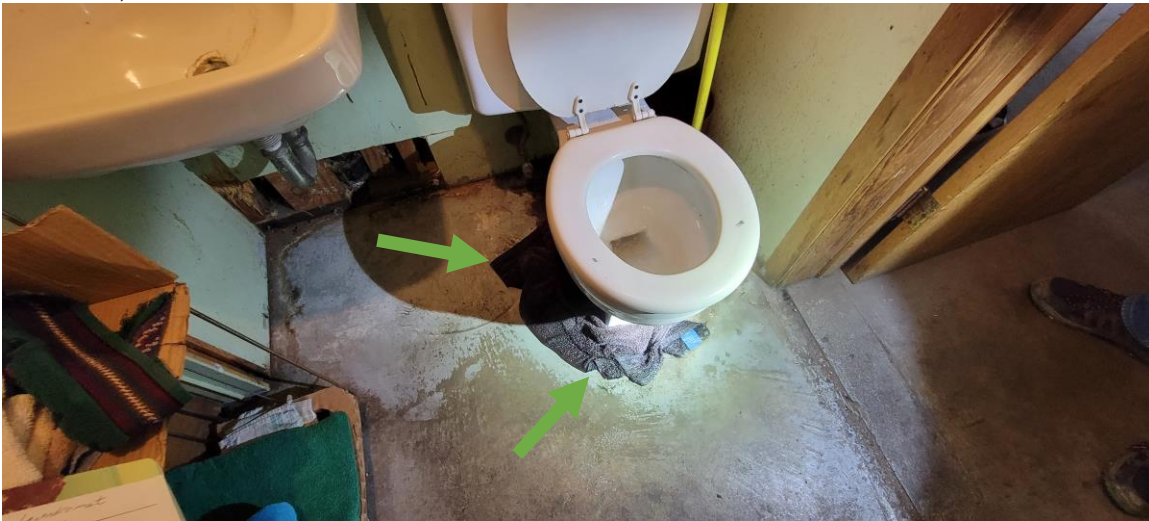
The interior is in good/fair condition. Some of the interior floorings are worn. The toilets are loose in Suites 2013 and 2019. The private restroom toilet in 2013 (laundromat) is leaking at the base with a rag soaking up wastewater (see below).

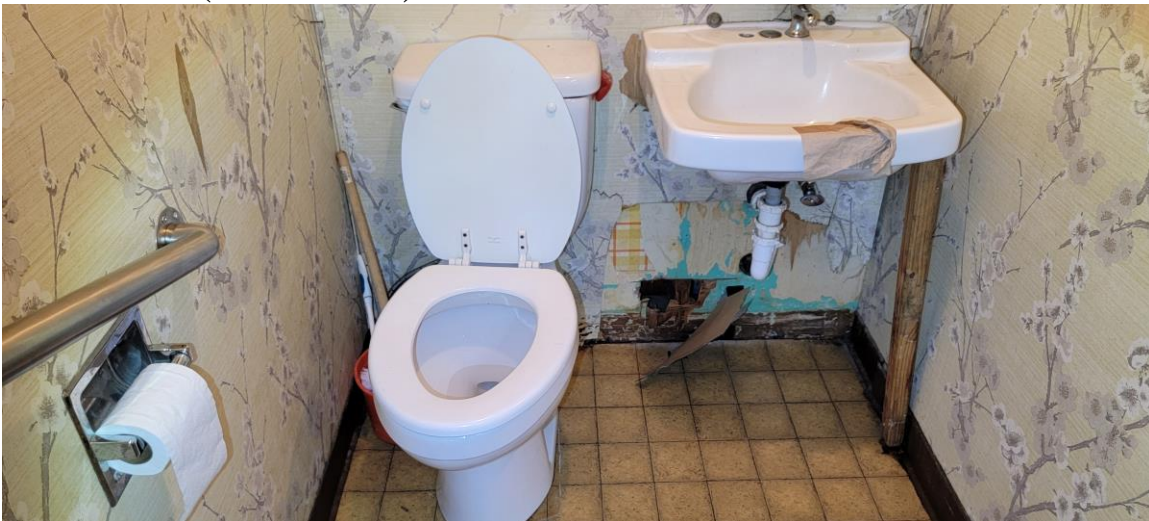
The public restroom does not meet the current ADA standards (see below).
