Property Inspection

The Sample Group Corporation

**445 Lake Benbow Drive, Garberville,
California**

**North Coast Property Inspections LLC
PO Box 422
Field's Landing, CA 95537
(707) 444-2326**

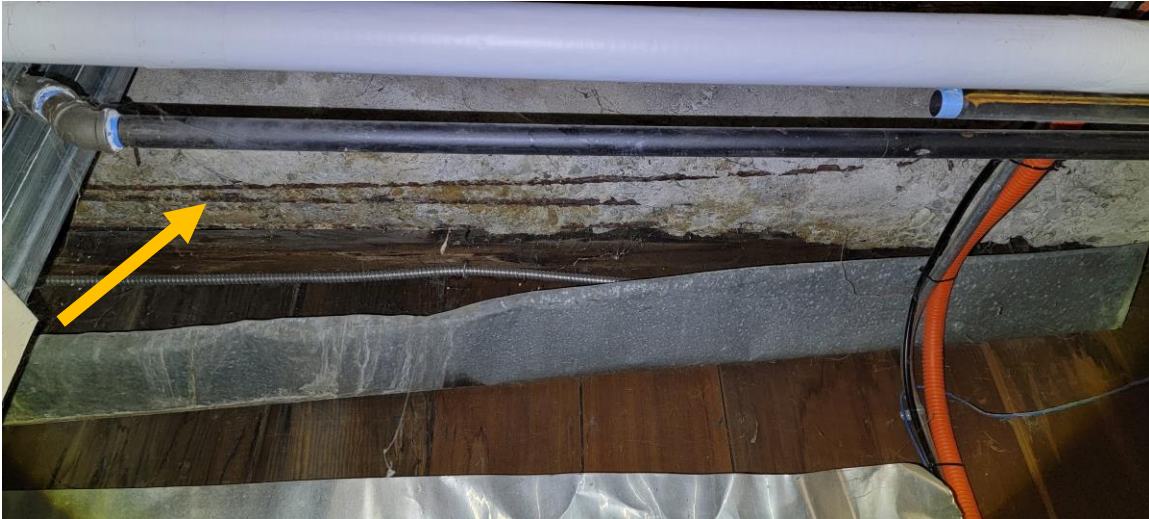
This main original structure is attached to a concrete perimeter foundation. The concrete foundation is steel reinforced with some rebar being exposed in the accessible mechanical areas (see below).

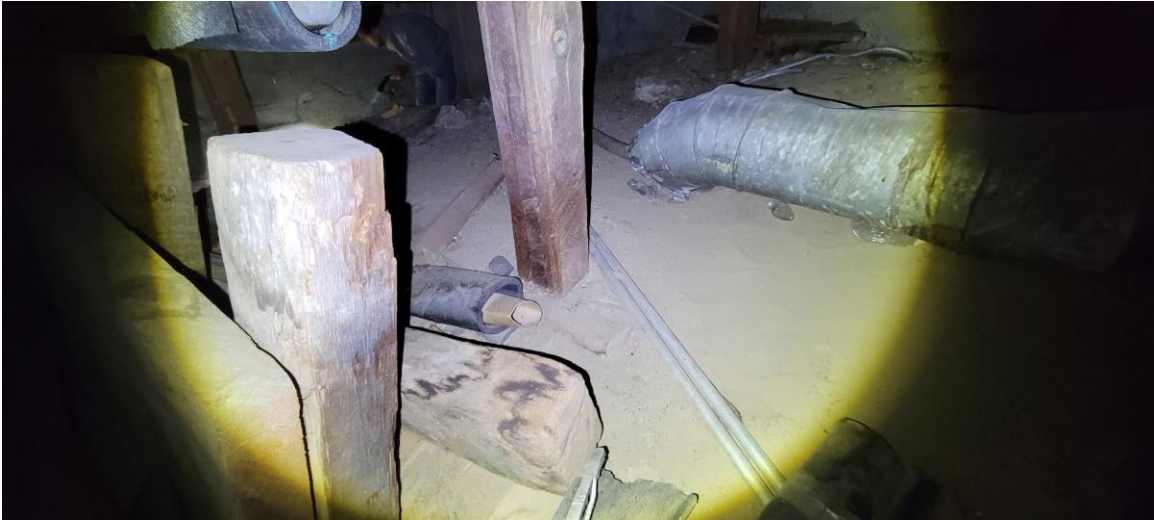
There is construction debris and earth to wood contact (see below).

1. **FOUNDATION:** Repair any live electrical wires not terminated within a covered electrical splice box. Complete the electrical upgrades by installing commercial grade wiring. Repair the freshwater leaks. Remediate any asbestos type of pipe wrapping still in the accessible crawlspace areas as recommended in the asbestos survey of Brunelle & Clark Consulting May 12, 2016. Repair the wastewater plumbing leaks and sanitize the contaminated area. Repair the earth to wood contact. Remove the construction debris from the crawlspace. Increase the ventilation in the accessible areas of the crawlspace. **I recommend that you consult with the engineer of record concerning the Terrace wing and 2017 addition in regard to the erosion and repairs to the river embankment.**

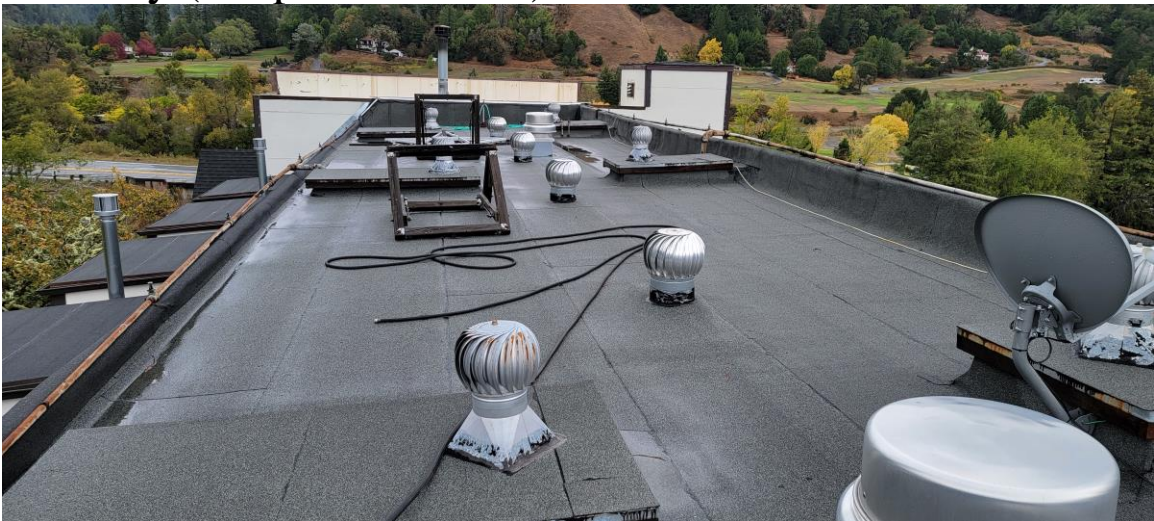
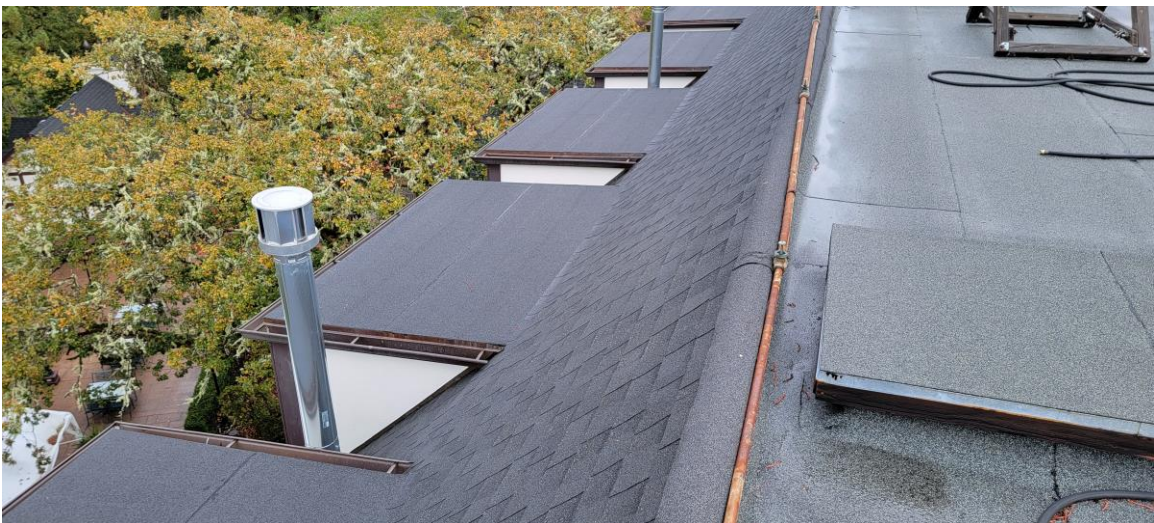
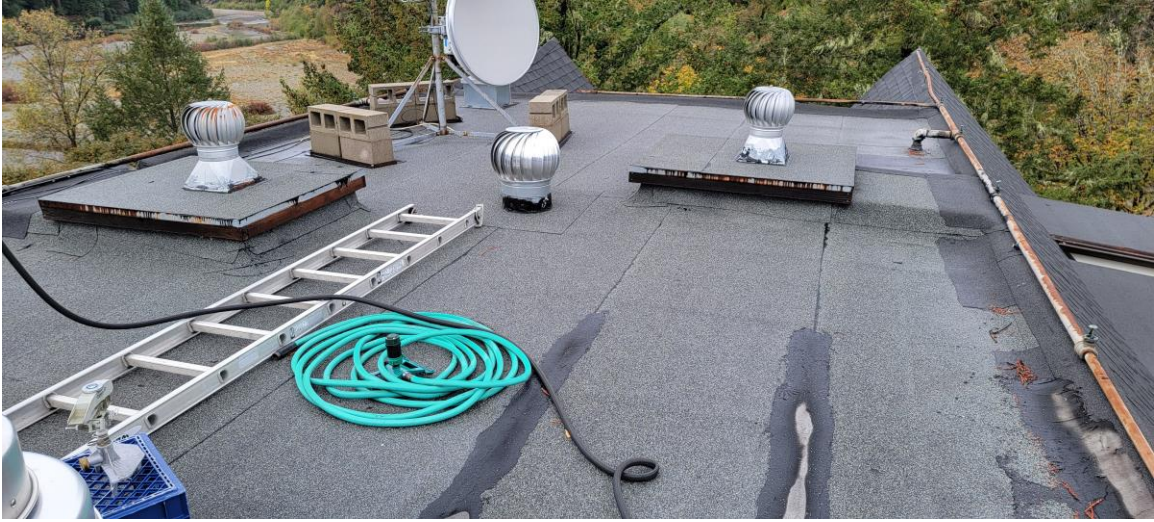
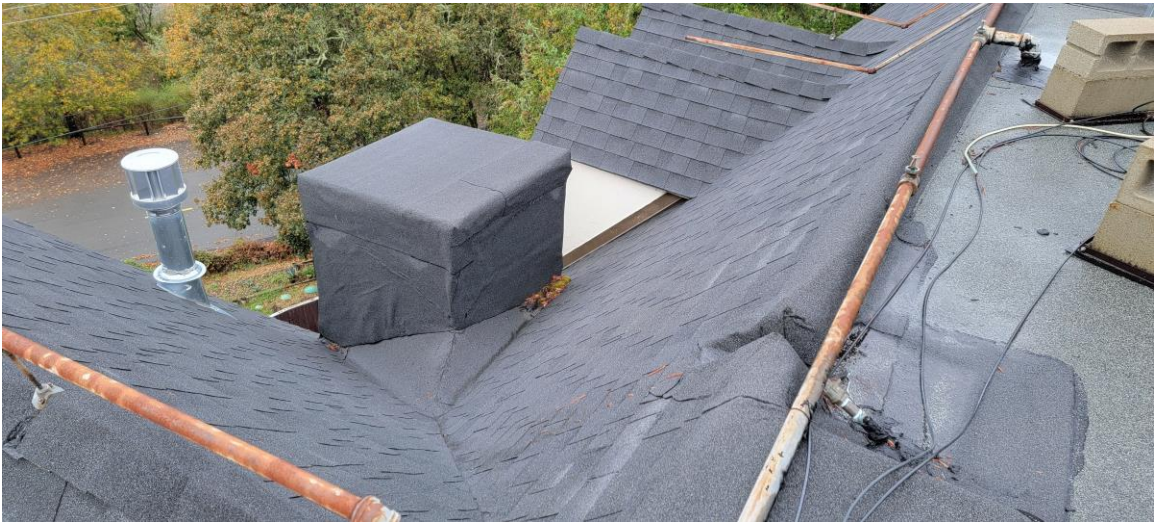
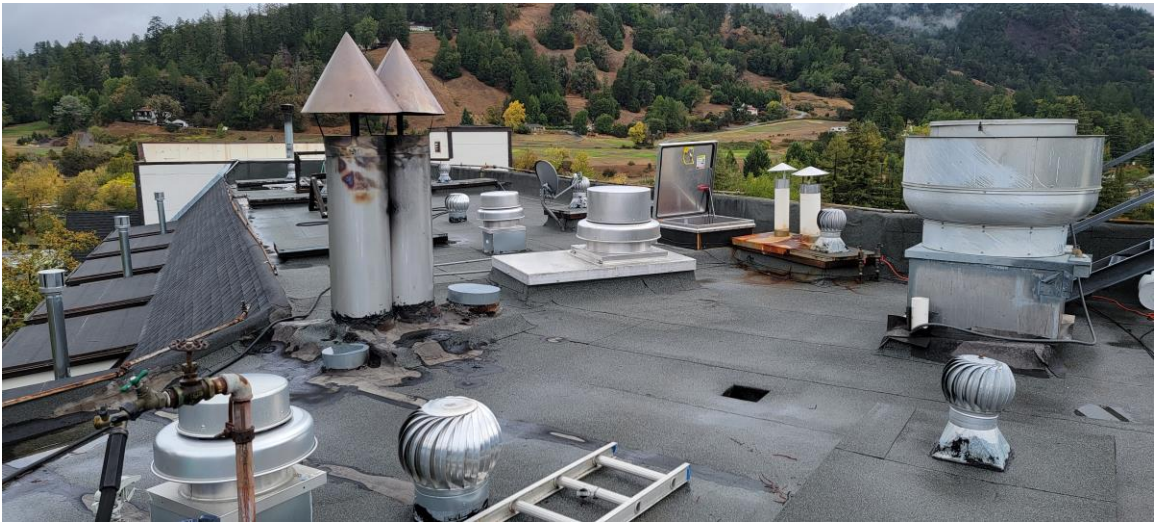
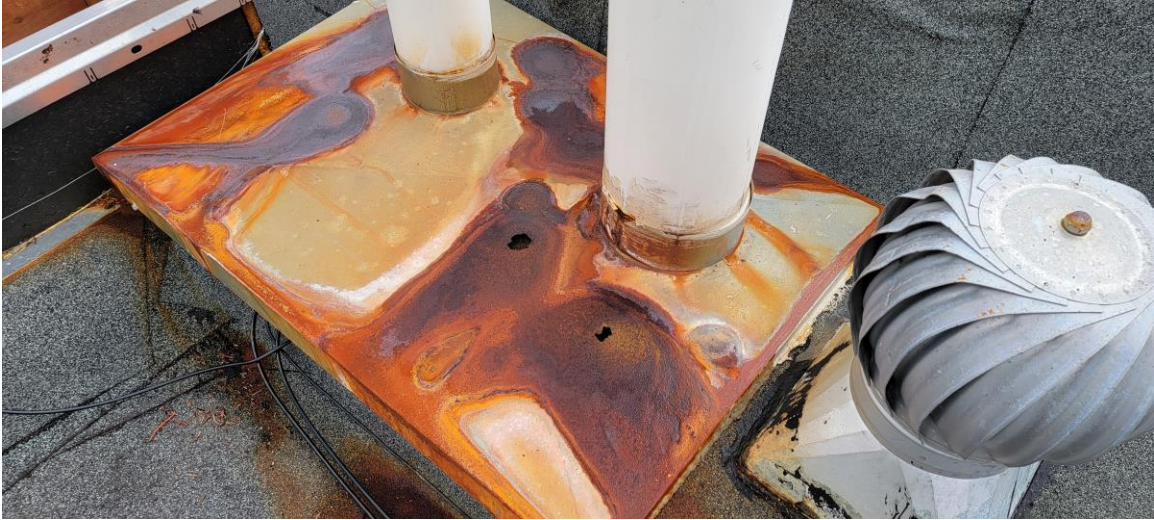
The roofing material for this building is a combination of rolled composition, asphalt composition shingles, **TPO (thermoplastic polyolefin)** and some wood shingles in spots over the gable rakes at the back of the original building. The condition of the roofing material is good/fair on the bulk of the structure but poor over the original building at the entry (see photos below).

Proper metal flashing is applied. There does appear to be a flashing weak spot for water intrusion at the original wood frame structure/steel framed 2017 addition roofing connection (see flashing photos above). There are asphalt shingles that are likely damaged by birds. There are exposed fasteners in spots. There is considerable ceramic granule loss and fiberglass matting exposed on the front face entry of the building. There are rusted flashings and cracks or missing sealant at many of the plumbing and heating penetrations. The wood chimney flues over the original building have no spark arrestor screen (see below).

2. **ROOF/ATTIC**: The condition of this roofing material should be evaluated by a licensed roofing contractor. Repair all gutters and downspouts as needed. Divert all downspouts away from the foundation. **Install spark arrestor caps on all wood burning chimney flue pipes. Repair any live electrical wires not terminated within a covered electrical splice box. Complete the electrical wiring upgrades to commercial grade.**

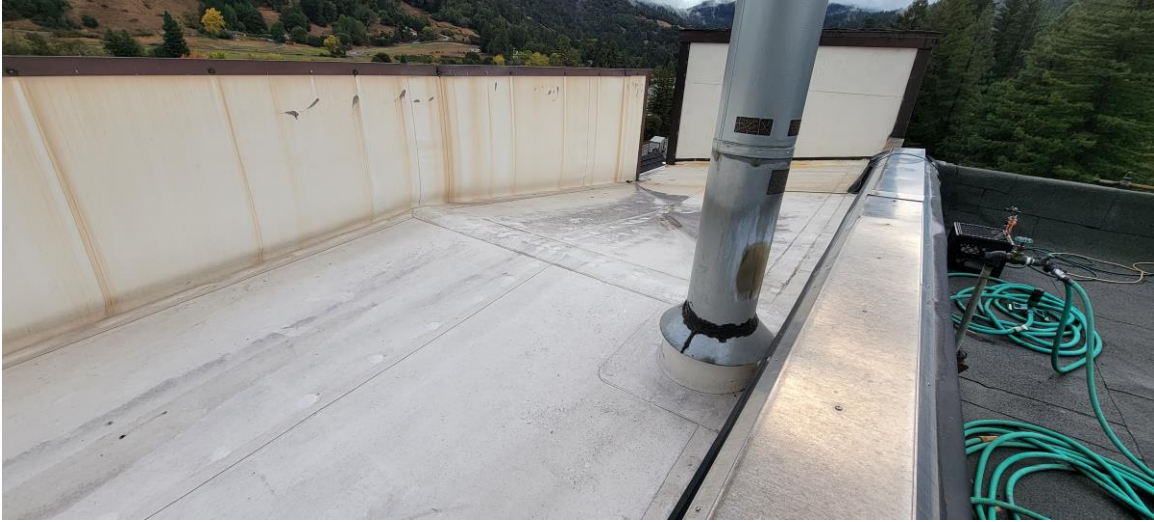
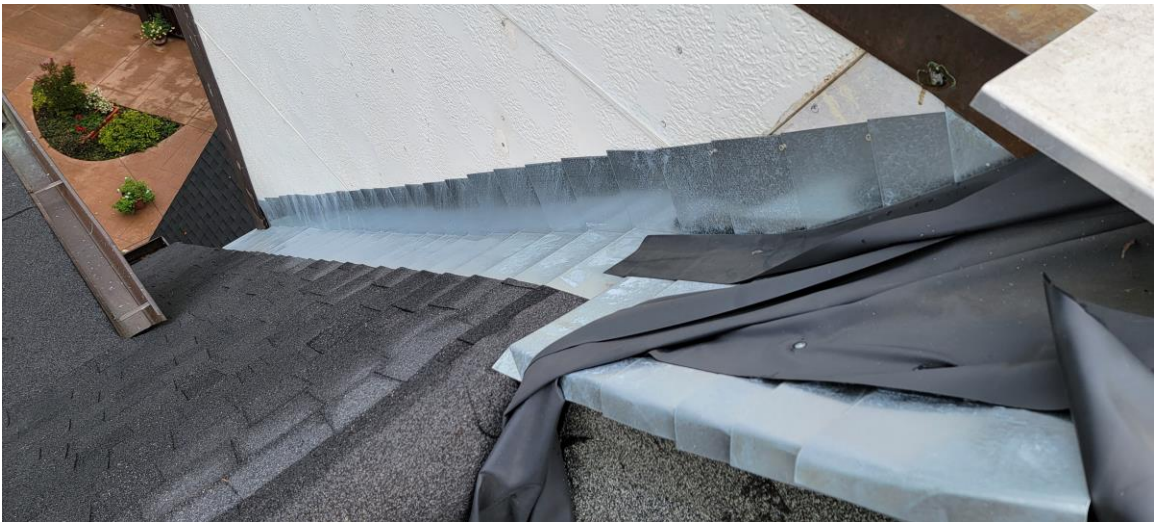
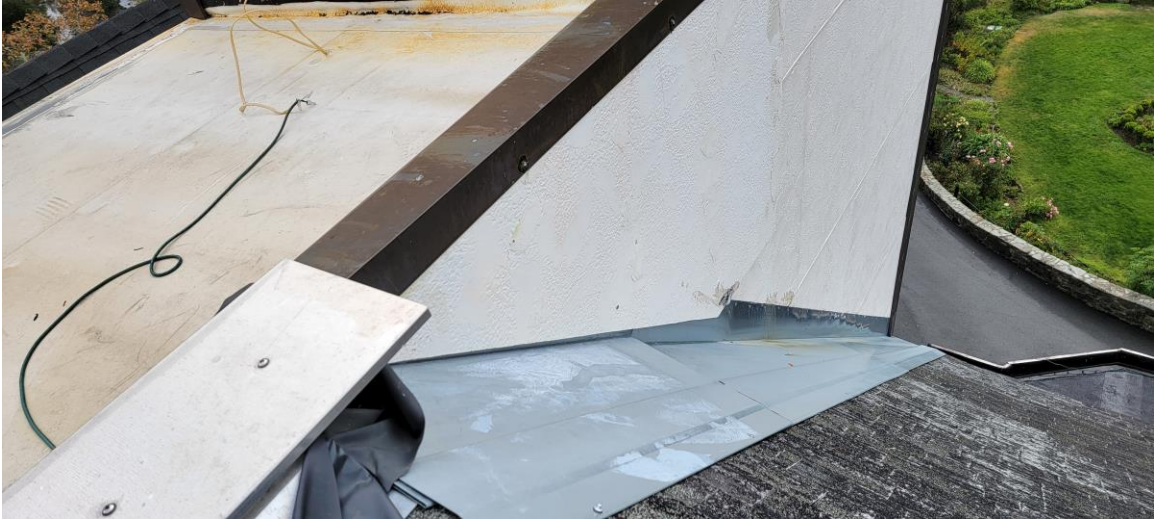
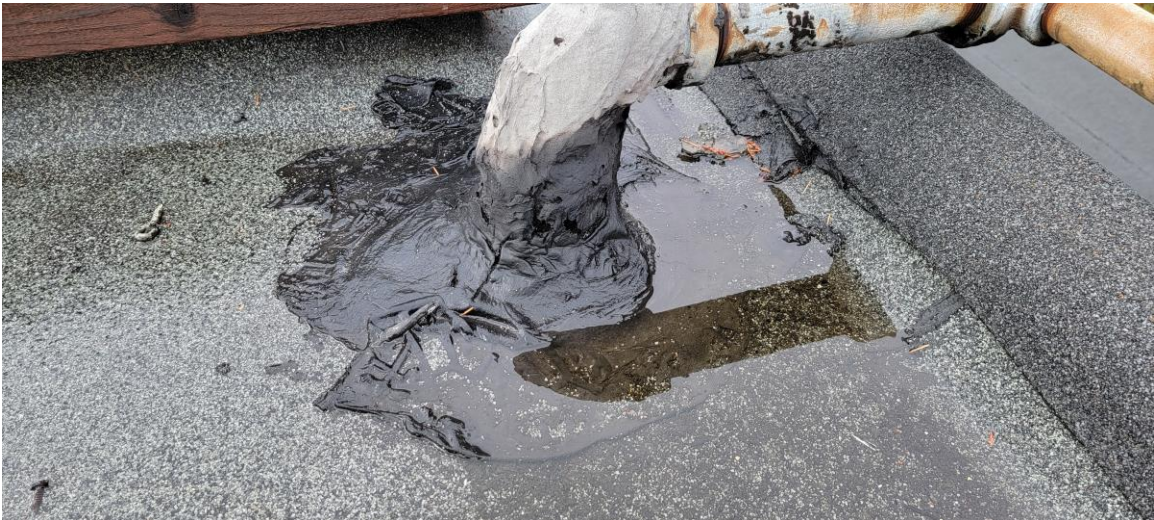
TPO (thermoplastic polyolefin) over the low slope section of the 2017 steel building addition (see below).

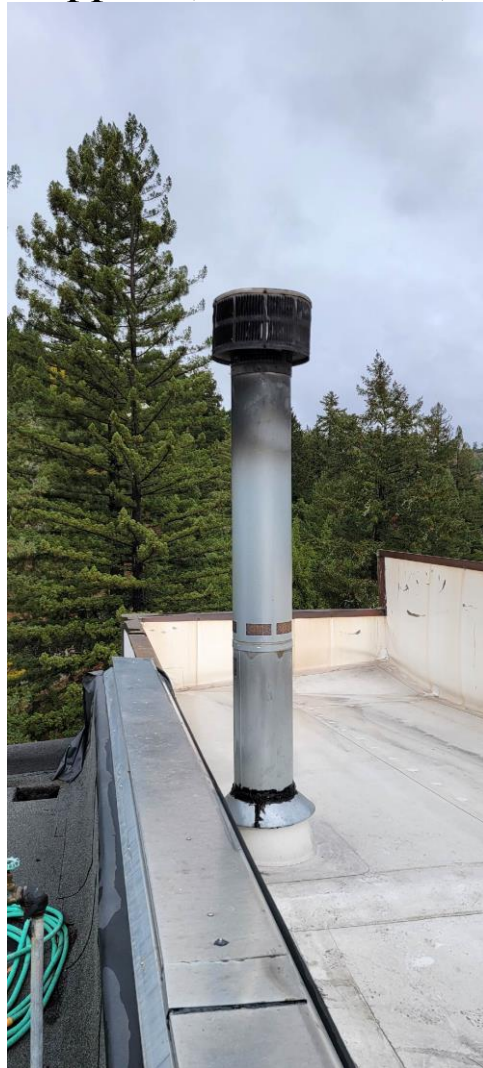
The chimney flue pipe for the great room fireplace has inadequate lateral support (no brackets (see below)).

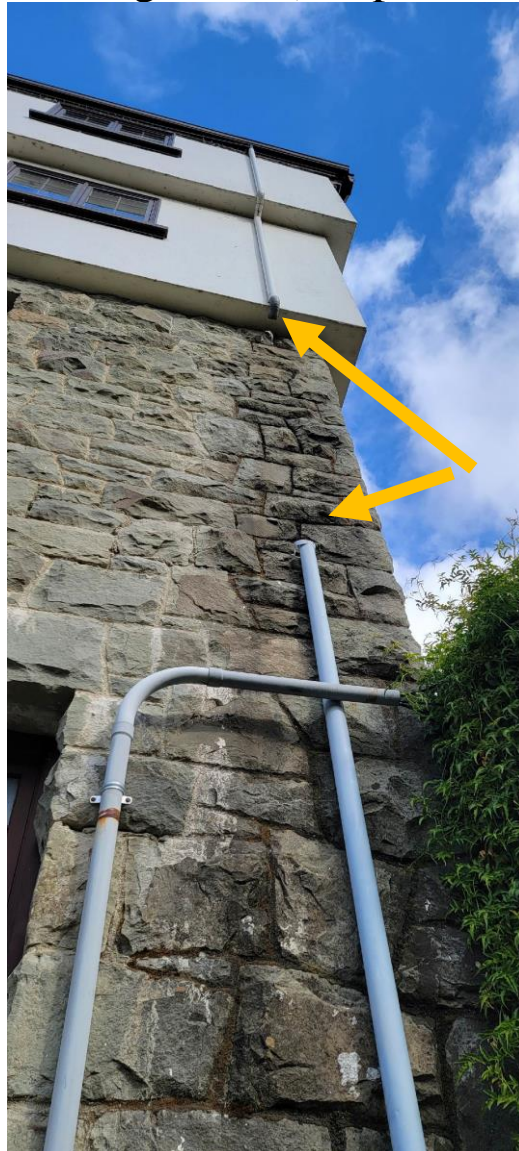
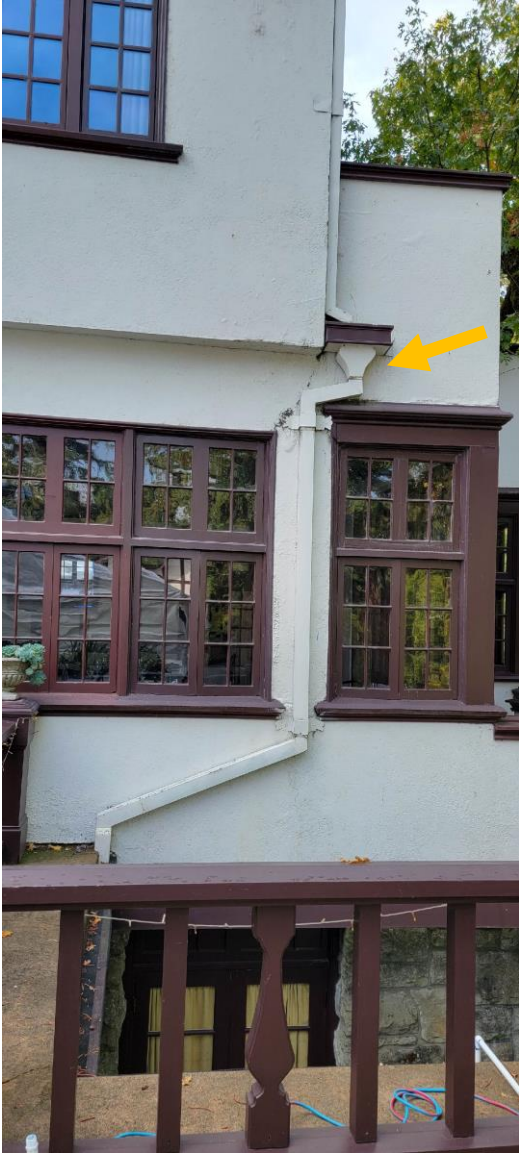
Dining outside wall

The gutters and downspouts are in good/fair and poor condition. There are gutters that have rusted out at the downspout connection over at the cottage east side. Some of the downspouts are not diverted away from the foundation of the building. Some of the downspouts are disconnected or appear to be allowing water intrusion in the wall cavity in the dining room (see photos below).

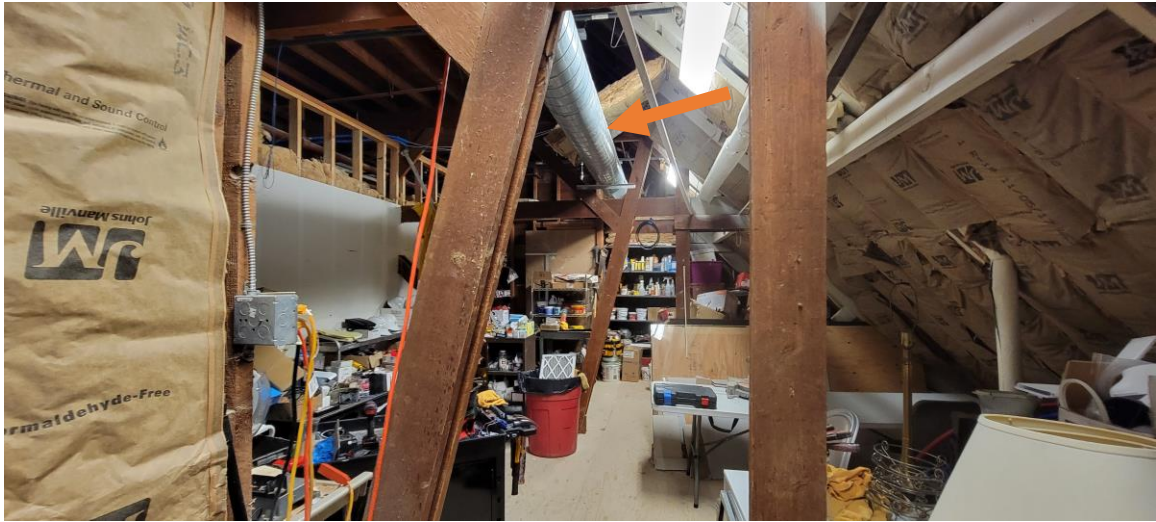
The visible portion of the attic appears strong & dry. The attic is vented with turbine vents and insulated (8-10 inches). The attic cavity is approximately 24"-30" in headroom. The attic is accessible from the housekeeping supply area or the engineering workshop space. There are heating ducts present over the engineering and housekeeping areas (see below).

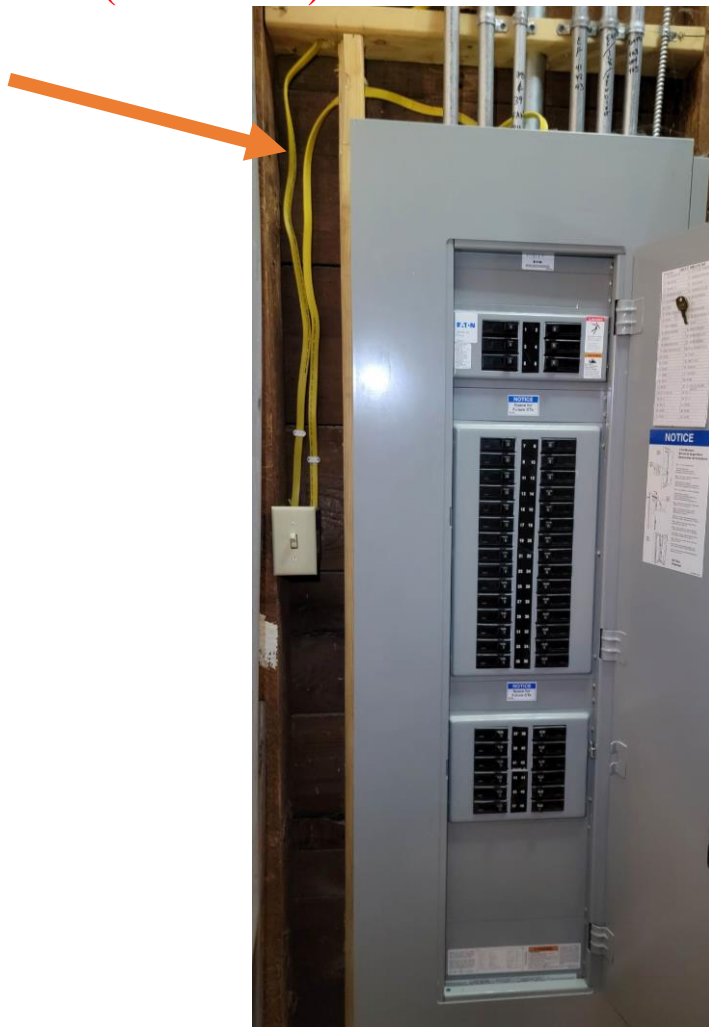
There are live electrical wires not protected within a chase or conduit in compliance with commercial grade electrical standards (see below).

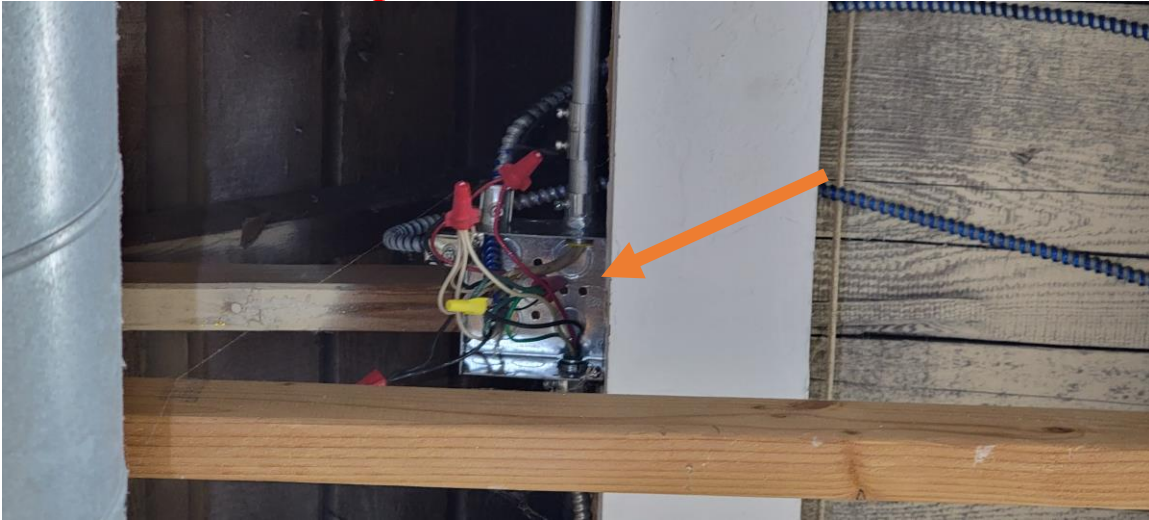
There are live electrical wires not terminated within a covered electrical splice box (see below).

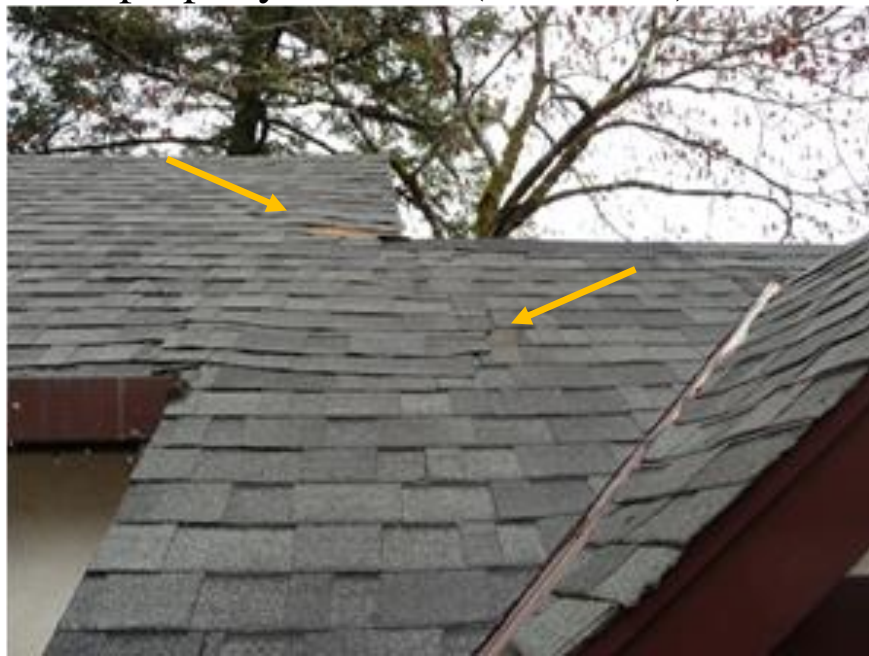
Some of the shingles on the main terrace wing (cottage) have been improperly installed (see below).

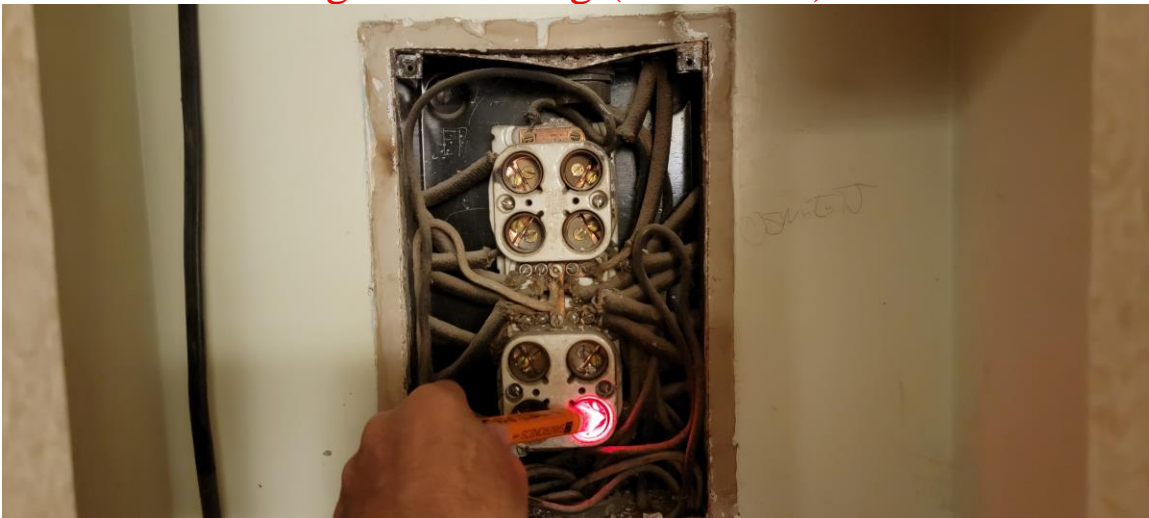
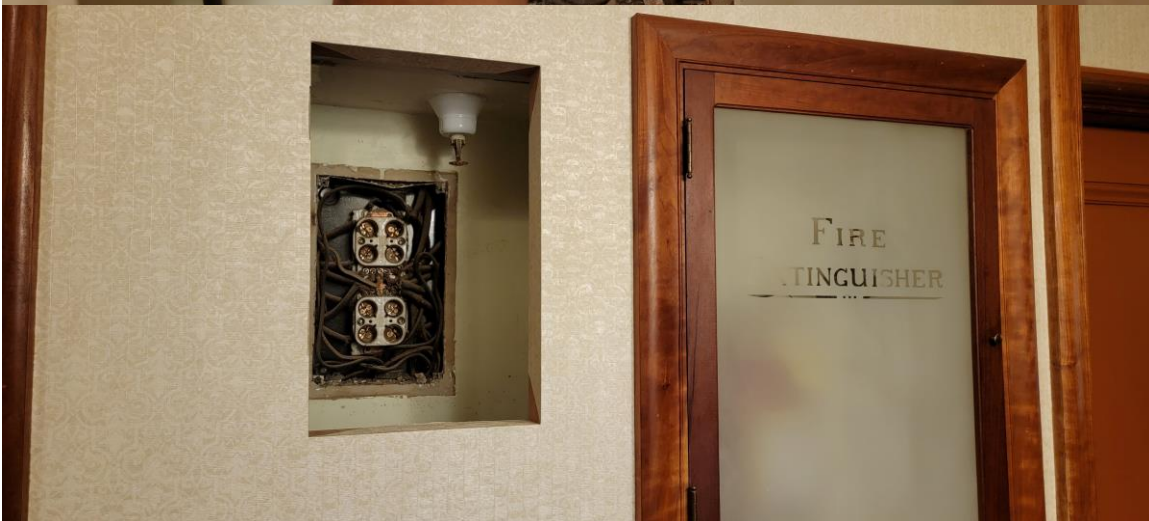
The electrical service panels are located in the basement. Two, 400 Amp. Service disconnects are present. 3-Phase power is supplied to the building. Many service sub panels are present throughout the building with circuit breakers. Ground Fault Circuit Interrupter (GFCI) protection is present in many (but not all of the bathrooms/restrooms/exterior outlets (see attached pdf sheets)). We could not locate the (AFCI) protected circuits. Live knob and tube wiring was found in the fused panels located in the original building (see below).

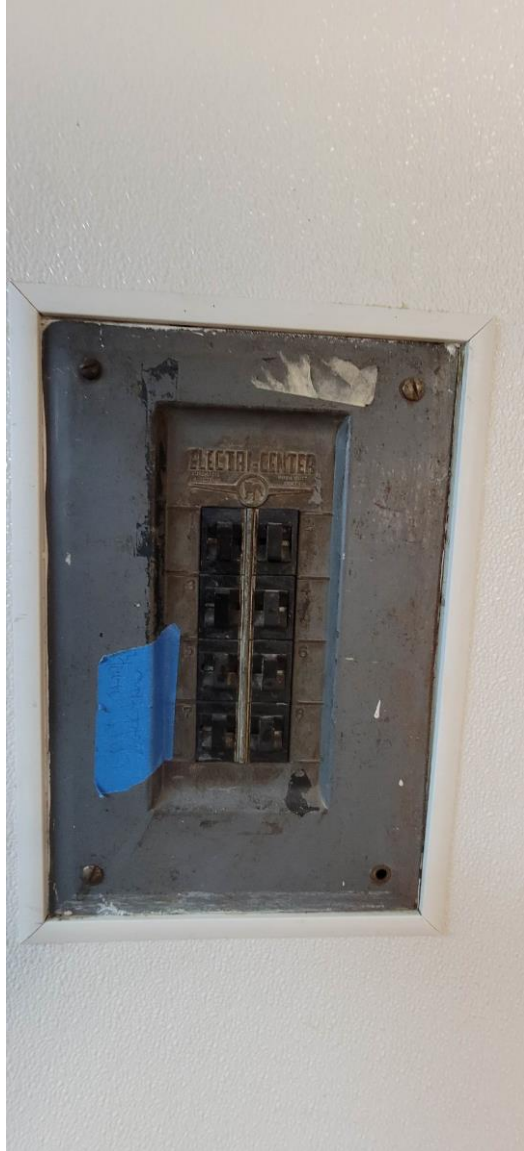
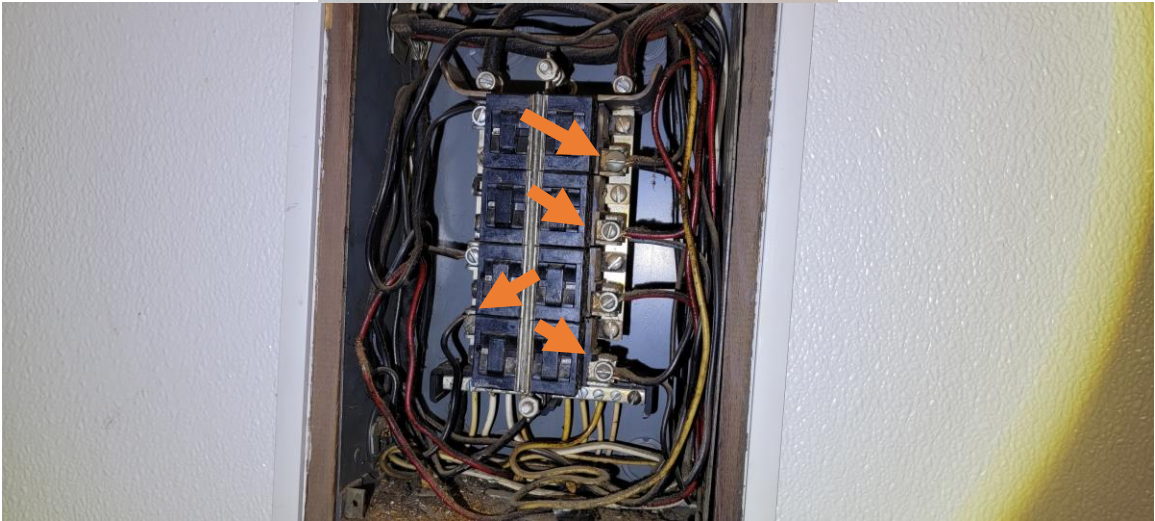
There are double tapped breakers in the old sub panel at the primary kitchen entry (See below).

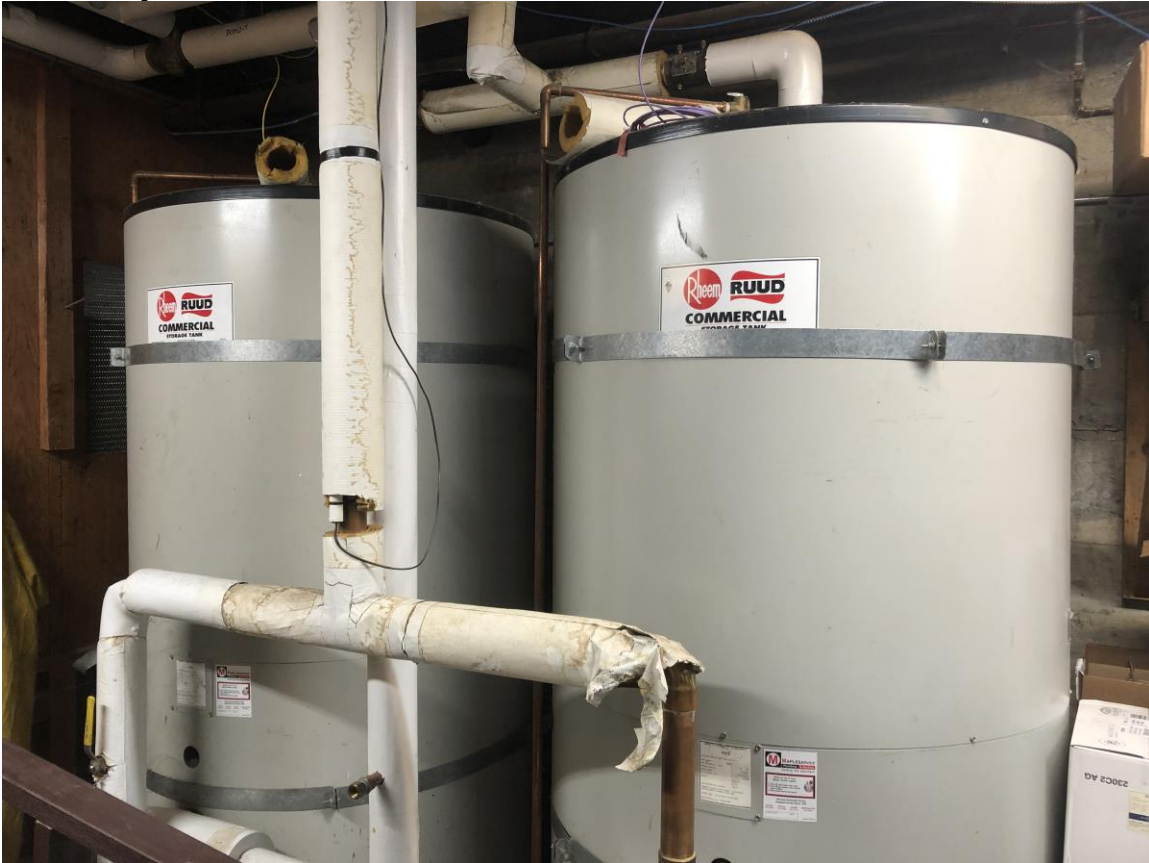
Fresh water for this building is provided by copper, galvanized steel and some plastic (PEX) (PVC) pipes. Domestic hot water is provided by two very large storage tanks by Rheem located in the basement (see below).

The water heaters are properly strapped for seismic stability according to today's standards. Some of the pipe wrap has been damaged (see above). The temperature/pressure relief valve at the water heaters are not adequately vented as they will dump hot water into the basement areas.

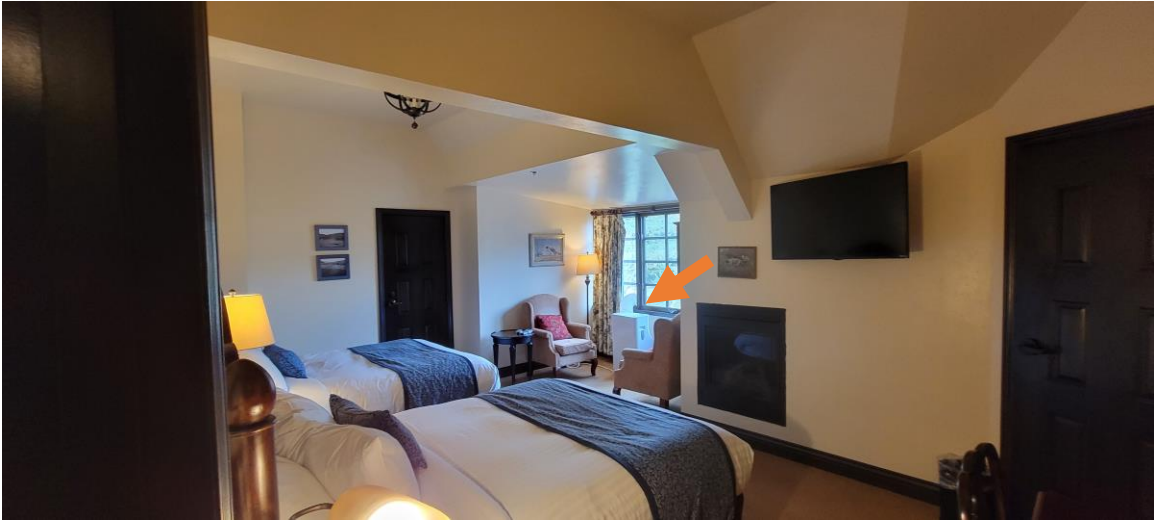
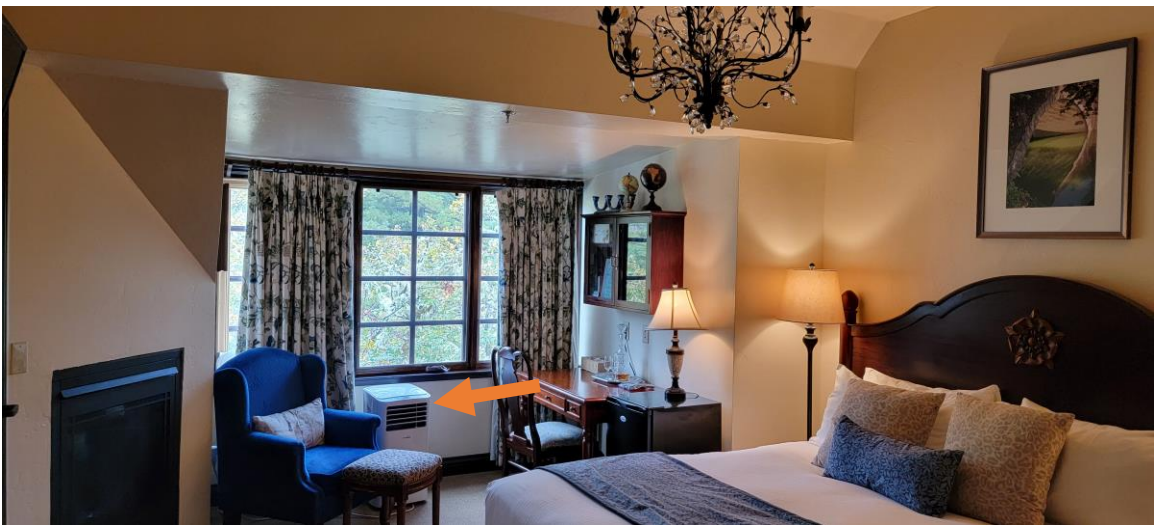
The system consists of distribution pipes that send heat to each room and select conditioned airspace common areas. A thermostatically controlled fan unit heats the room as needed. The original building floors 2-3 and the Terrace wings appear to have air handler units installed during the 1984 Terrace wing construction. These units are loud, worn, and many are not cooling the rooms properly. Many have dirty filters or none at all. Many rooms use portable coolers that vent through an exterior window on the west

side of the Inn, including rooms added during the 2017 addition (see below).

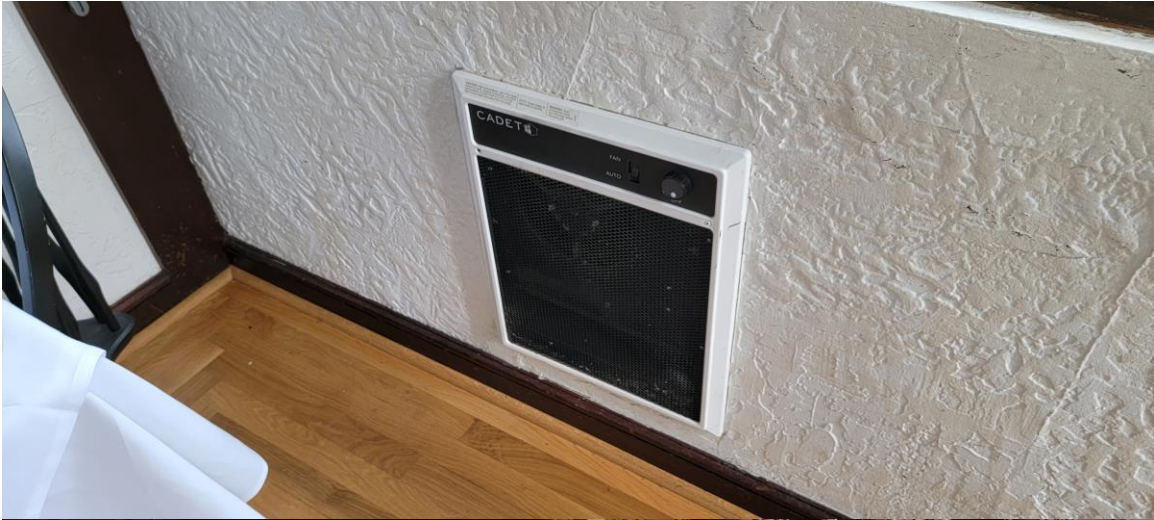
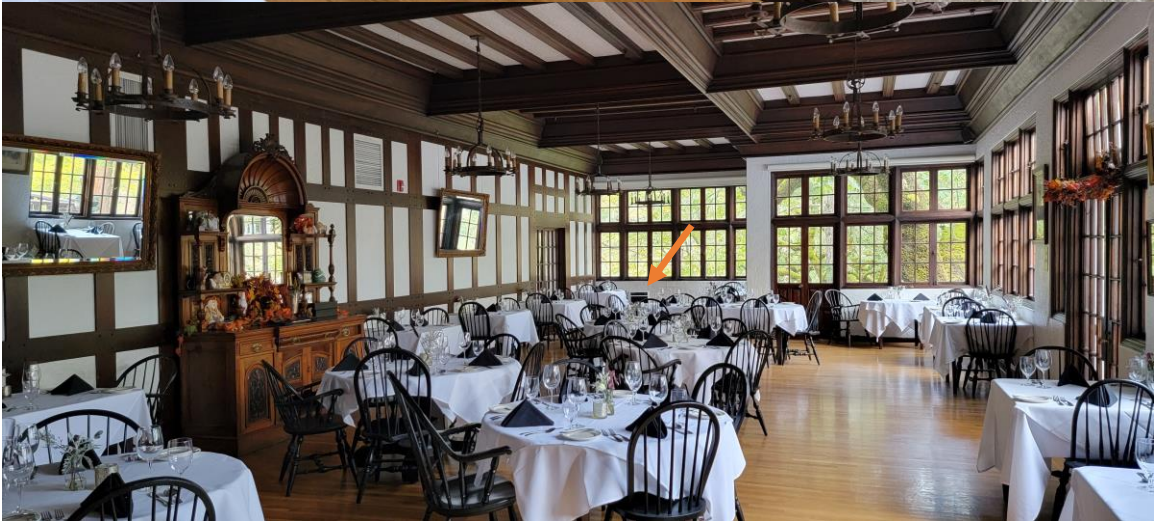
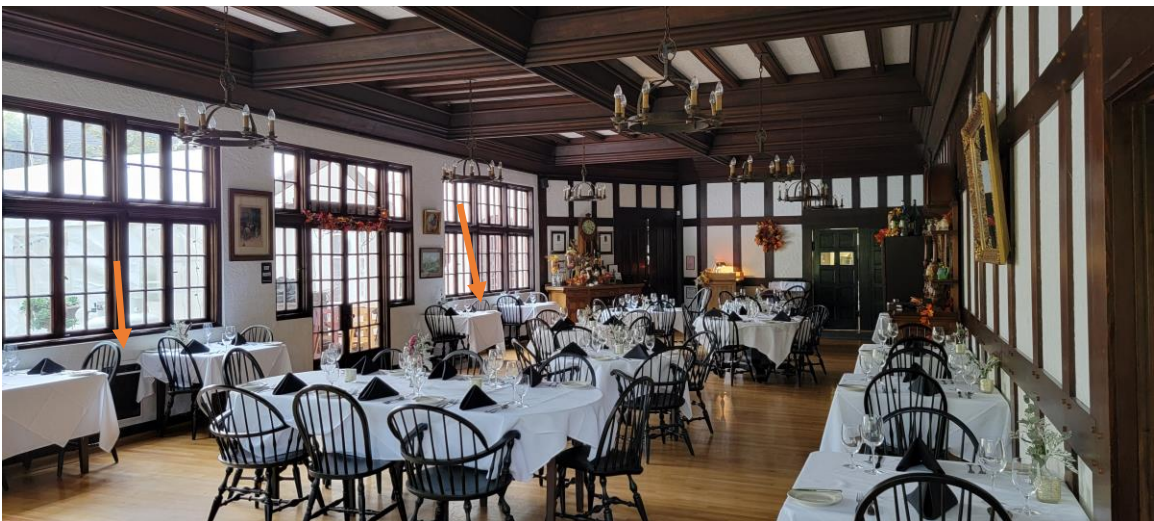
The dining room has additional electric wall heaters. Two of three heaters are nonfunctional (see below).

5. **HVAC SYSTEM:** Upgrade all of the old air handler units in the original building and Terrace wings. Or due to the age and condition of the heating/cooling air handler systems, I recommend that you call a qualified commercial heating professional to clean and service the air handler units in the rooms. Install, replace/clean the air handler filters as often as needed. I also recommend that you call a Heavy Commercial Technician to evaluate the load demands of the Trane chiller, the pipe distribution distances and the system balance given the condensing problems in the Terrace wing hall ceilings. A licensed heating contractor should evaluate the installation of the fireplaces and woodstoves heating systems for continued safe use. Install spark arrestor screen caps on the roof flue pipes designated for the fireplaces. Install support brackets on the loose chimney flue pipe on the 2017 steel building addition. Repair the electric wall heaters in the dining room. Repair any water leaks associated with the system.

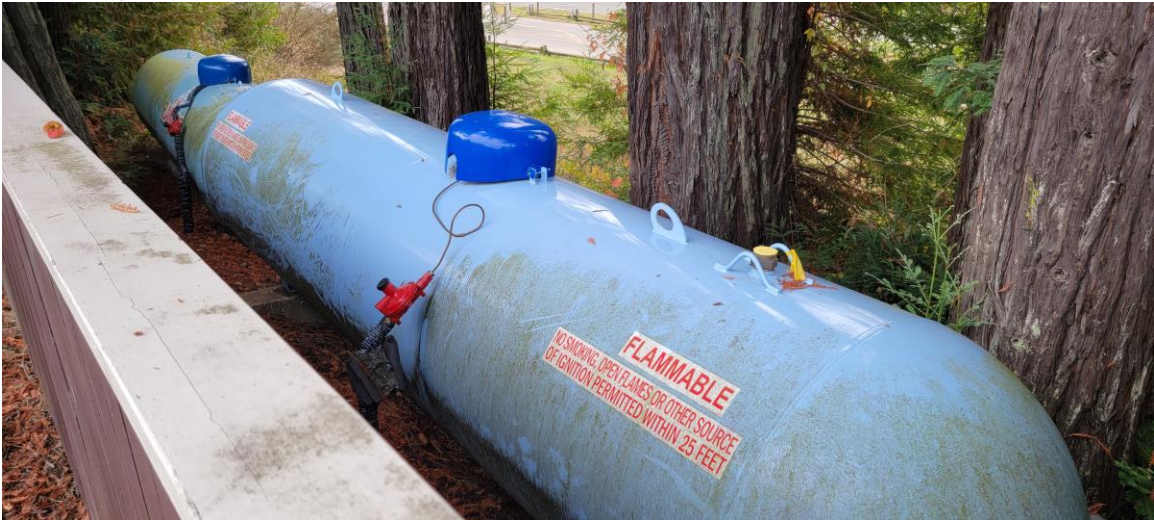
The utilities supplied to this building are community water by Del Oro and PG&E electricity. L/P gas is supplied by Blue Starr gas. The tanks are located across the street near the administration buildings behind an enclosure (see below).

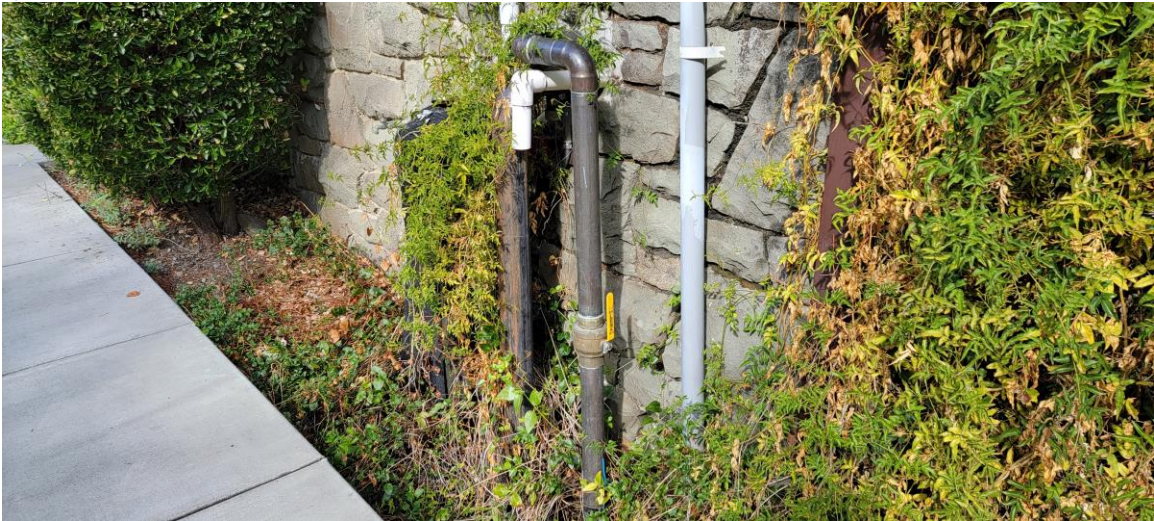
There are two 1,000 gallon propane tanks. The water shut-off valve is located on the southeast corner of the building (see below).

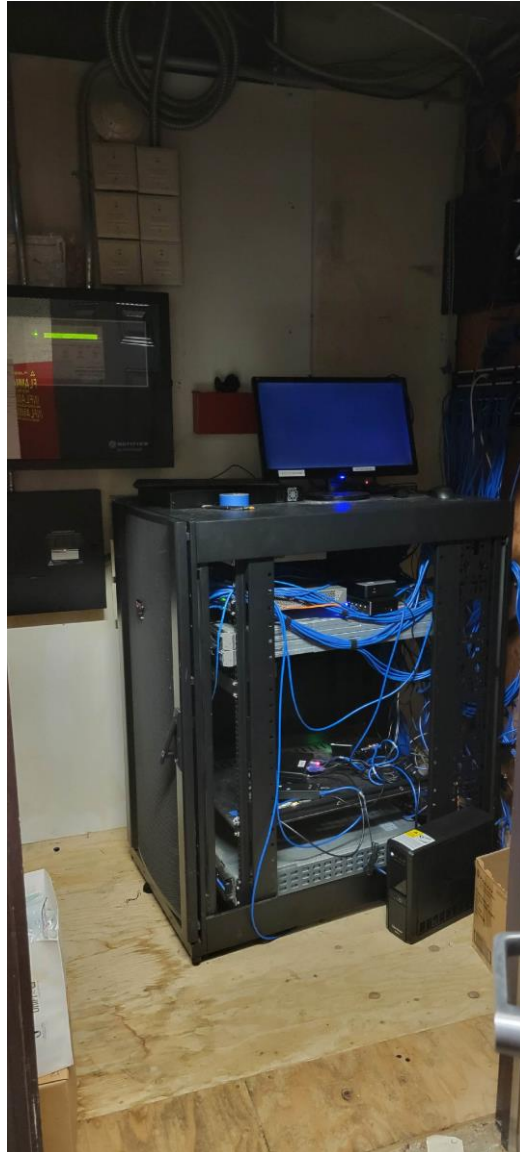
The communications panels or IT room can be found at the interior of the building near the mechanical room entry. It is within a secure room (see below).
