Property Inspection

The Sample Group Corporation

**445 Lake Benbow Drive, Garberville,
California**

**North Coast Property Inspections LLC
PO Box 422
Field's Landing, CA 95537
(707) 444-2326**

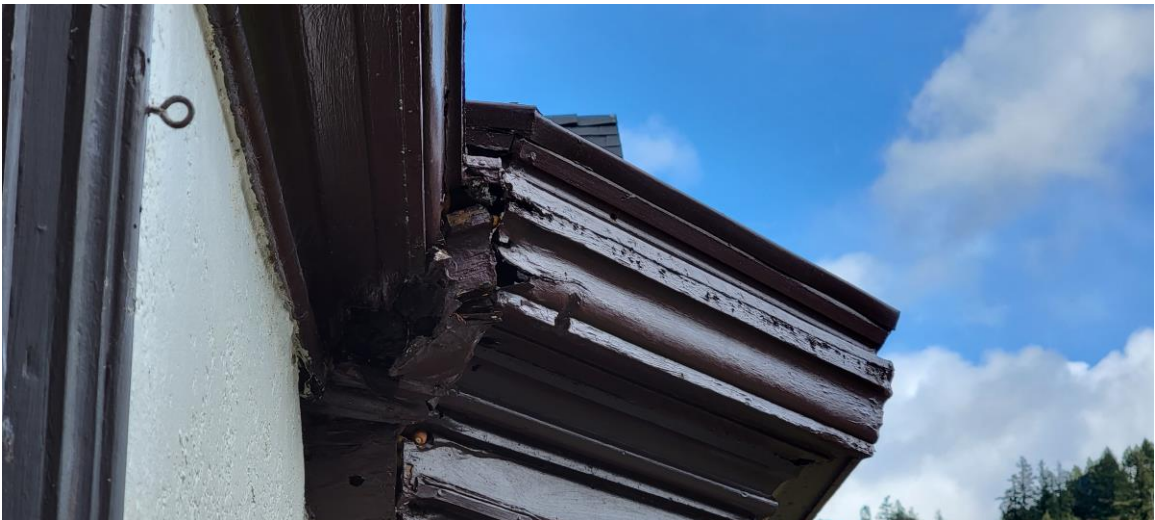
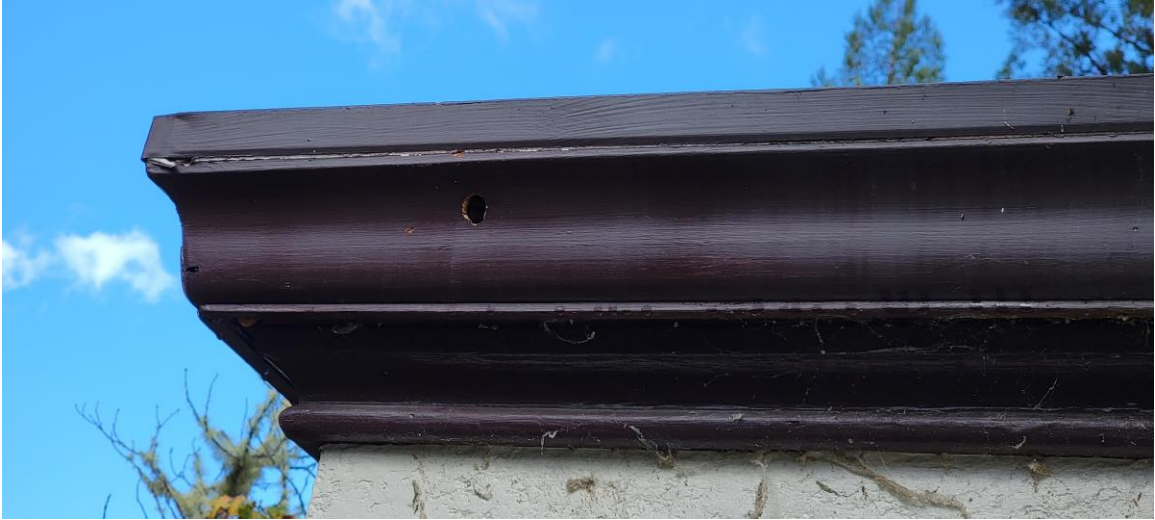
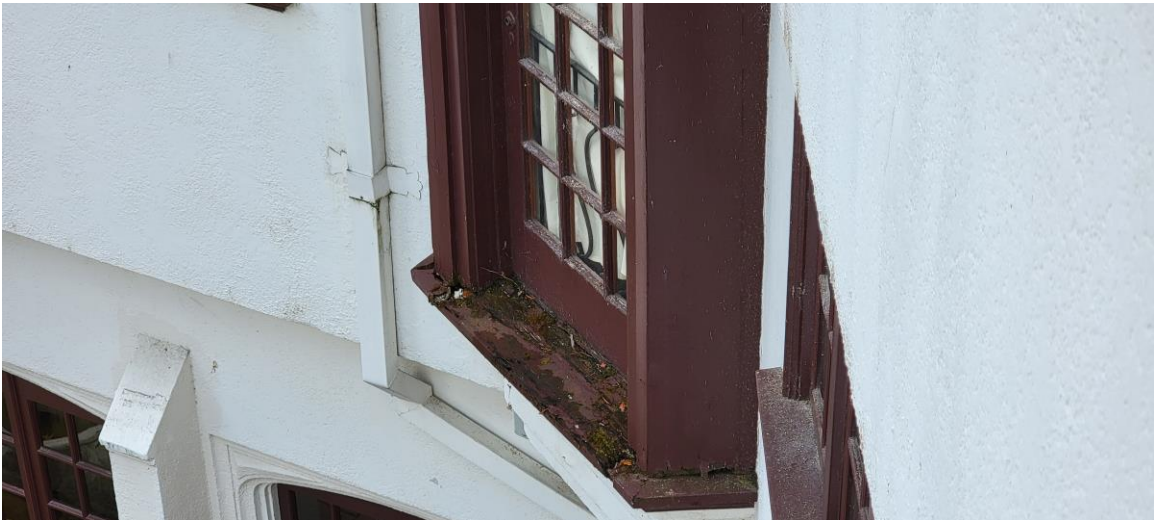
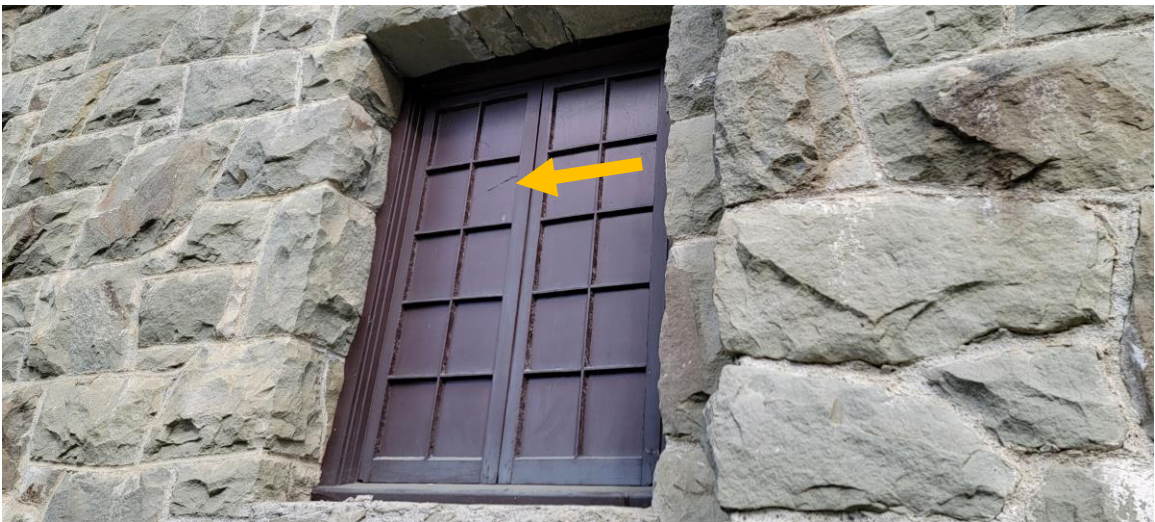
The exterior is in good/fair condition. There is evidence of water penetration in many areas of the stucco siding, wood window sashes, trim and corbel moldings on all sides of the original building. Neighborhood woodpeckers have extensively damaged the old growth redwood trim on all sides of the building depositing acorns into the void cavities. There is broken single pane window glass. There are many dual pane windows with failed seals. Many of the original windows do not close/fit properly. The hardware of many original windows are non-functional or damaged so as to not operate properly. Some balconies may be allowing water intrusion (see below). Many exterior doors and door jams are water damaged and allow water intrusion into some rooms (see photos below).

8. **EXTERIOR:** Repair the water and bird damaged original old growth trim and custom woodwork on the exterior. Repair the damaged stucco as needed. Paint the siding and trim as needed. Repair or rebuild the damaged original wood casement windows and doors. Replace or repair the damaged window and door hardware as needed. Replace the dual-pane windows with failed seals. Rebuild the upper lobby exterior stairs water damaged landing and safety railings for safe guest use. Repair the upper lobby porch water damaged wood columns and custom trims as needed. Repair the trip hazard at the upper lobby entry porch new building connection for guest safety. Repair the irregular lower stair landing pavers trip hazard for improved guest safety. Improve the weather seal at all windows and doors as needed for better energy efficiency. Repair the damaged and settled stone walkway to the river. Repair the Terrace wing tree damaged concrete patios as needed. Repair the water damaged Terrace wing decorative fencing. **Repair the exposed live electrical wiring at the terrace patio and garden transition areas and install (GFCI) protection at all exterior outlets.** Repair the broken window glass on the single pane windows and doors. Repair the water damaged trim on the building additions. Consider

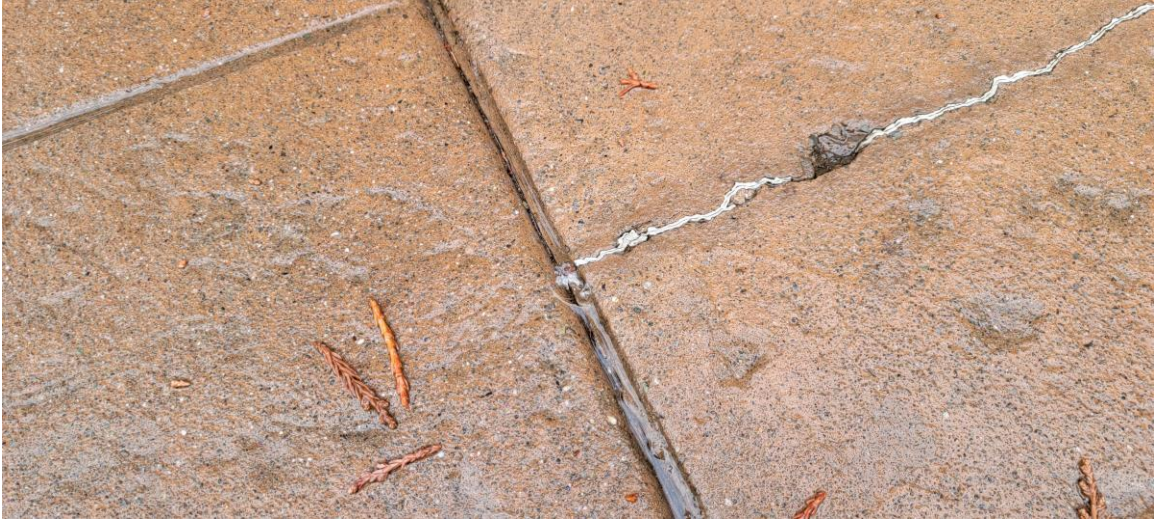
There are many terrace patio pavers in the courtyard that are cracked, allowing water intrusion into the space between the bottom of the pavers and the unseen waterproof membrane (see below).

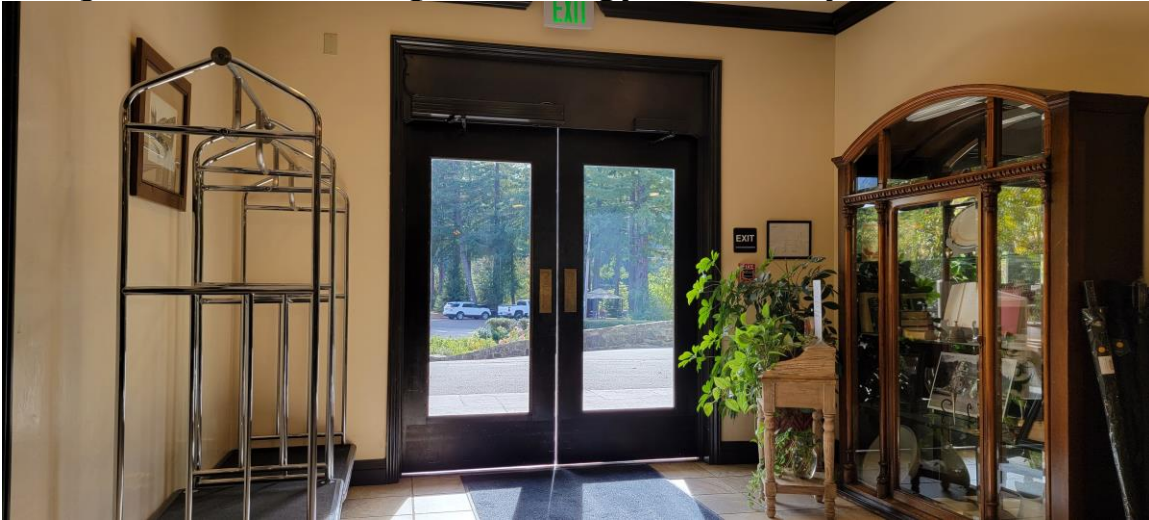
The registration entry doors are drafty and without adequate weather strip for energy efficiency (see below).

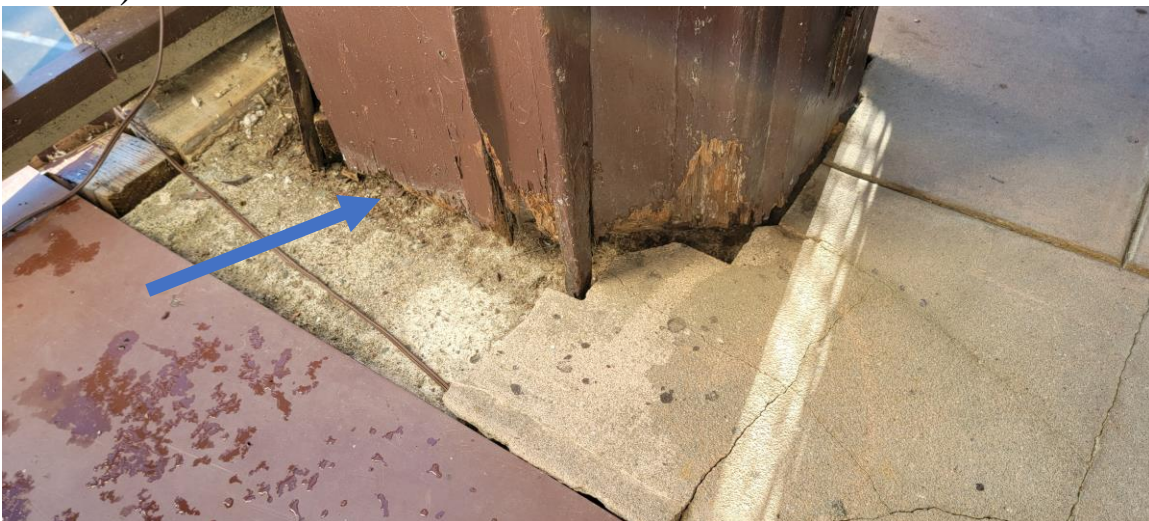
At the upper lobby porch there is water damaged posts and safety railing. The wood landing and framing members atop the entry stairs are water damaged. The safety railing is too low for guest safety and protected by planters (see below).

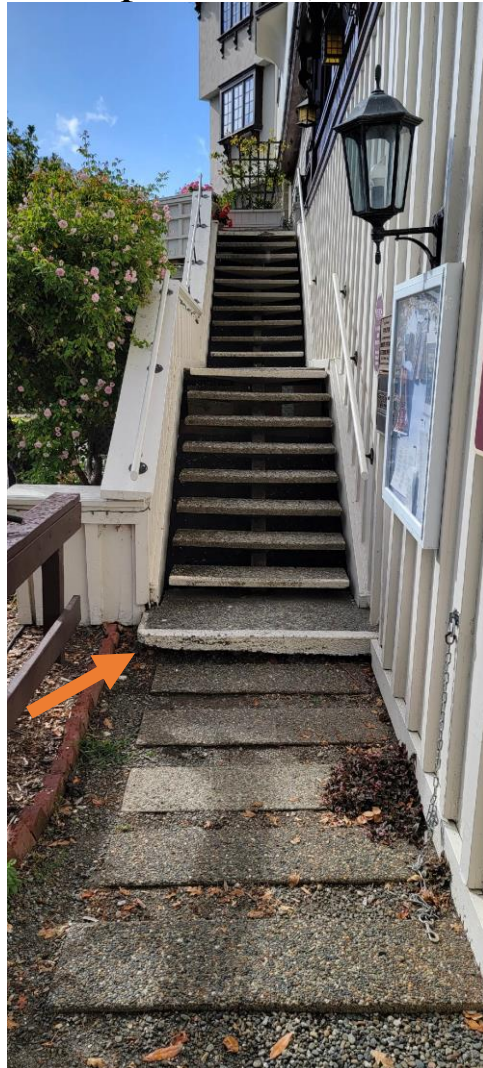
The upper lobby porch concrete steps and pavers are irregular and a guest trip hazard (see below).

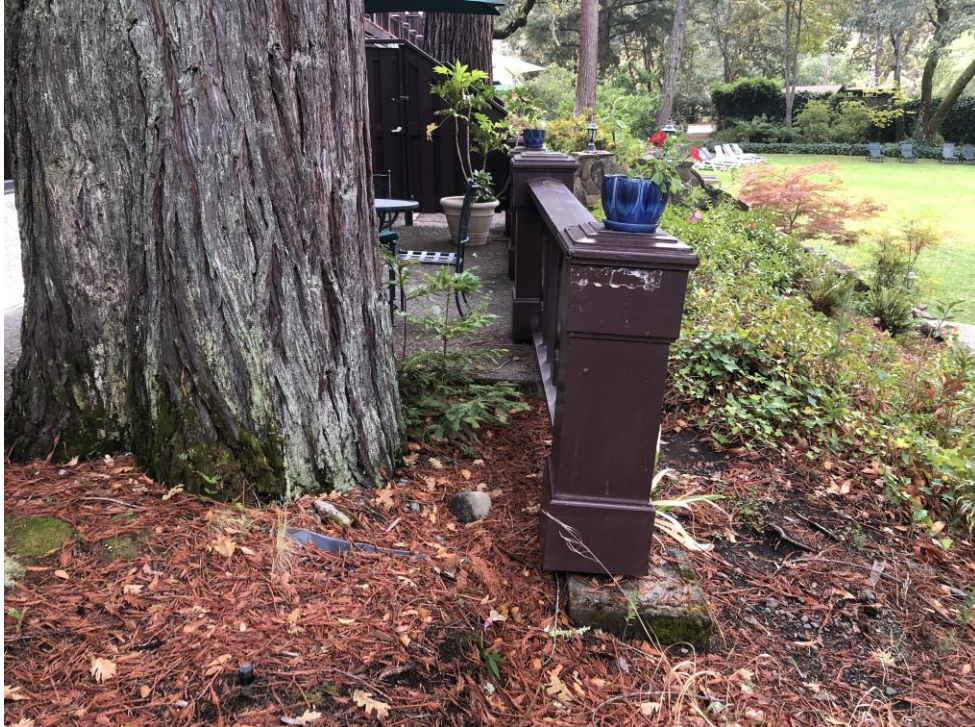
The trees at the terrace wing are lifting and damaging patios and decorative railings (see below).

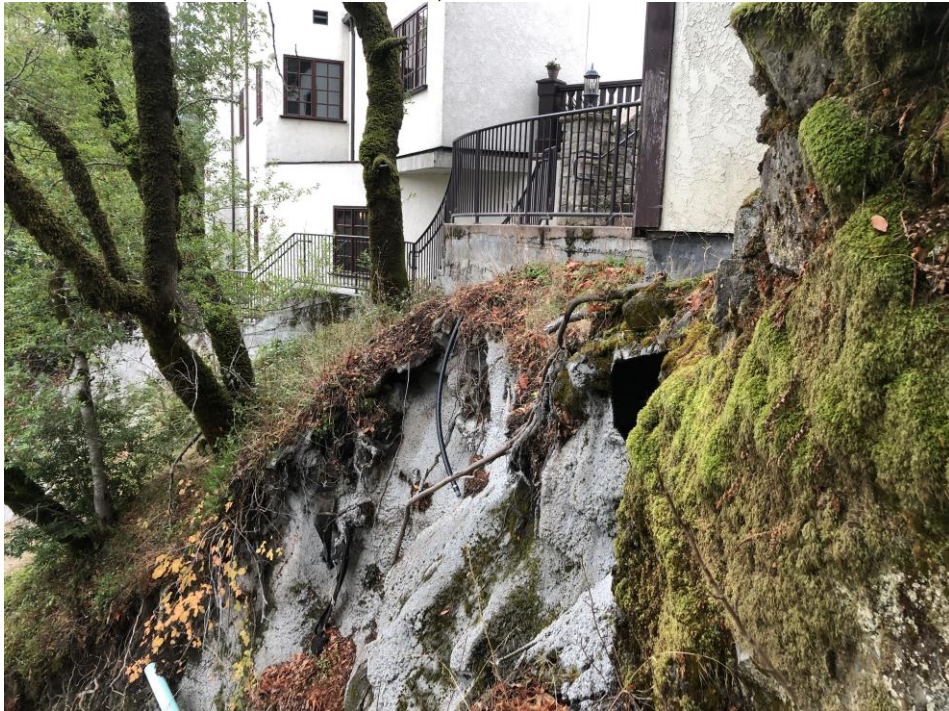
The cottage and terrace wing is too close to the grade drop off into the river (see below).

NOTE: The evident hillside erosion and any repair may have to be addressed with documentation by the engineer of record for the benefit of any new owner.

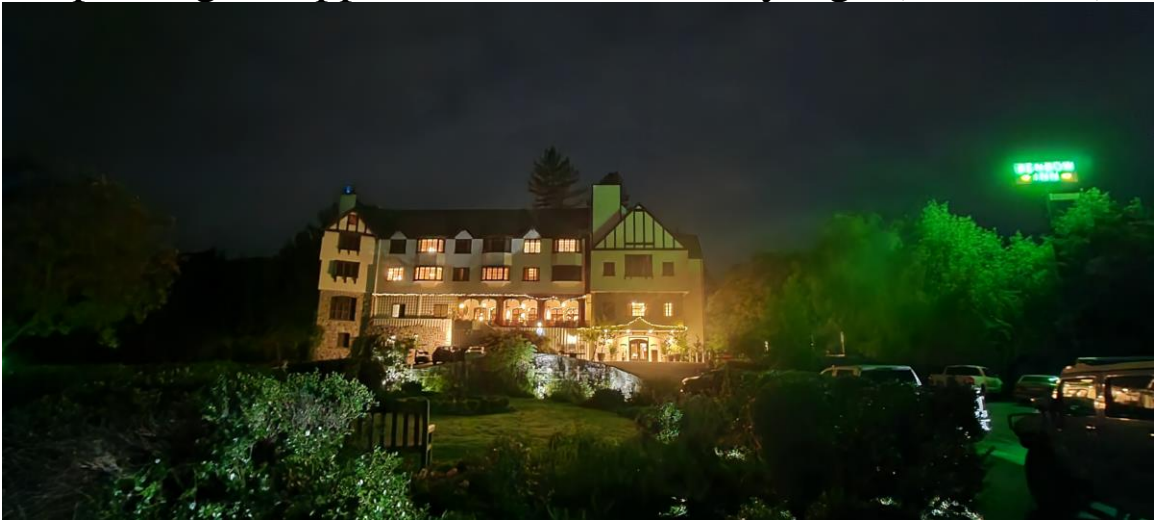
Storm water flows away from the structure. There are no catch basins in the parking lot areas. Storm water flows into the street or eventually into the river. There are low spots in the parking lot that pond water. The primary lighting for the parking lot appears to be the freeway sign (see below).

improving the parking lot lighting. Correct the conditions as needed (see exterior section pages 38-52 above).

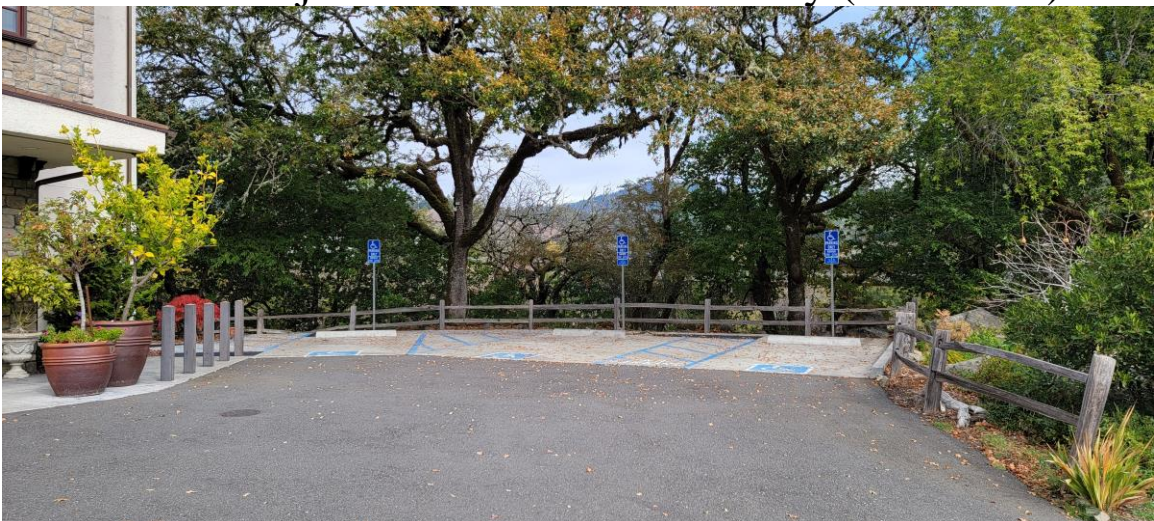
There are three designated parking spaces reserved for ADA access adjacent to the check in lobby (see below).

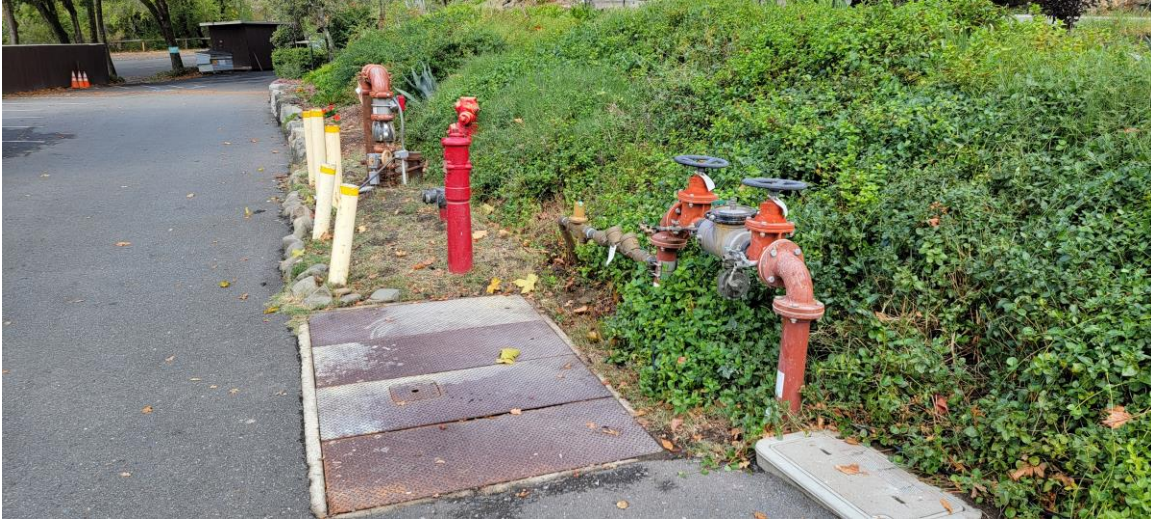
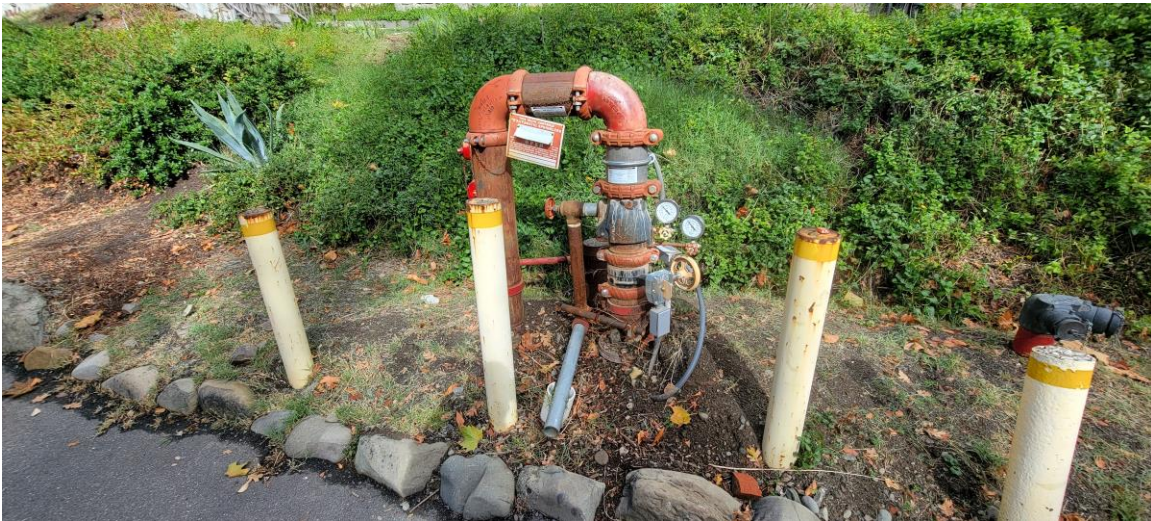
The fire hydrants and suppression valves are located at the southeast lower driveway area (see below).

The fire system could benefit from additional steel post protection to guard against vehicle damage.

7. **FIRE HYDRANT/VALVES:** I recommend that you call the fire Marshall for his recommendations on better protecting the fire hydrant and valve system from vehicle damage.

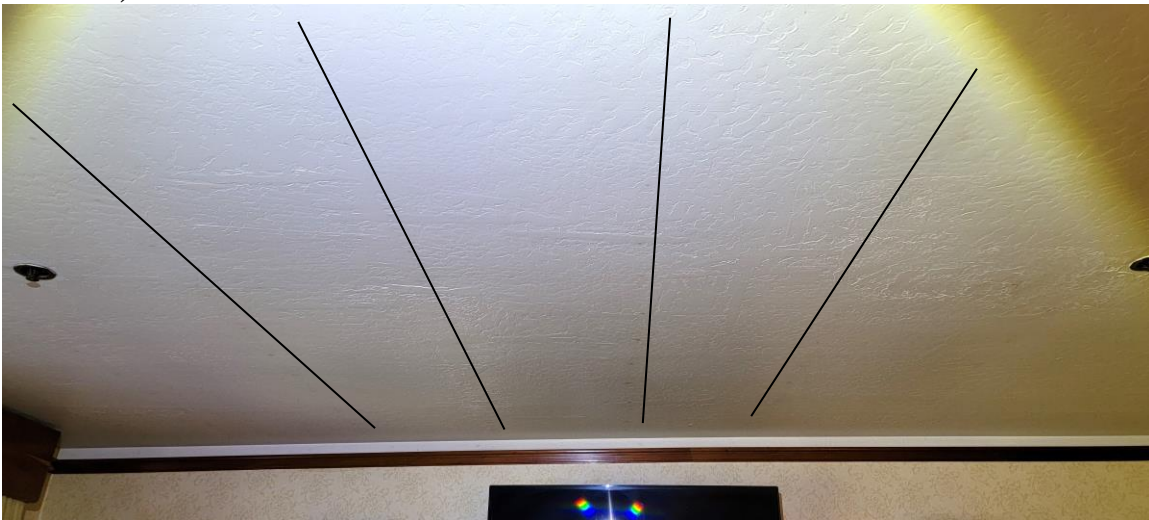
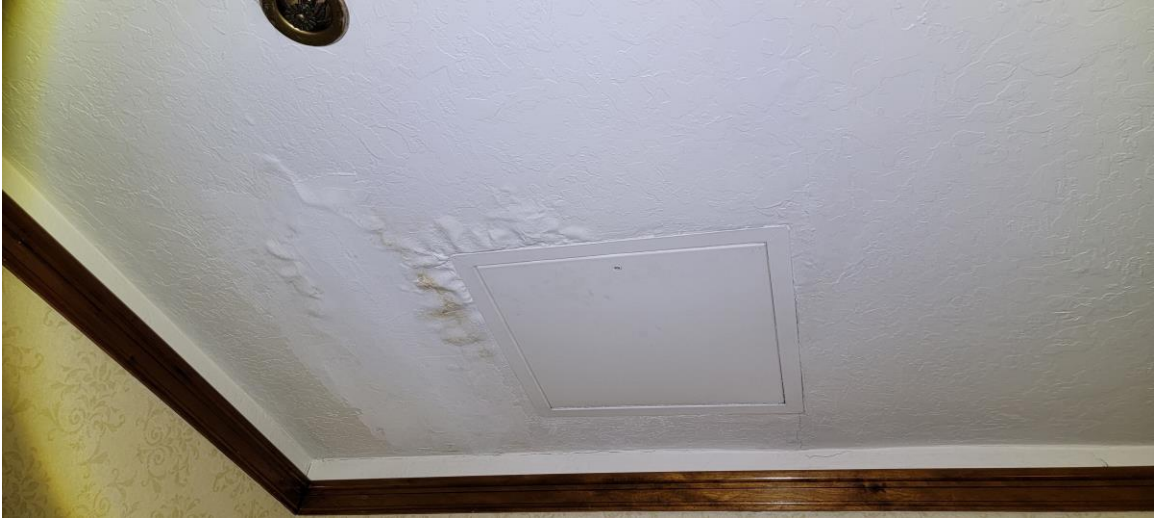
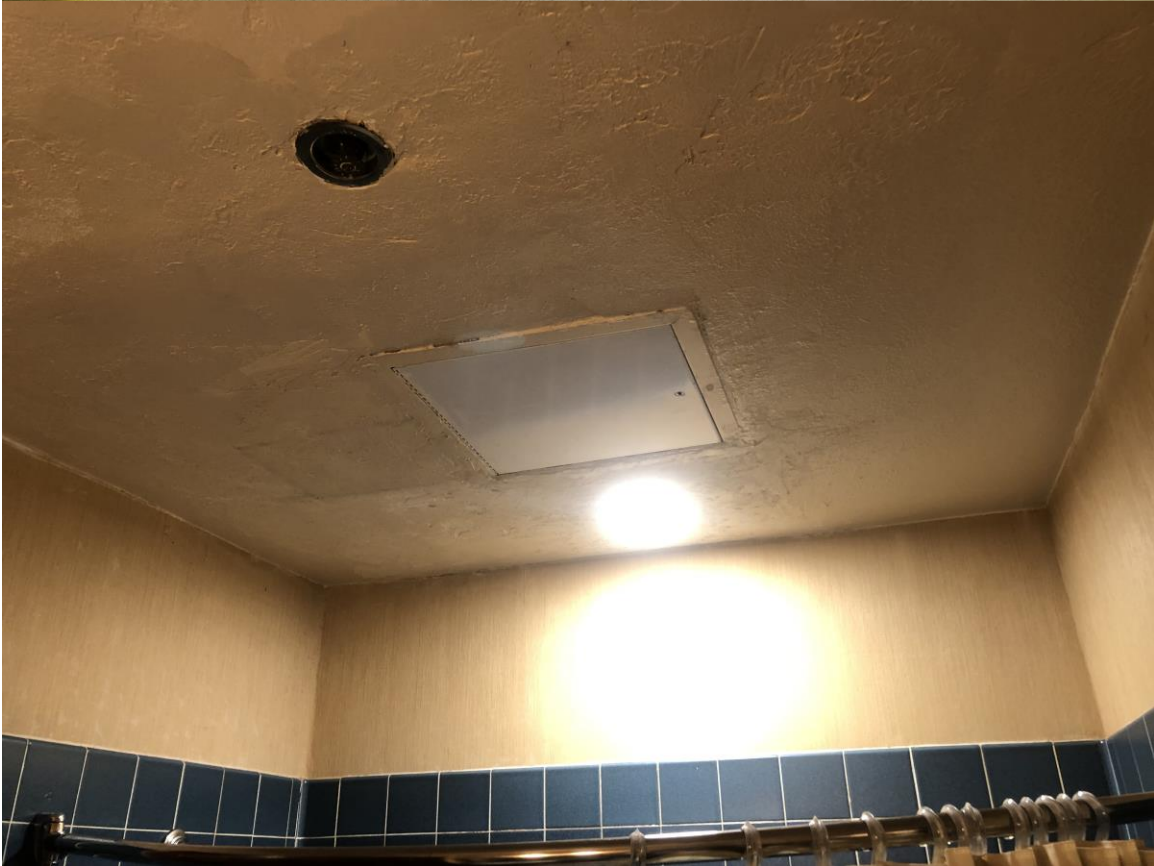
The interior is in good/fair condition. Much of the interior is original. The carpet, vinyl and hardwood flooring is worn in much of the original structure. The newest restrooms in the 2017 steel building addition appear to meet the current ADA standards. There is evidence of water damaged ceilings throughout the original structure, terrace wing rooms under the cottage, and hall at the stairwell. Room 110 ceiling fasteners are rusting and discoloring (see below).

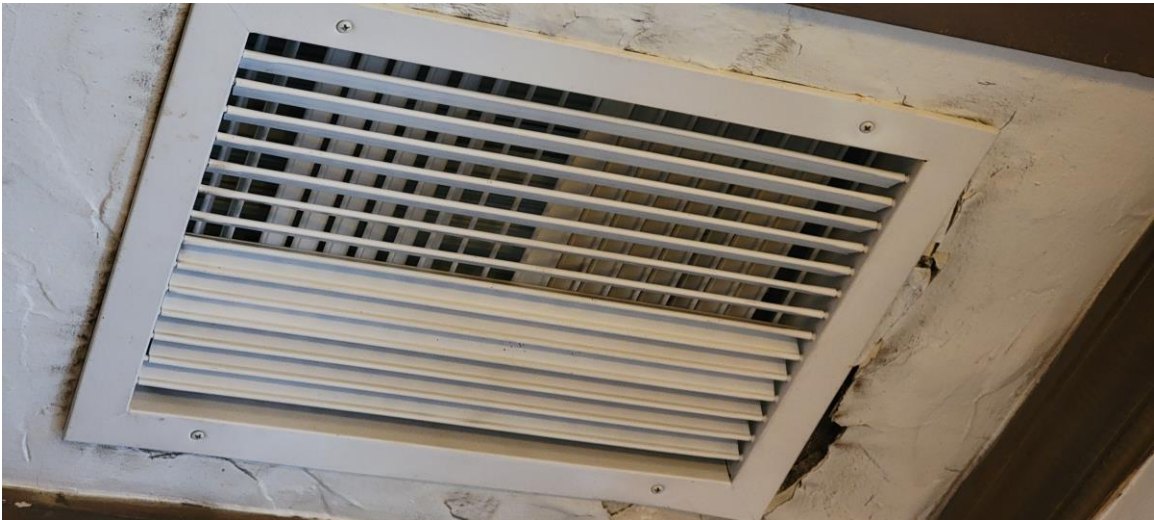
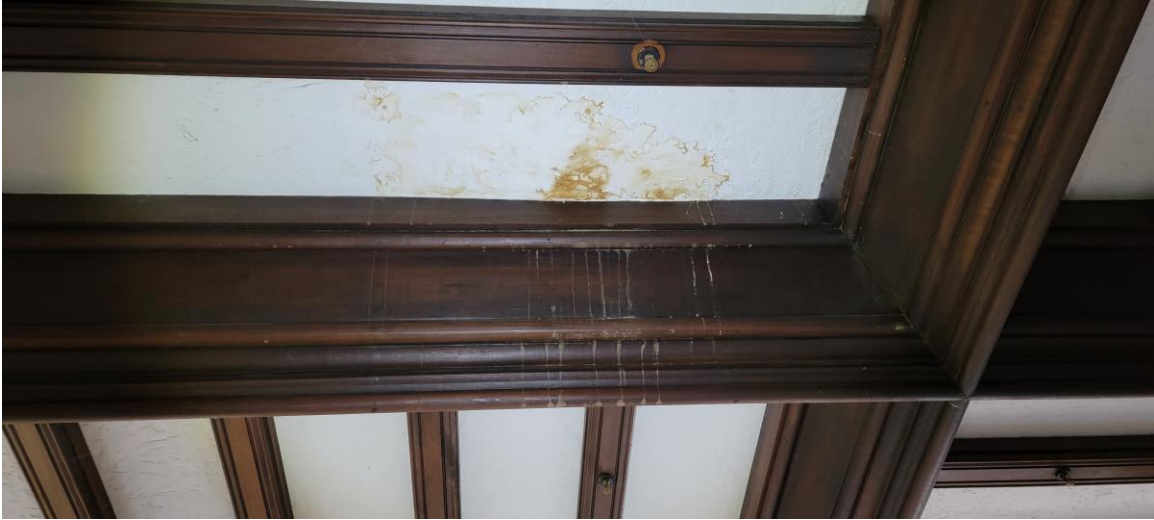
Wooden window sashes, sills, and trims are water damaged in many rooms. Much of the plumbing trims are worn and missing stoppers in the tubs and vanity sinks. There is evidence of water damage to ceilings in the common areas of the upper lobby, bar and formal dining room, likely caused by plumbing leaks in the above rooms (see below).

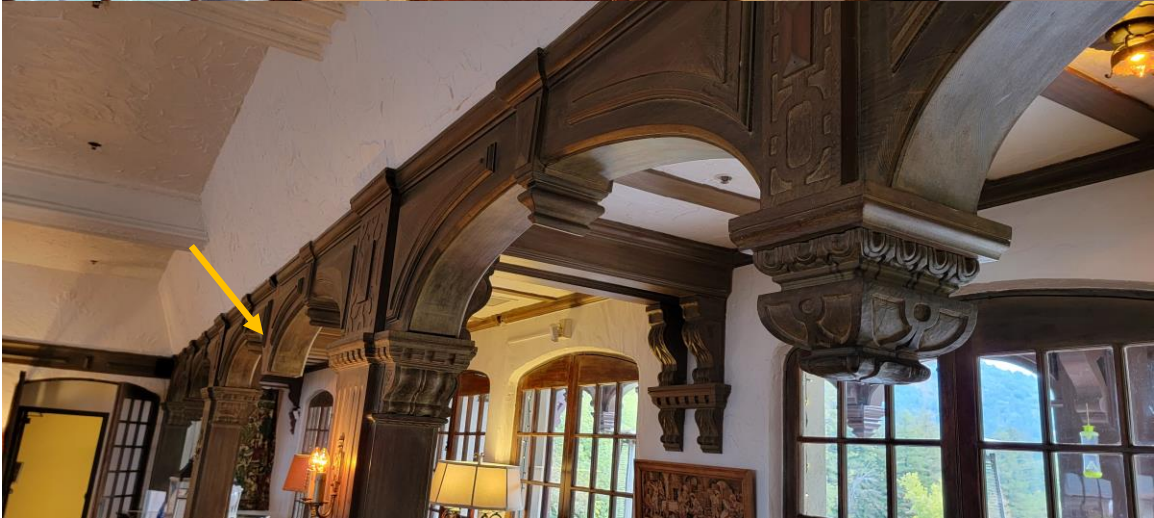
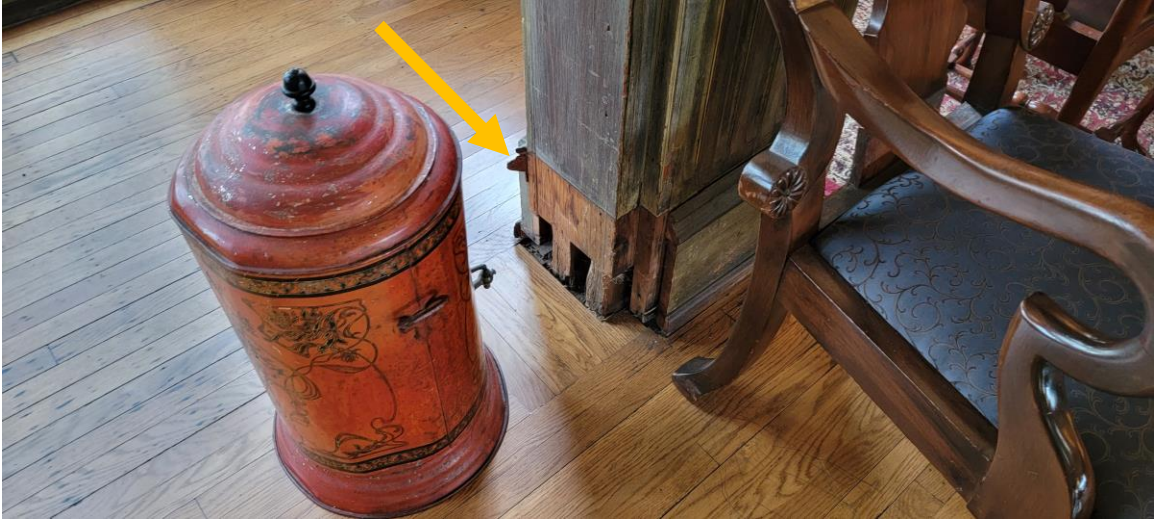
There are missing or damaged light fixtures, moldings and decorative corbels or column caps (see below).

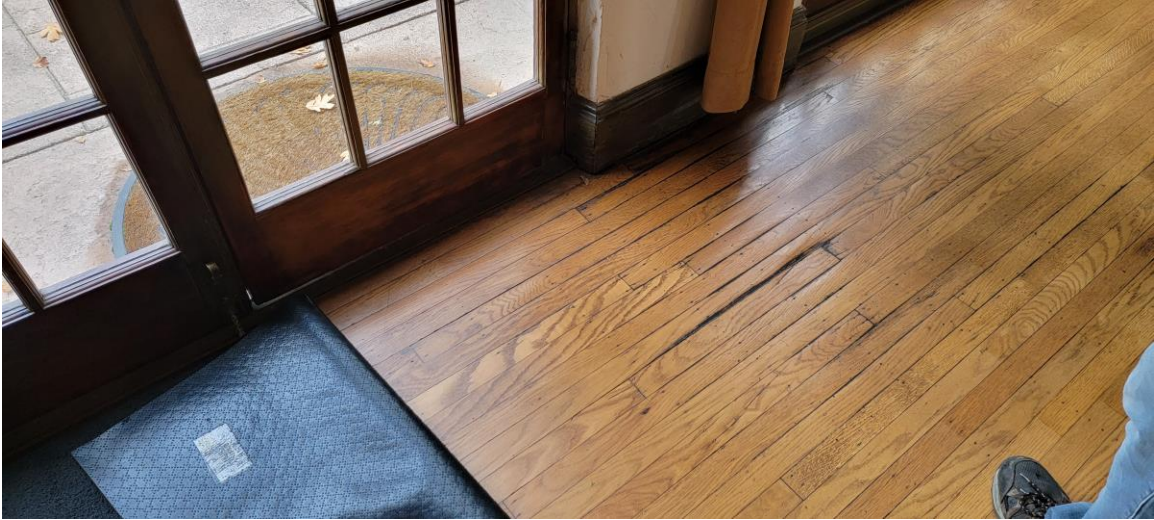
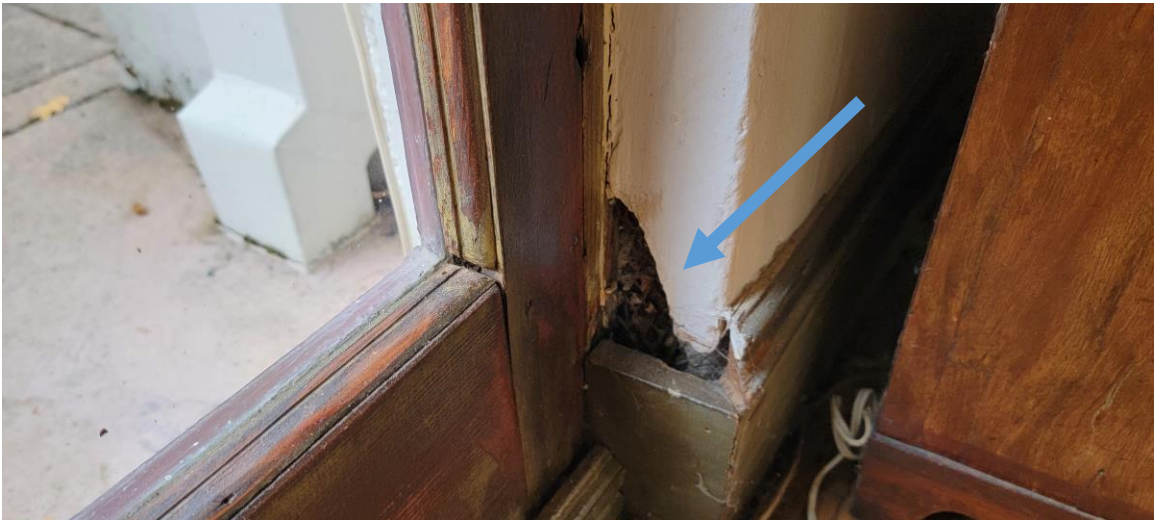
The hardwood floors in the upper lobby, bar and dining areas are water damaged in places, some from water intrusion at the thresholds (see below).

Some water damaged plaster walls (see above).

9. **INTERIOR**: Clean, paint, and update the interior as needed. Repair the worn finished plumbing trims as needed in the rooms. Repair the water damaged flooring as needed. Repair the water damaged bathroom floors as needed. Seal out the weather intrusion at the windows and doors as needed. Repair or rebuild the missing or damaged wood trims and moldings where needed. Install the missing lighting and repair the water damaged ceilings in the upper lobby, bar and dining rooms. Repair the open electrical boxes without cover plates. Repair the loose electrical boxes. **Update the fire extinguisher certifications as needed. Update the elevator certification and post. Post the fire evacuation maps where missing. Verify that the 20 minute fire rated door at room 404 is rated correctly for its location.** Correct the conditions as needed (see interior section page 55-64 above).

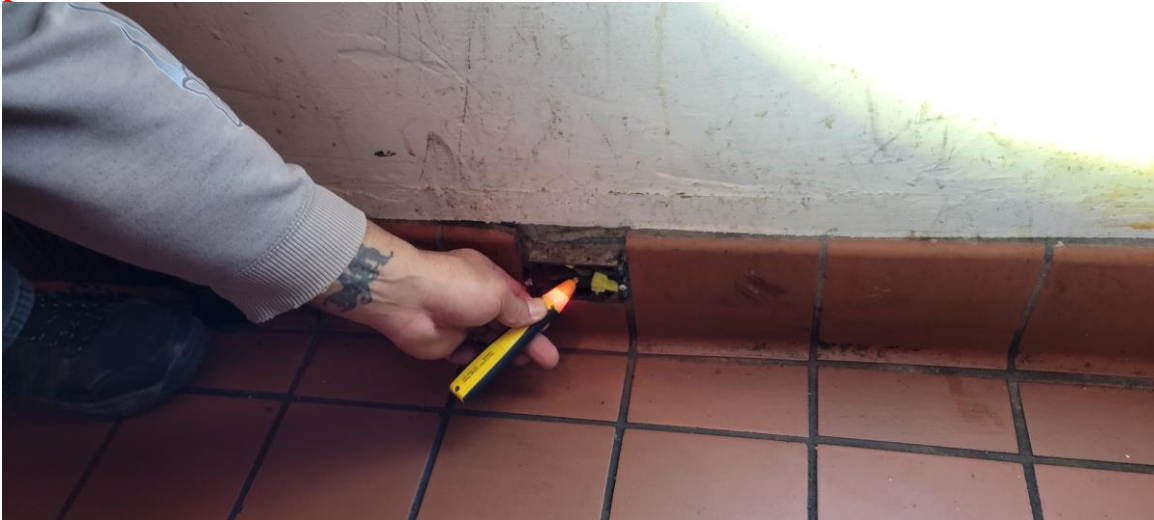
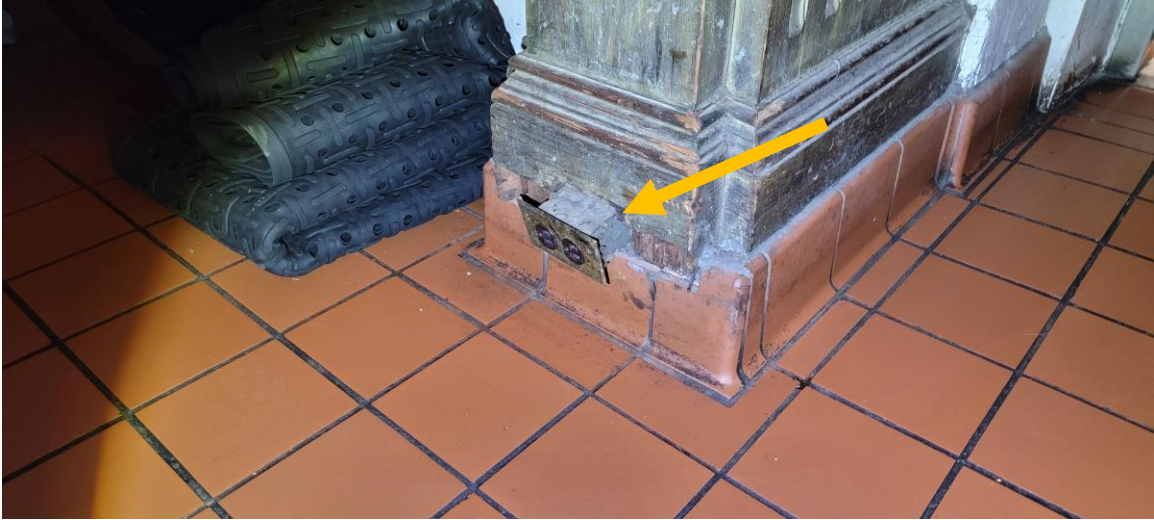
There are loose or open electrical boxes without cover plates in the bar area (see below).

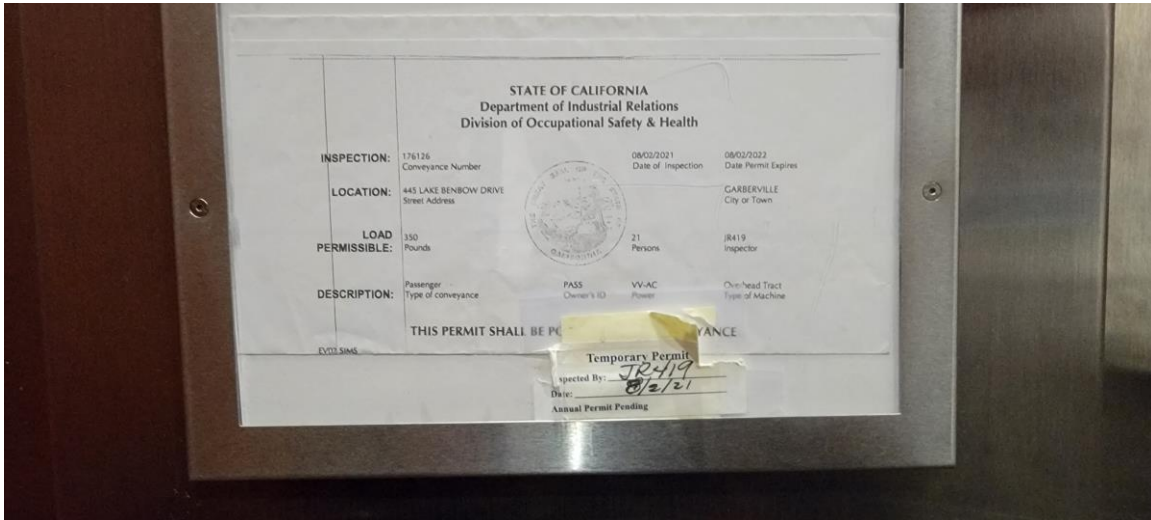
The elevator does not have a current certification posted (see below).

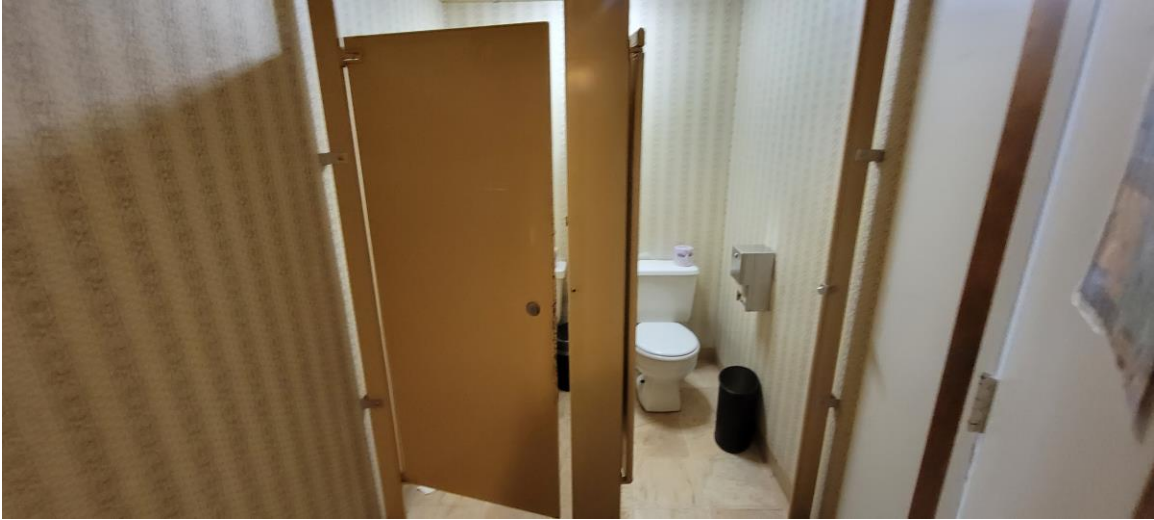
Women's Restroom

The employee restrooms near the kitchens are very worn and outdated. There is no mechanical ventilation in the restrooms to vent unsanitary air properly to the exterior. The walls do not have a sanitary surface for cleaning (see below).

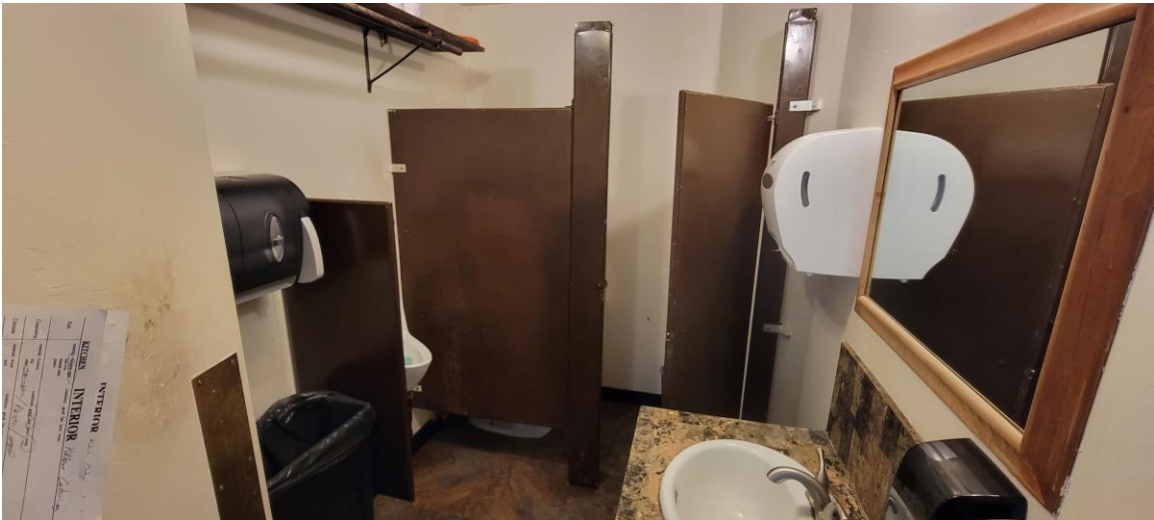
Men's Restroom

The outlet in the men's room is not (GFCI) protected.

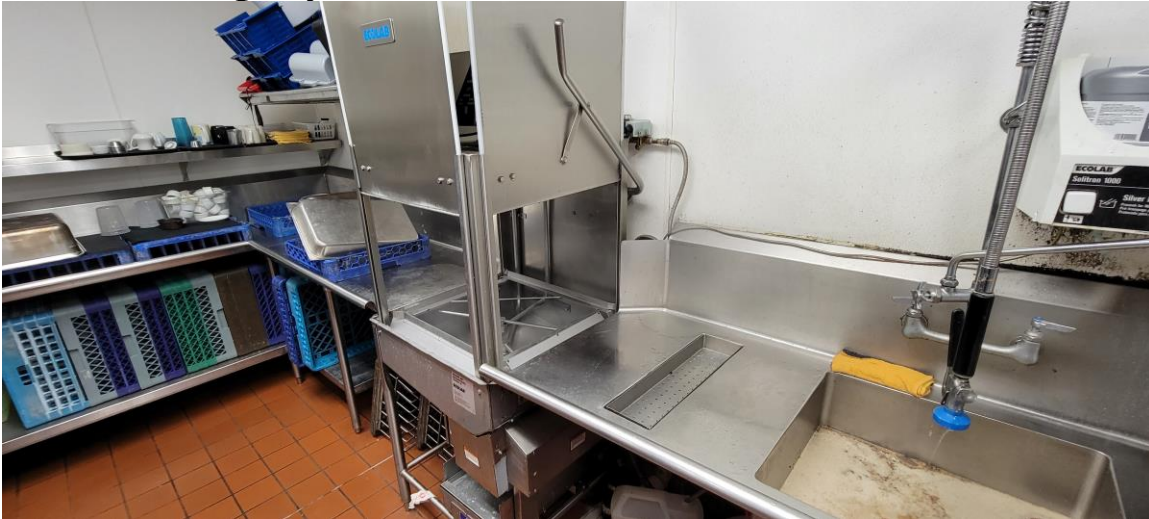
with some cracked tiles in spots. The newer cooking equipment is mostly in good running order. There are a couple of old stoves and ovens that have been reduced to limited use because of age and condition in both kitchens. There is a newer dishwasher that is being leased from an outside company (see below).

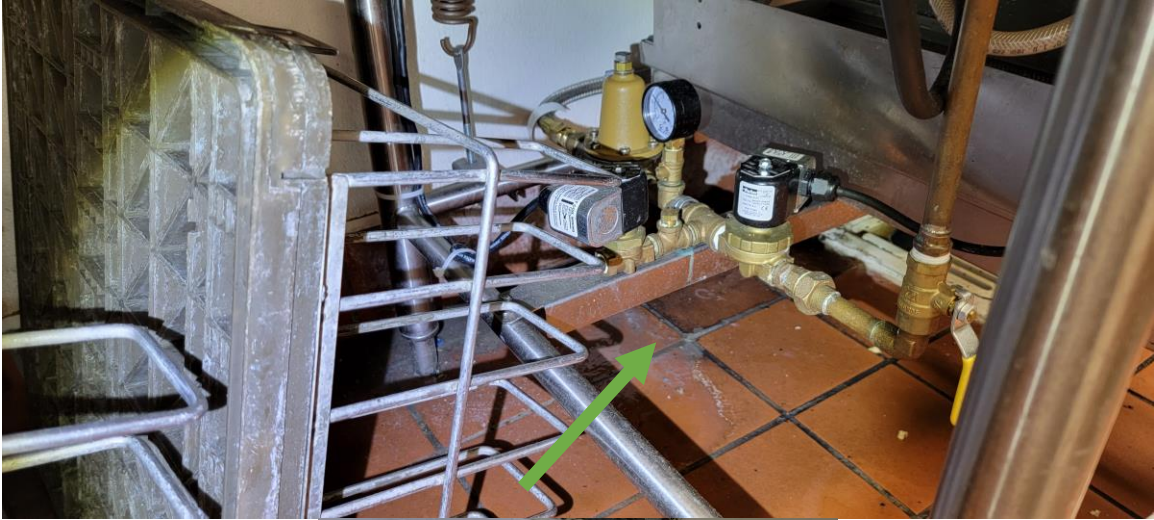
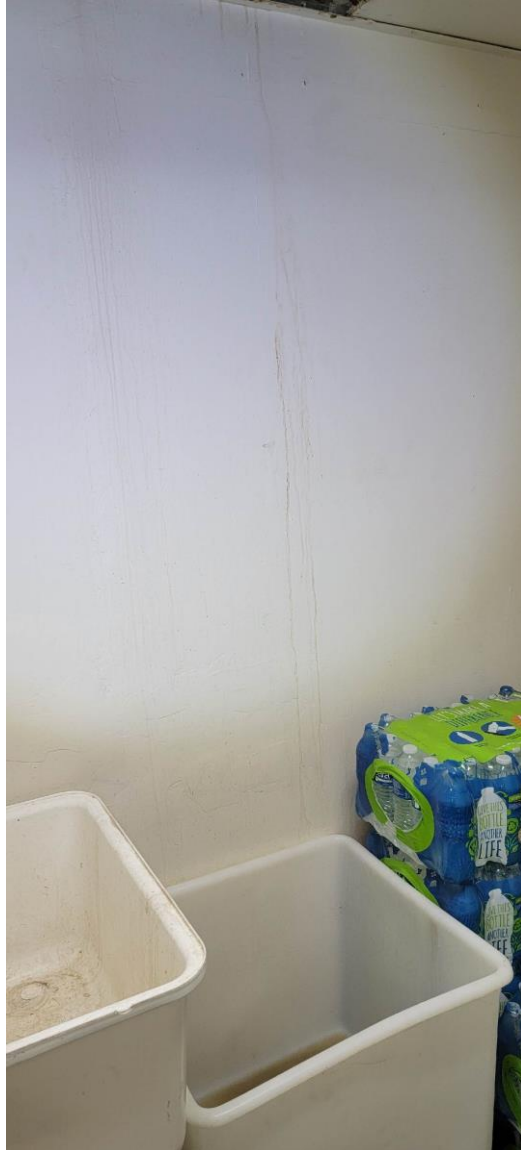
The cooking equipment and hoods are stainless steel. There was a valve or wastewater leak under the dishwasher and a subsequent leak at a floor sink that was leaking into the hallway below. The wastewater was being caught by a large plastic tub (see below).

10. **KITCHENS**: Update or repair as needed the damaged or worn equipment. Repair the dishwasher leaks. Maintain kitchen cleanliness. Repair any trip hazards in the kitchens. Clean the cooking oils off of the employee stairs regularly and or apply a non-slip surface.

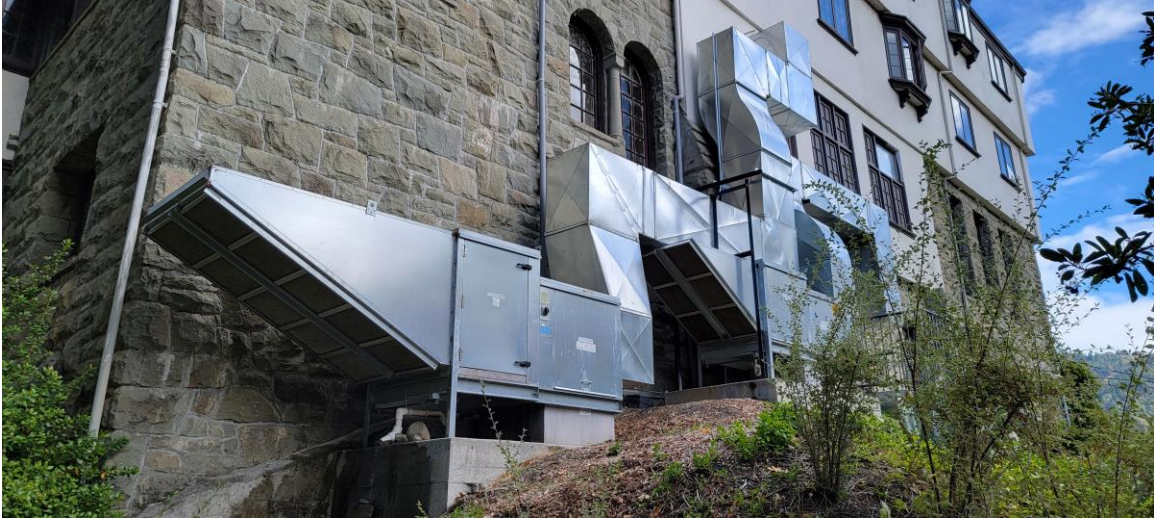
Air Intake Units Both Kitchens

The stove hoods and outside air ventilation systems were working well (see below).

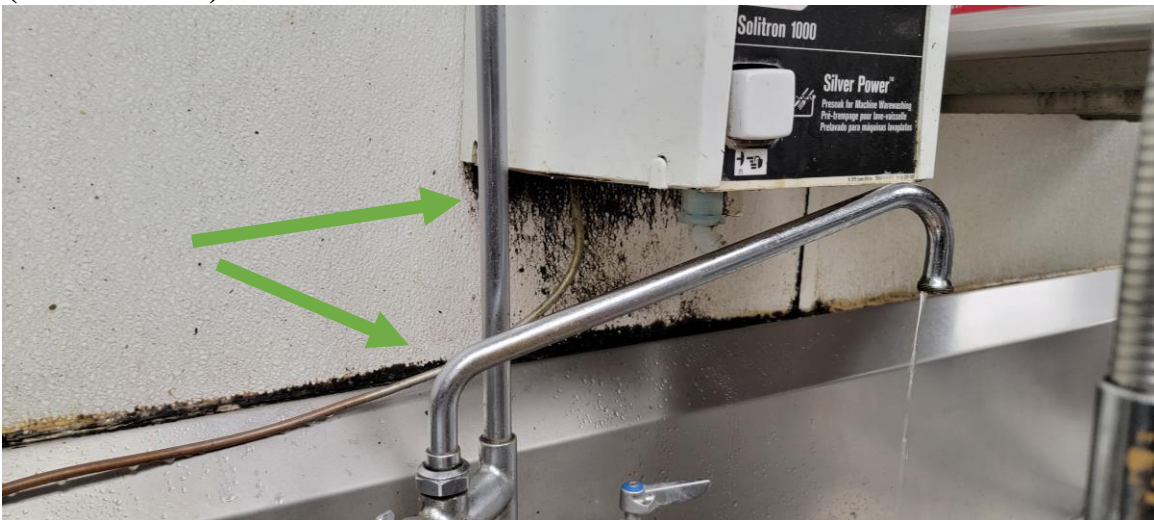
The back employee stairs tread to rise ratio are nonstandard and slippery from cooking oils. At the dishwasher there was some mold, mildew or algae type growth on the wall (see below).

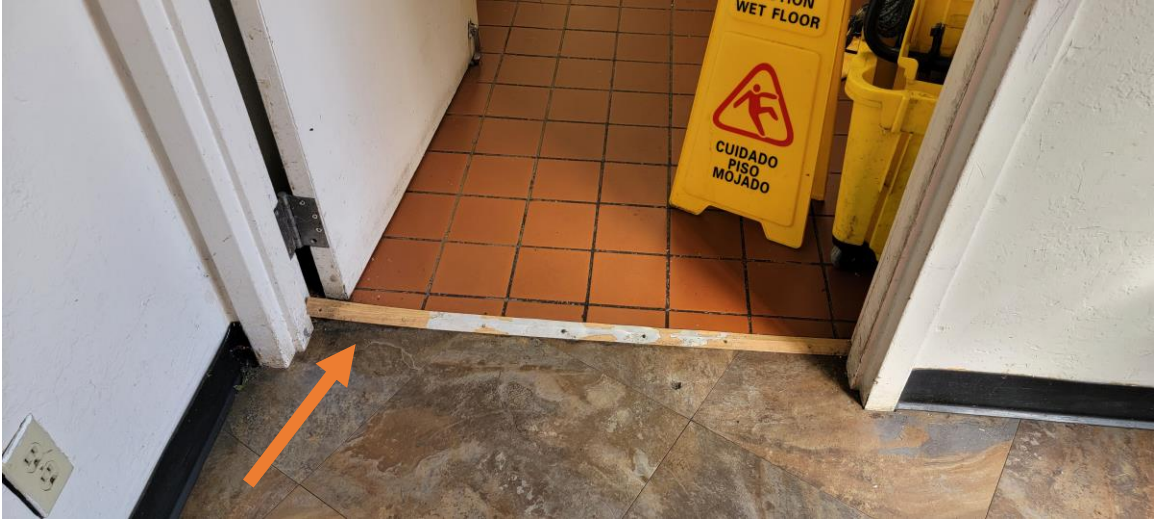
There is a loose flooring transition at a kitchen entry door that may be an employee trip hazard (see below).
