Property Inspection

The Sample Group Corporation

**445 Lake Benbow Drive, Garberville,
California**

**North Coast Property Inspections LLC
PO Box 422
Field's Landing, CA 95537
(707) 444-2326**

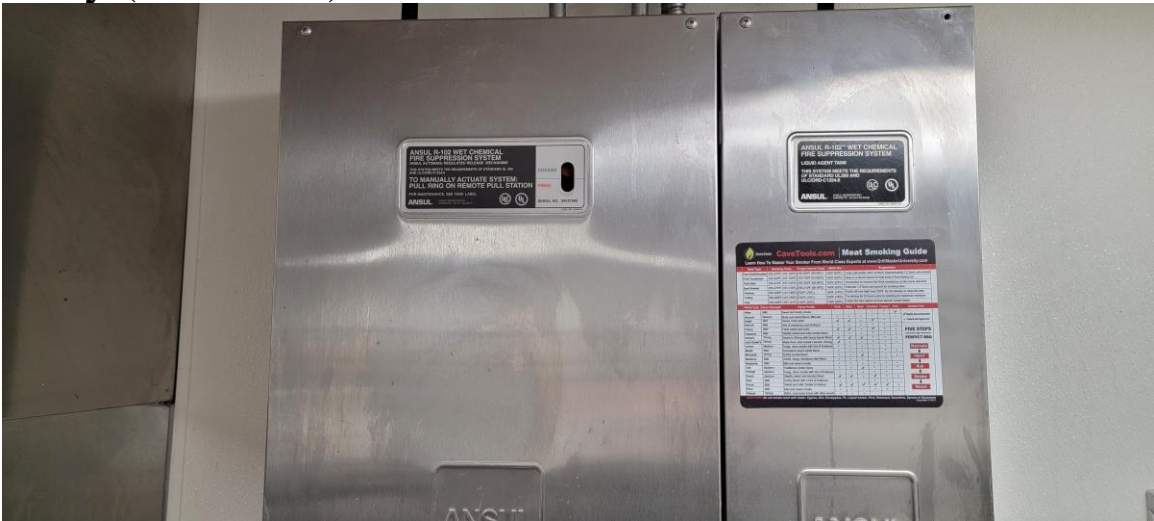
Both kitchens have fire suppression systems charged and ready (see below).

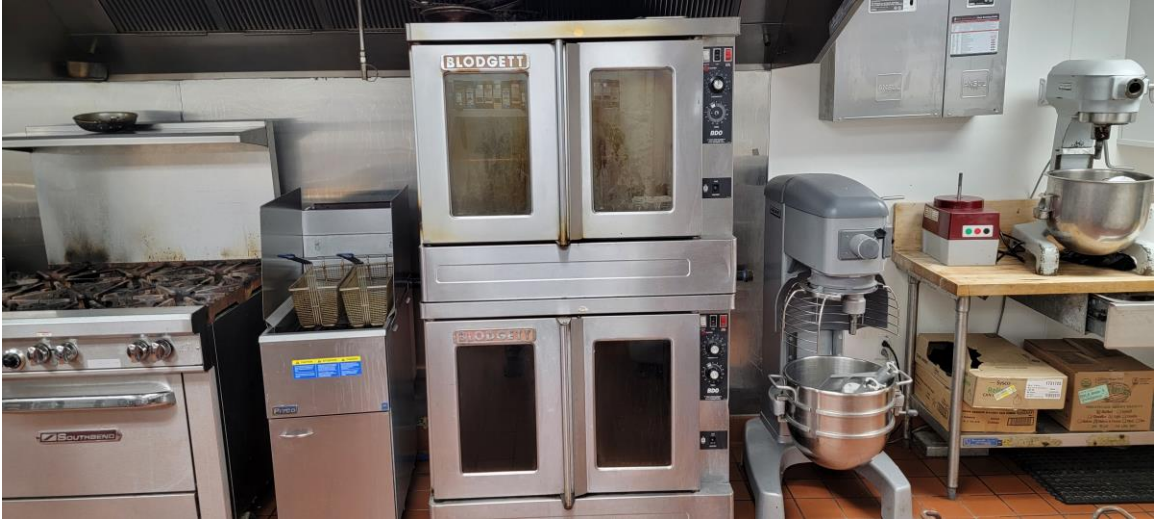
Below are photos of the older ovens that have limited use. Similar ovens are in both kitchens.

10. **KITCHENS**: Update or repair as needed the damaged or worn equipment. Repair the dishwasher leaks. Maintain kitchen cleanliness. Repair any trip hazards in the kitchens. Clean the cooking oils off of the employee stairs regularly and or apply a non-slip surface.

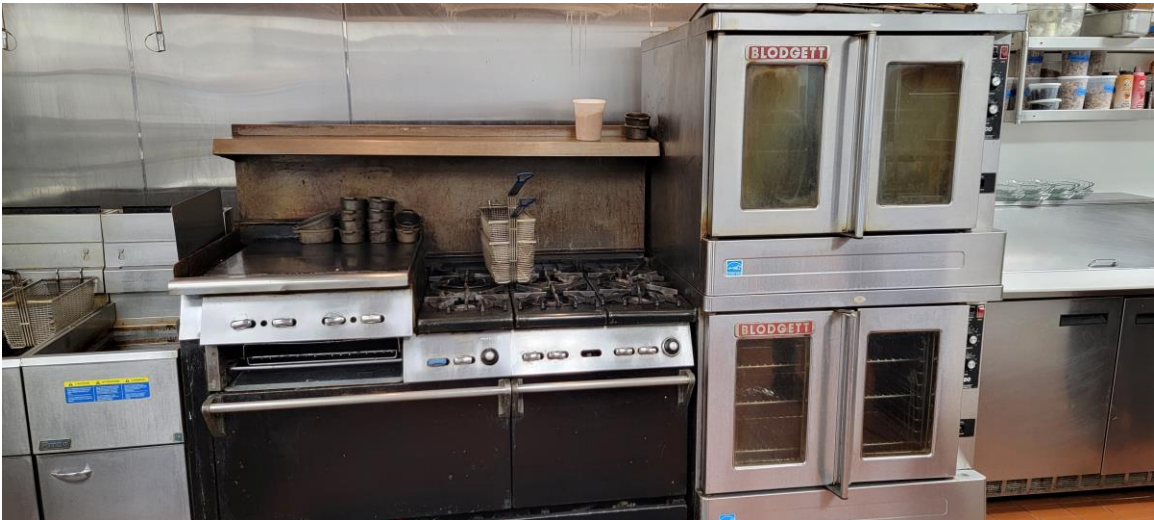
Old oven and stove with limited use shown below.

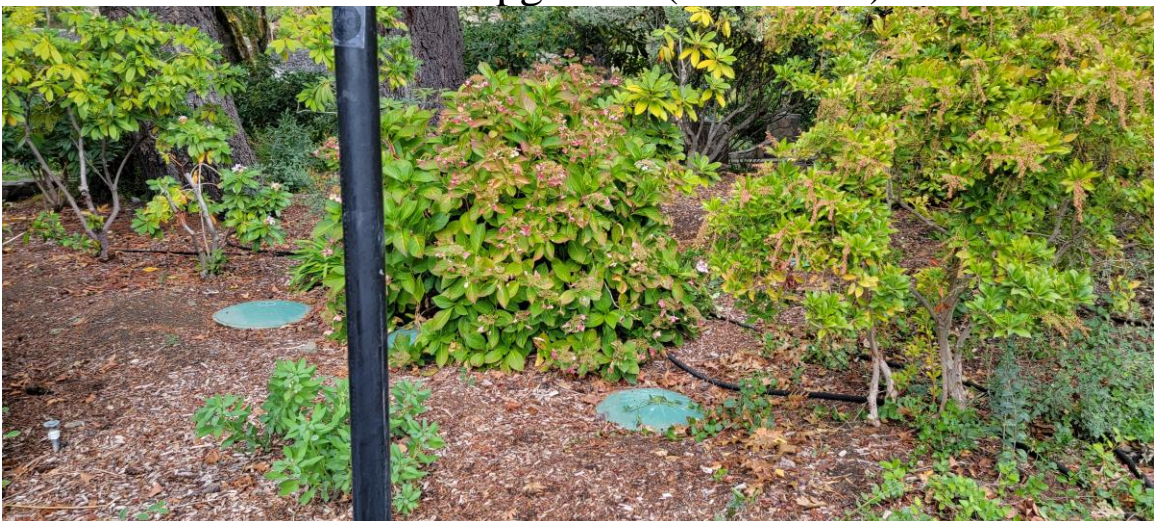
The grease traps are located at the exterior southwest corner which have been upgraded (see below).
